**The Solite Dutch Barn, June 1998**

Report on  
**The Solite Dutch Barn**  
Saugerties, Ulster County NY  
its recent history,  
a comparison with other barns  
and  
plans for its future.

January 2004

by Peter Snclair

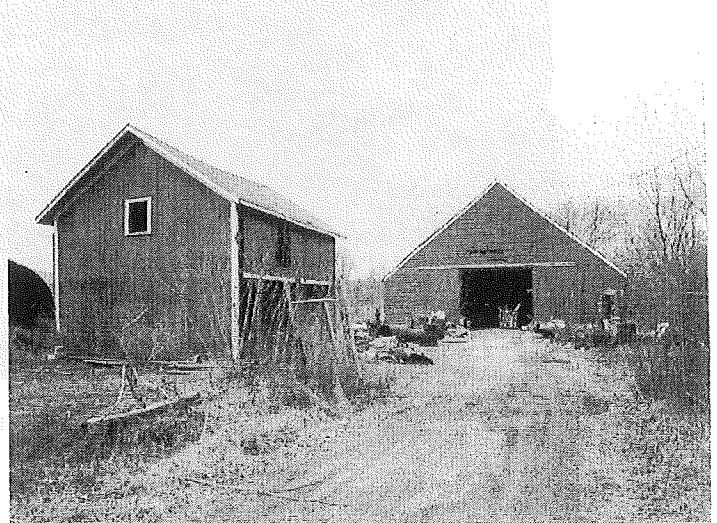
**The Solite Dutch Barn and Carriage Barn  
December 2001, photograph by John Stevens**

The oak frame of the Solite barn is in generally good condition. A good roof and recent repairs to one wall plate and replacement of several rafters has stabilized and saved the structure. It no longer has a threshing floor and not much of its sills survive. The Brink barn has a wood pegged threshing floor in good condition and many original features, like the latching system for the wagon doors, that could help in the restoration of the Solite barn. In both barns the longitudinal struts on the cow side have been removed.

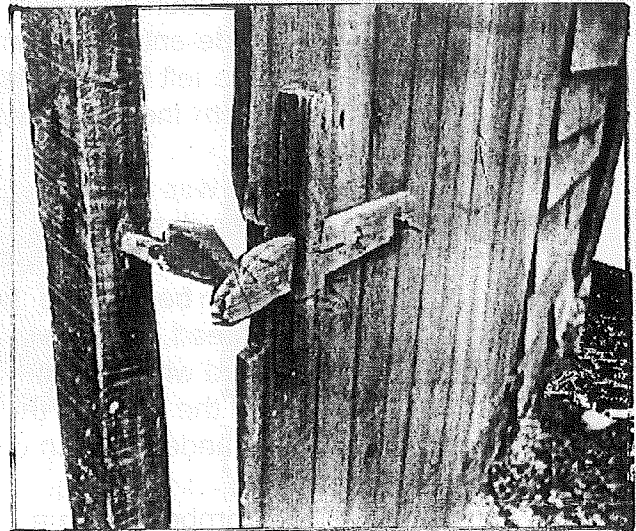
**Wooden latch and Removable  
Center-Pole of the Wagon Doors  
Brink/Mueller 4-bay Dutch U-barn (Uls-Sau-9)  
Saugerties, Ulster County, NY**

The pole was known in the local dialect as the "middelmans" or little-man-in-the-middle.

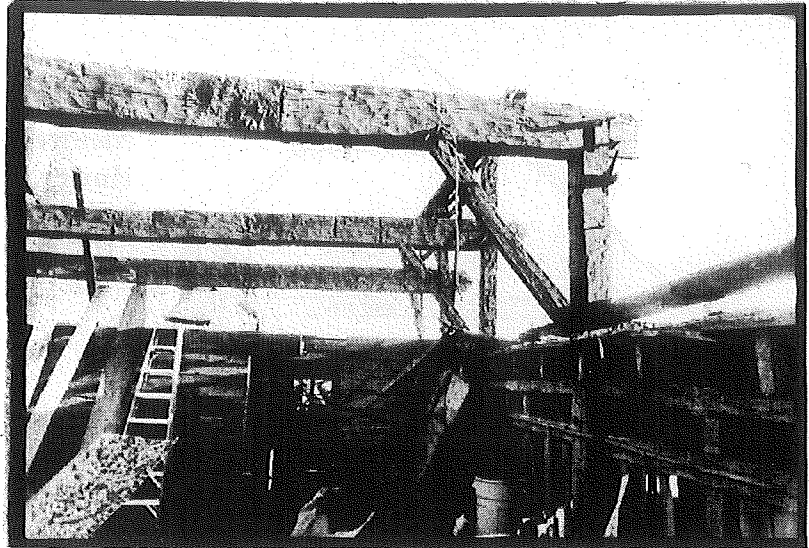
**Hornbeck/Myers/Grace 4-bay Dutch Barn(# 58 )**  
**Town of Rochester, Ulster County, NY,**  
**November 1994**

century by raising the side walls and its major/minor rafter system replaced with common rafters. Three of the six 30-foot anchorbeams survive including the inscription beam. Some of the frame has already been removed by Robert Stevens and is in safekeeping in the 30x40-foot circa 1870 side-entrance barn that has an end wall in need of repair. Two longitudinal struts from the left horse-side of the Hornbeck barn survive with notching for a hay manger and struts from the cow side survive with a series of holes drilled vertically to form a stake wall.

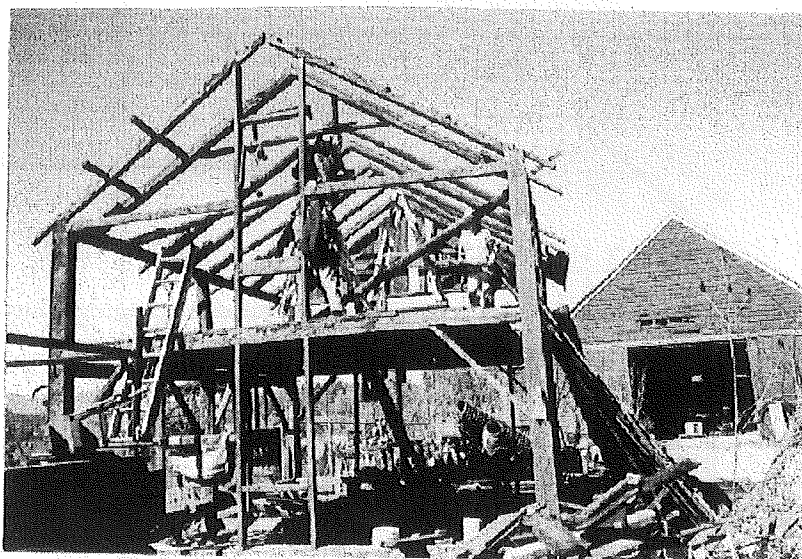
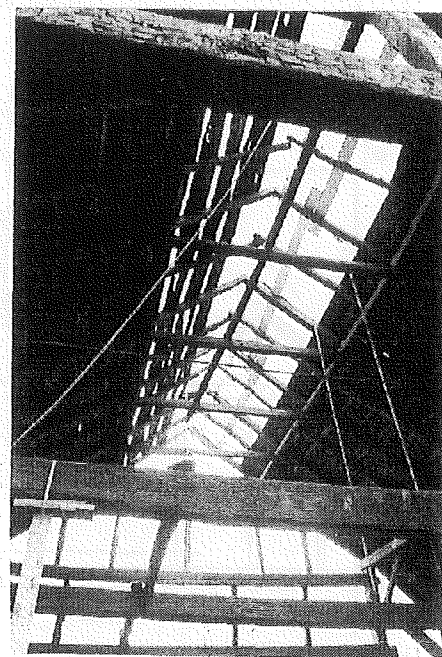
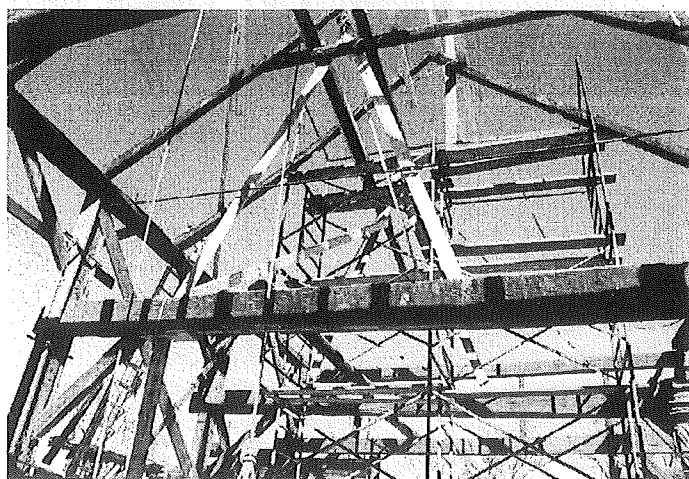
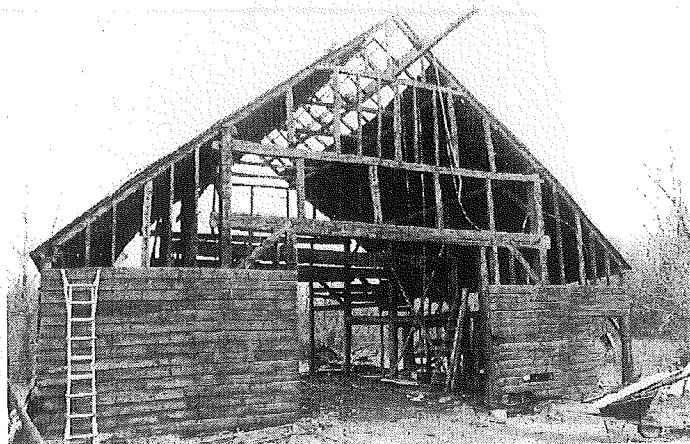
(upper left) **Bob Hedges and crew disassemble the Solite carriage barn, April 2002**

(upper right and lower right) **Jim Krickler and crew remove the ridge pole, December 2003**

(lower left) **Upper purlins and rafters removed, December 2003**

The removal of the light and delicate 45-foot long 4-sided ridge pole and two upper purlins was a unique situation that required good planning and teamwork.

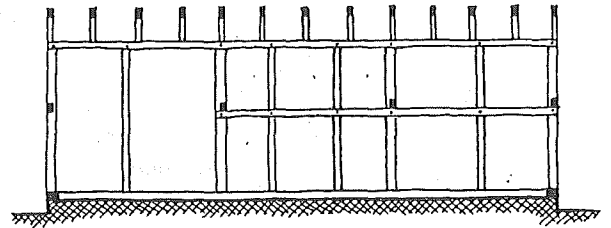
Section C-C

There were parts of two rough shaped **riven planks** held with wooden pins to the wall posts on the west side-wall (see section C-C, Stevens drawing). These correspond in height with their longitudinal struts and appear to have been used to support poles for a hay mow above the cows. These need to be reconstructed.

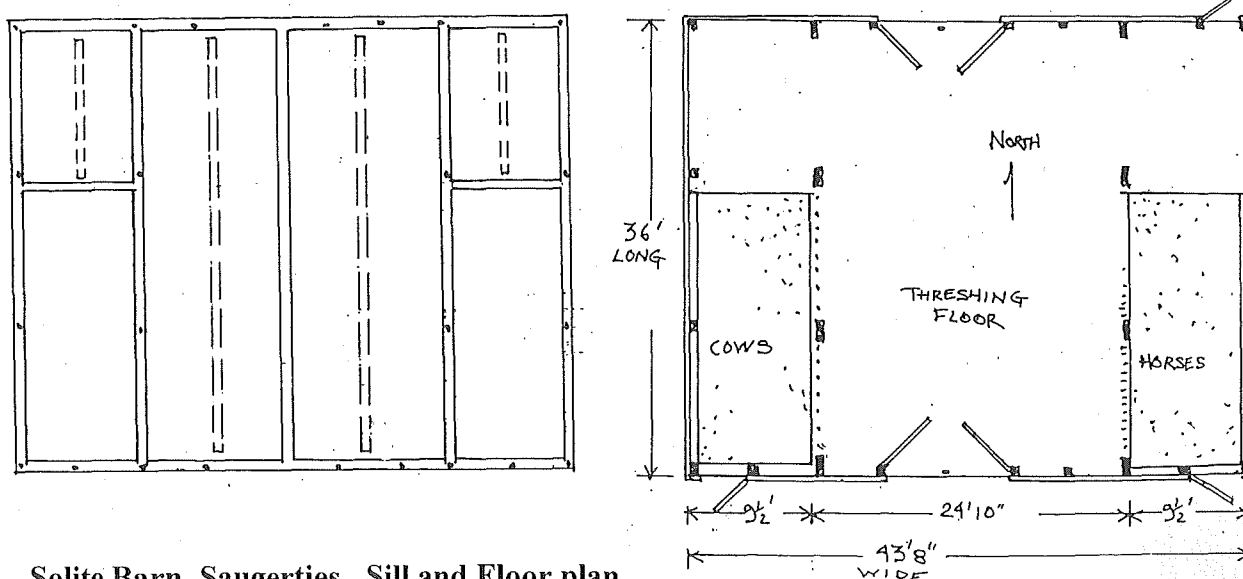
#### Solite Barn, Saugerties, Sill and Floor plan

(left) The sill beams rest on a dry-wall foundation. The sleepers, shown with interrupted lines, rest on stones and are unconnected to the sills

(right) The plan shows the horse and cow stalls with dirt floors. The two sets of 4-part wagon doors have traditional wooden hinges and open into the barn.

The **sills and sleepers** should rest on a **dry laid stone foundation** with large stones under the posts.

The **threshing floor** should be of 2 1/2-inch pine planks splined and held to the **sills** and sleepers with wooden pins. There should be a **longitudinal center sill** and longitudinal **sleepers** to either side. Sills are one of the least studied parts of the Dutch barn. Often they and the floor are missing and when there is a floor the sills are hidden. The best evidence is gained when barns are disassembled.
