DUTCH BARN RESEARCH MISCELLANY

VOLUME III, No. 1, 1-34, 1990

INDEX

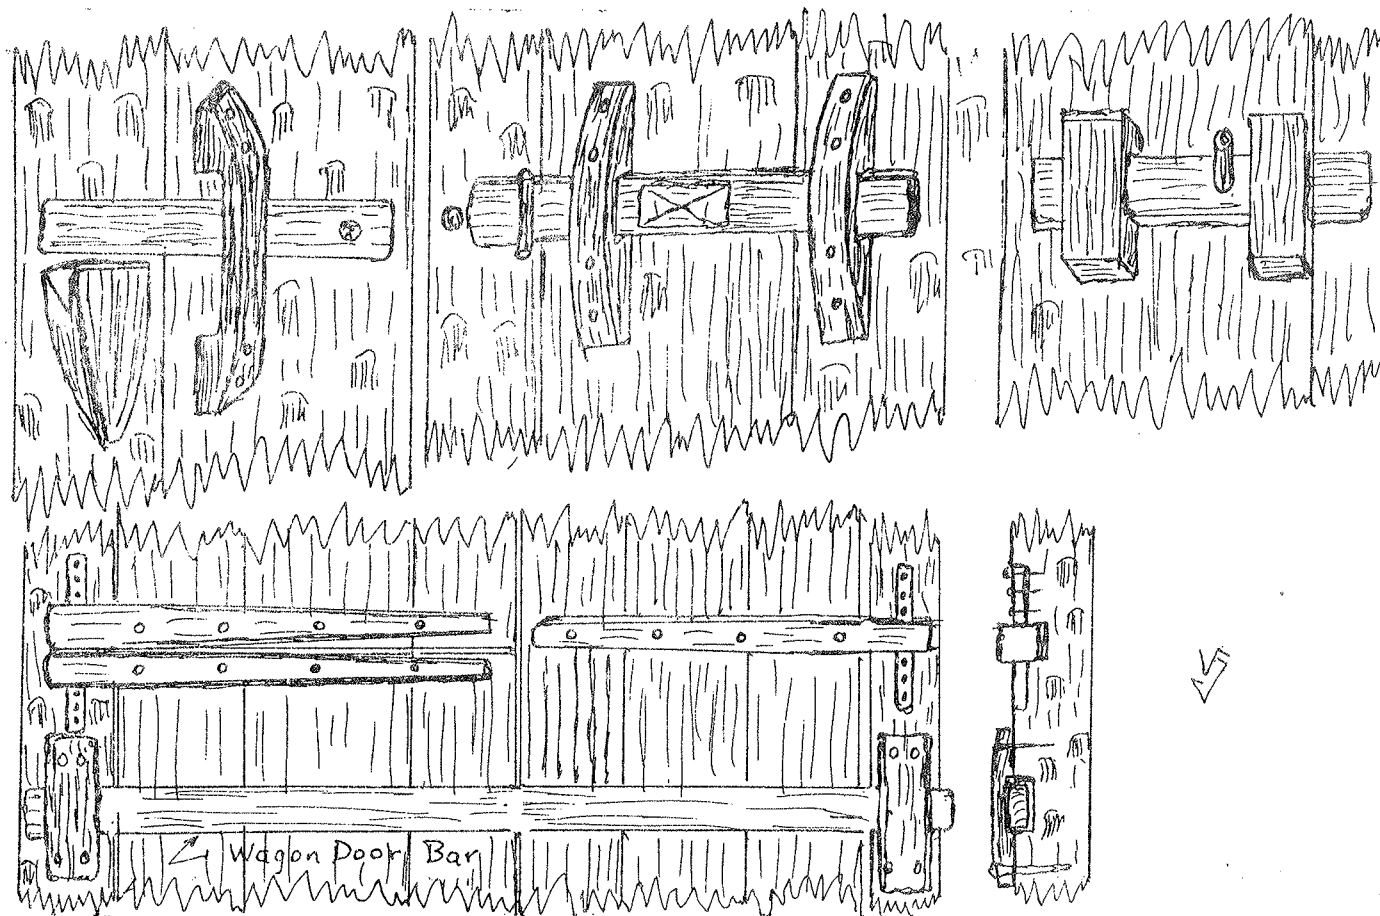
Among the smaller but beautiful objects in the interior of Dutch Barns are the wooden latches and bars which controlled the security of the granary and the large and small doors of the structure. These were generally made of oak or hickory and those that remain bear a beautiful patina polish from centuries of contact with human hands. Most of them, as shown in the three sketches, are extremely simple but very functional.

The swinging latch sometimes is installed on the animal doors. The retainer of the latch complex consists of a notched, round pin which projects through and beyond the inside of the timbered frame of the door and is held in place with a rectangular tapered wedge.

The latch is retained with a single slotted bracket which limits its movement within an angle of about 20° . This can be mounted on either side of the outward swinging door. A different sliding bar assembly is located on the inside of the animal door, is retained by two brackets and is generally manipulated with a projecting boss which is operated from the inside of the door.

Another simple latch is a miniature of that on the animal door and is generally located on the granary door. It is considerably smaller with a bar that is slid by grasping a pin which moves the bar held by two small wooden brackets.

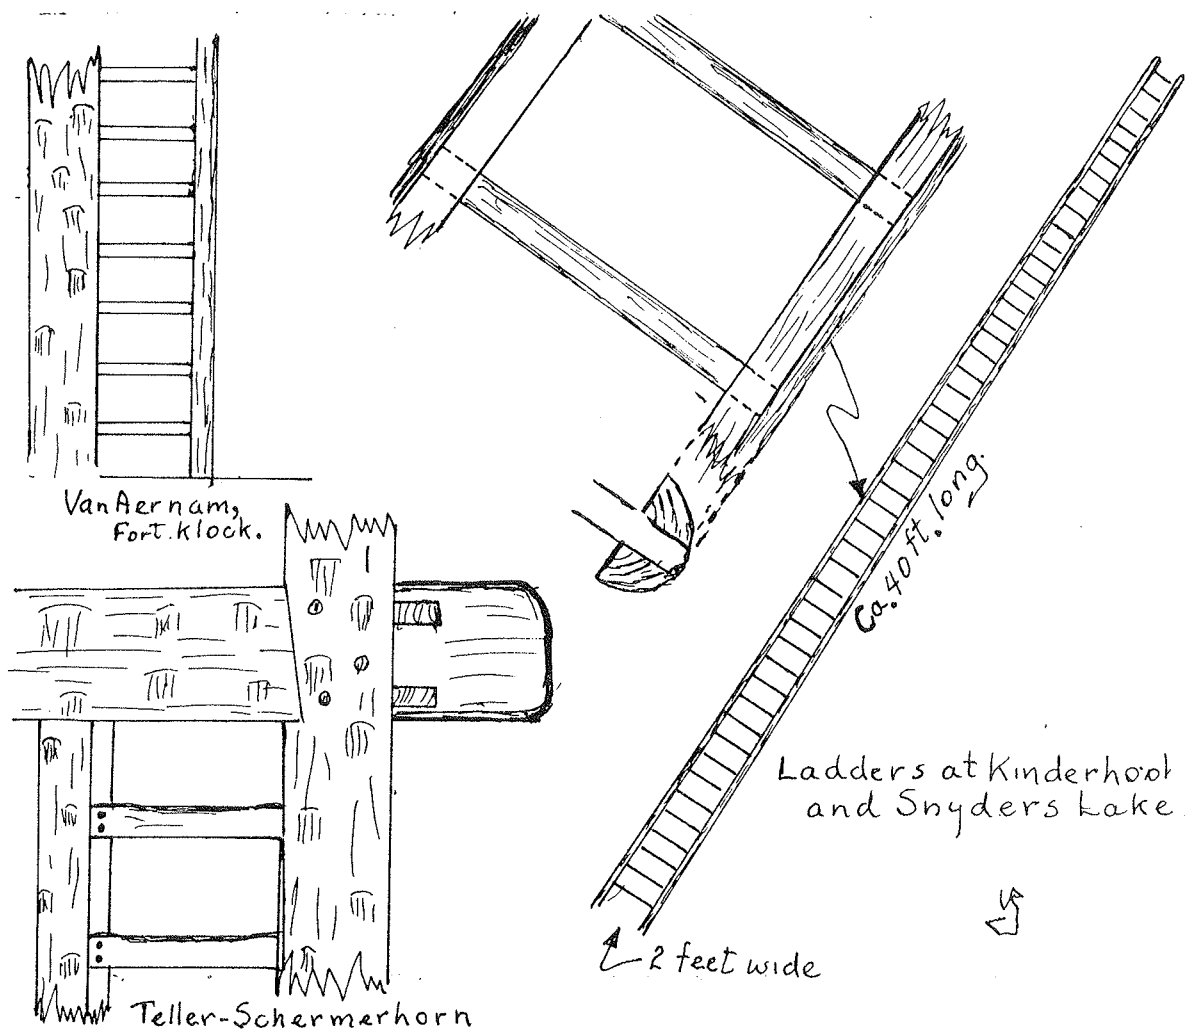
In the Town of Guilderland which has some pre-Revolution barns nearly every one has such ladders. All of them are built using one of the vertical timbers as one side of the ladder the rungs being rounded. The other side is generally made of a smaller hewn timber which is located either parallel to the gable wall or where it is located on one of the anchor beam posts at an interior bent.

In other barns such as the Teller-Schermerhorn Barn the built-in ladder is at the gable end with its flat rungs being recessed in the vertical timbers supporting the outer wall.

Several free standing ladders have been found of massive size. These were over forty feet long, two feet wide at the base but tapered. The side members were made of a split tree having the rounded portions on the outside. It is difficult to visualize how such a ladder could be moved or manipulated.

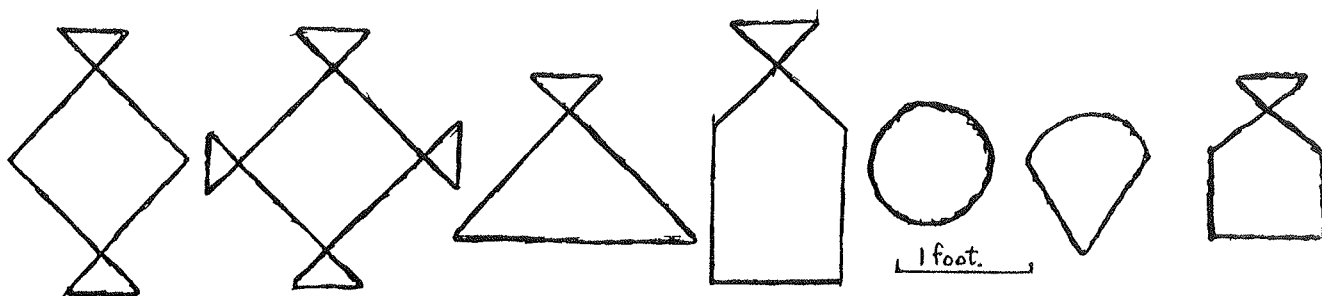
At least seven shapes have been observed in the shape of the Martin Holes. Most of them were made as square or rectangular holes but almost invariably they had a secondary hole as shown in the sketches disclosing the artistic sense of the builders.

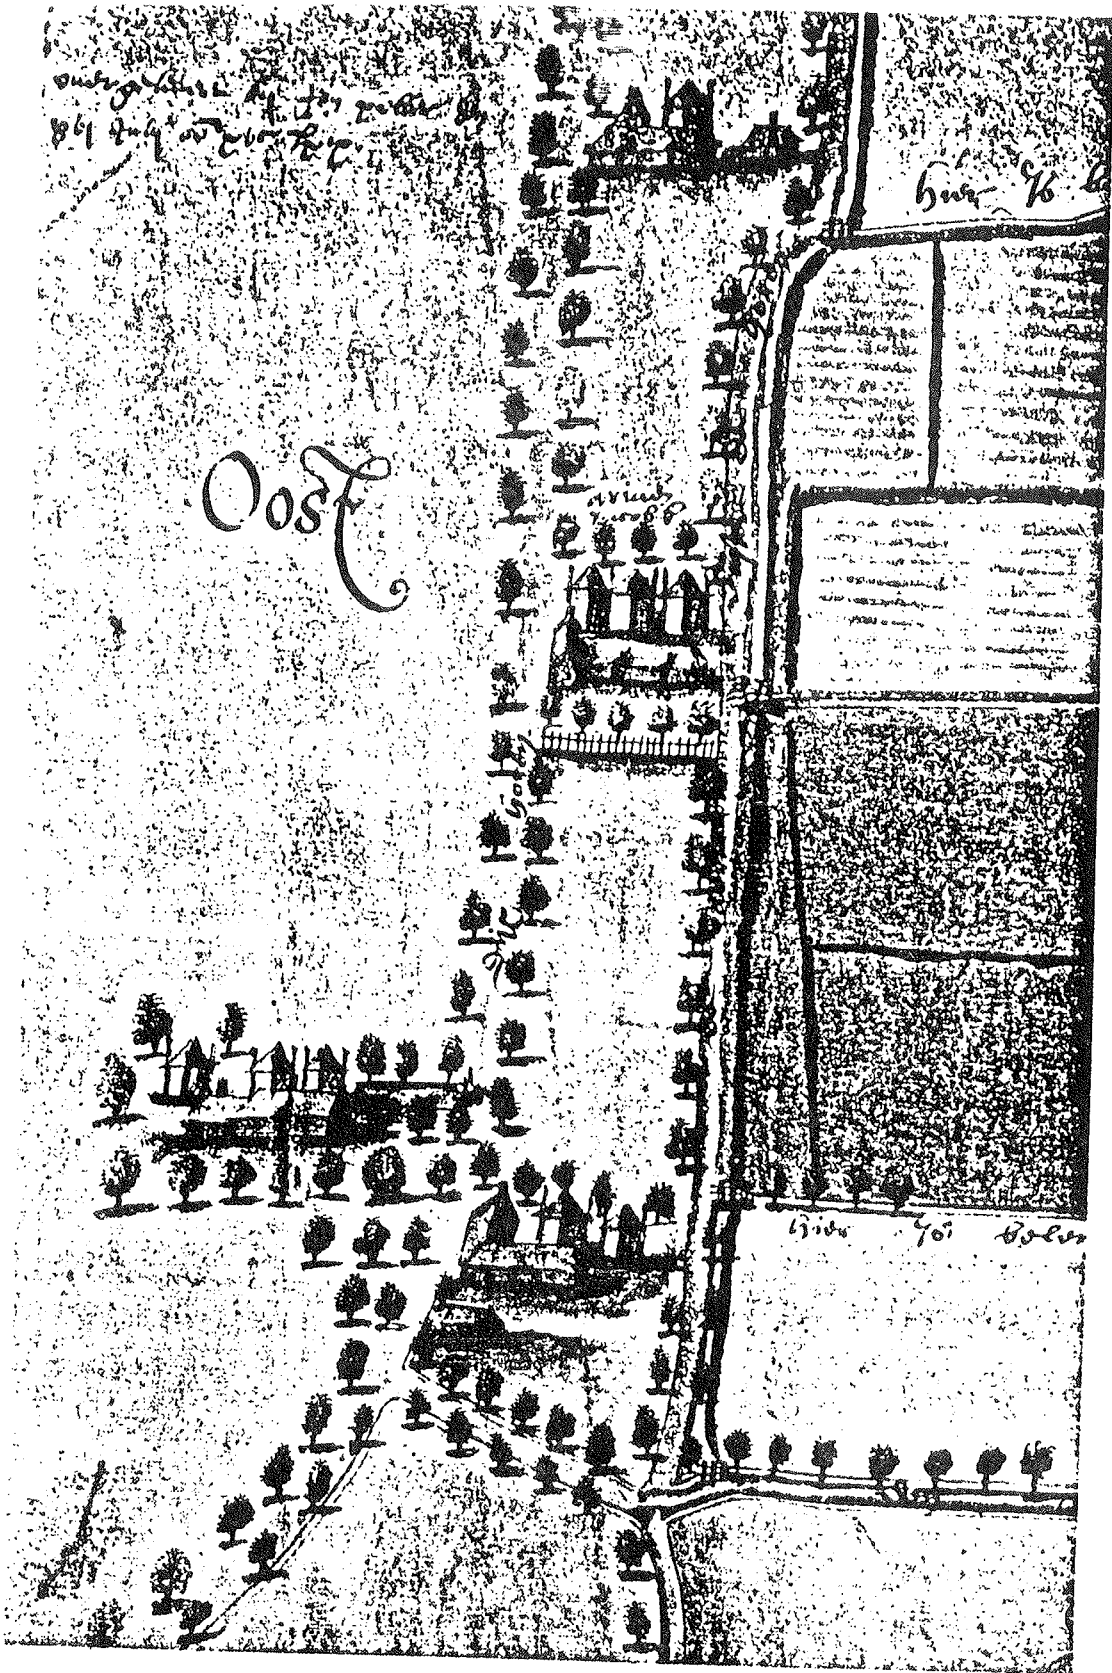
19. Farms in the vicinity of Delft c. 1569. Note farms have one, two or three hay barracks. (Voskuil 1979:82)

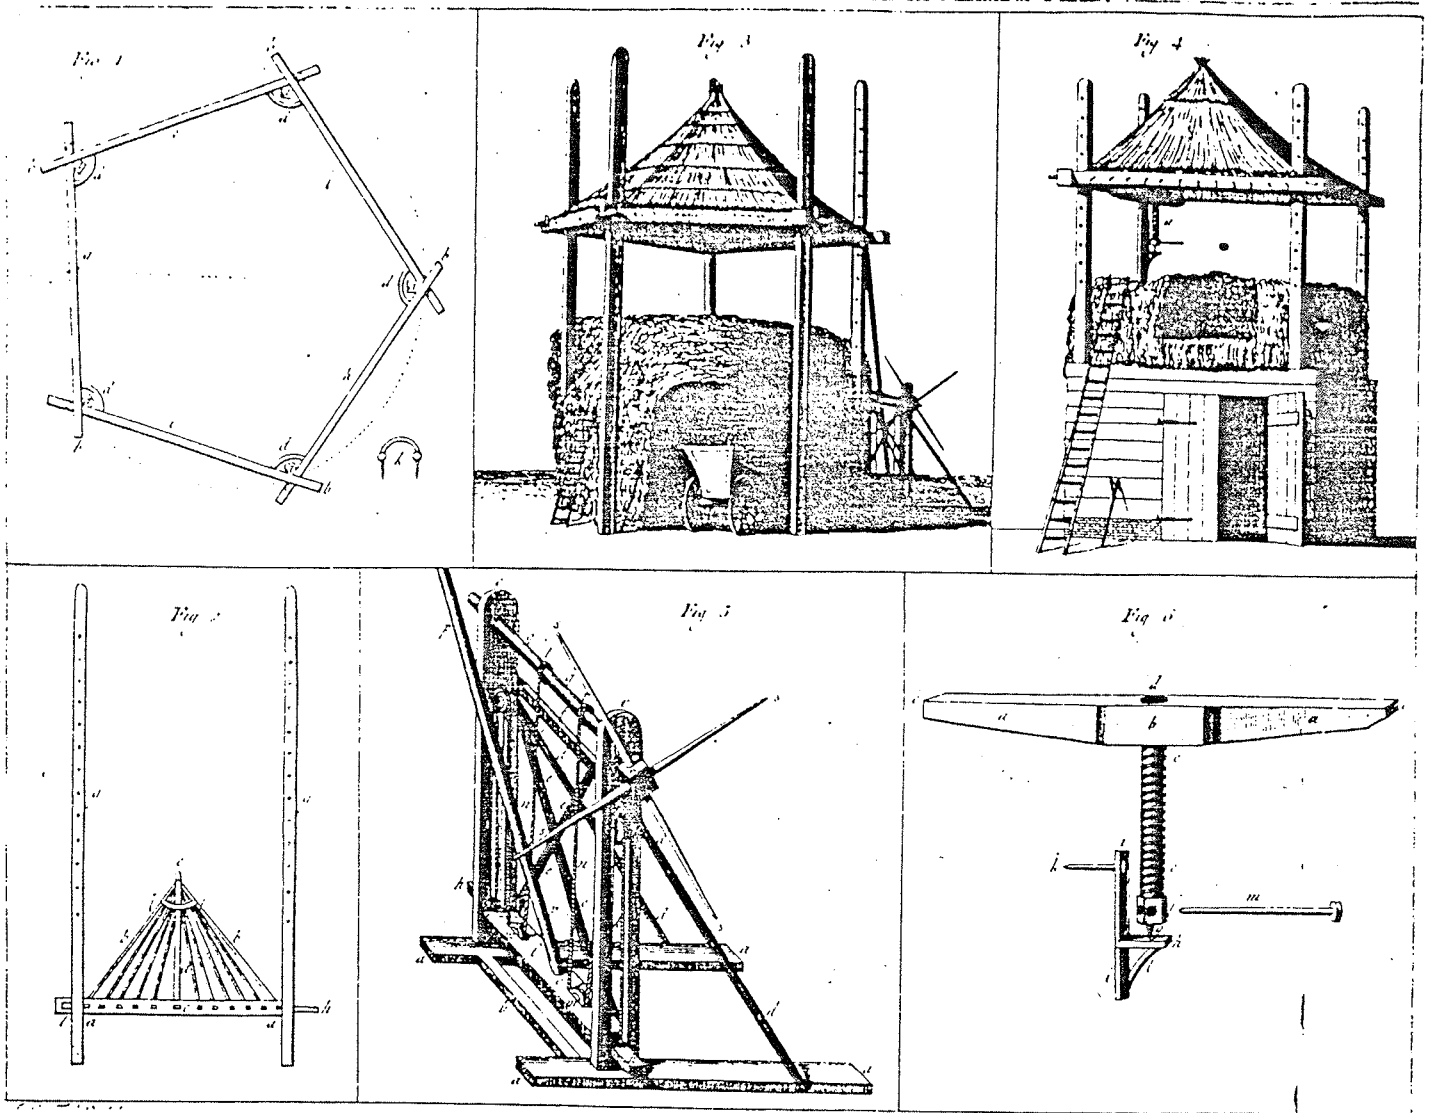
Afb. 9. Vijfroedenhooiberg, Zuid-Holland, naar Le Francq van Berkhey, 1811

4. Six engravings of a South HOLLAND hay barracks and parts c. 1811: Fig. 1) five-sided plan for the plates with iron cleats around each pole; 2) structure of a roof and two poles for same barrack; 3) same barrack with jack in place; 4) a four-sided barrack with enclosed lower portion; 5) a winding jack; and 6) a screw jack. (van Berkhey 1811: vol.9 part 1, plate 9.)

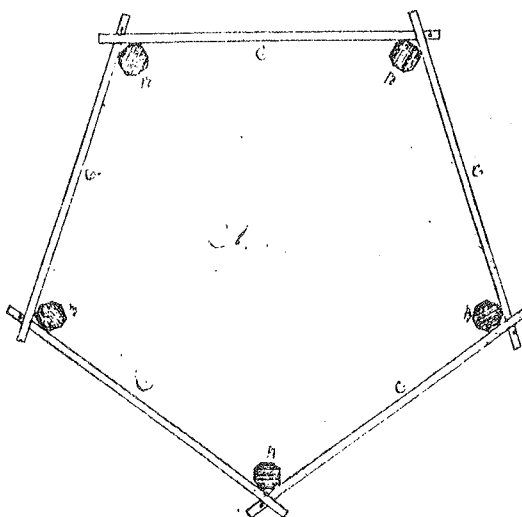
Pl. 7. Vijfroedige hooiberg, prov. Utrecht

5. A five-sided hay barrack from Utrecht province, c. 1811. Note the rare use of octagonal posts. The scale indicates that the posts are 42 feet above ground and are spaced about 14 feet from each other. (van Berkhey 1811: vol.9 part 1, plate 7.)

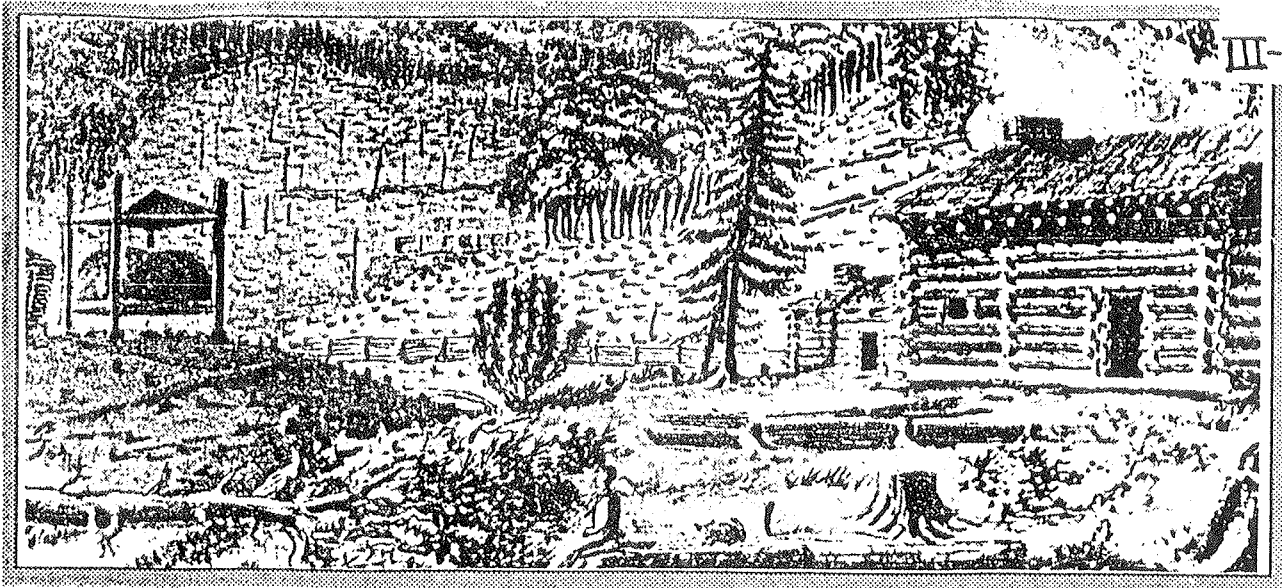
6. A small raised-floor hay barrack of c. 1800 in Schoharie County, New York. (reproduced in Catskill Country magazine, Winter/Spring 1988-89 p.25)

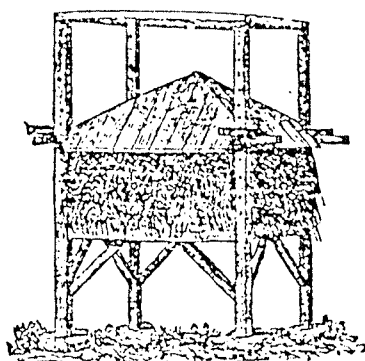
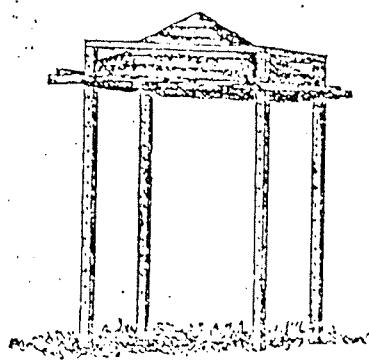
Fig. 155.—BARRACK WITH BOARD ROOF.

Fig. 156.
BARRACK WITH THATCHED ROOF.

Fig. 157.
MANNER OF RAISING

8. Two hay barracks c. 1899. Note both have top plates to insure spacing of the posts. One is braced so as to be free standing on stones. Figure 157 shows the manner of raising the roof: using a ladder pried up by a heavy stick fulcrum. Perhaps the simplest method since the spaced wrongs of the latter accomodate lifting the roof at any height. (Homemade Contrivances for Farm and Garden, Dairy and Workshop, Orange Judd Co. 1899).

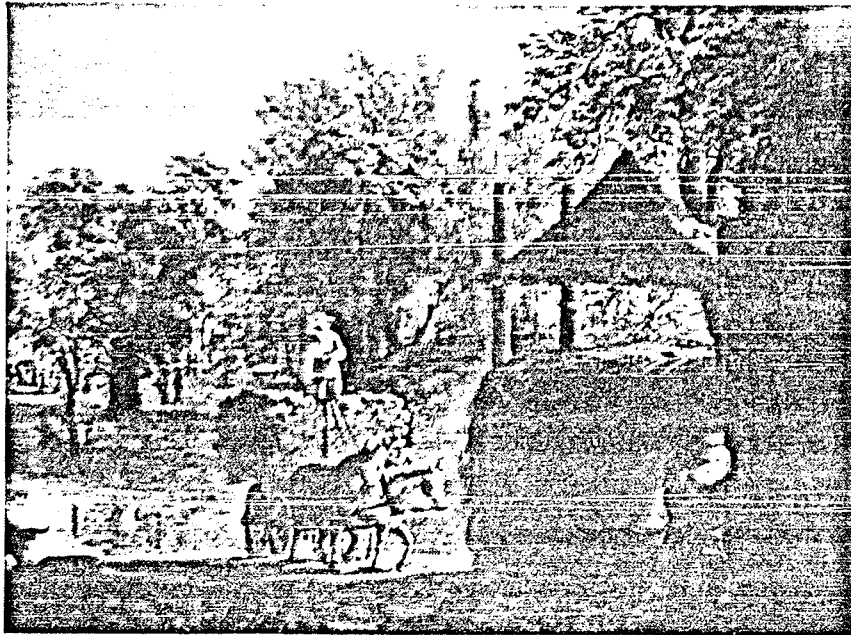
10. Detail from the painting Haying by Asher brown Durand (1796-1886), 1838, possibly New York State. A typical four-post hay barrack with thatched roof.

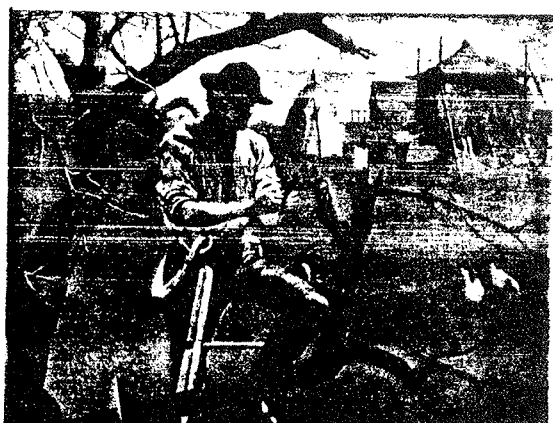
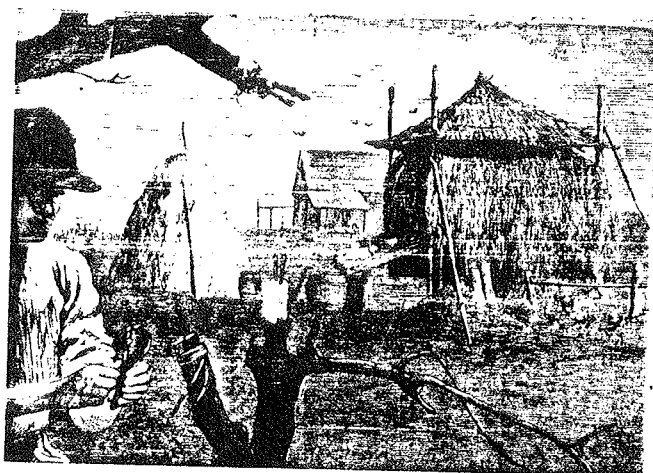
13. Spring Hay Work - Grafting, after a drawing by Winslow Homer (1836-1910), last quarter of the 19th century, probably New York. Note the long forked pole, likely for raising the roof which is of light construction with the plates made from poles. A small roofed pen for small domestic stock is attached to the barrack. The haystack formed around a single pole is at left.
