The Society for the Preservation of Hudson Valley Vernacular Architecture

January – March 2010

Newsletter

Vol. 13, No. 1-3

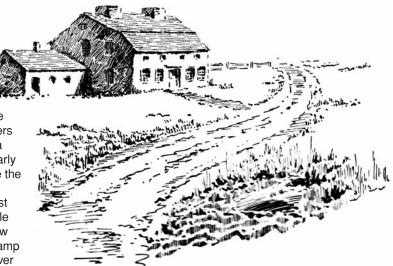
1746 Parsonage House (Pfarrhaus) in Germantown

Today, unfortunately, virtually nothing exists of the East Camp settlement. The closest testament we have of the Palatines of the area is the 1746 Parsonage House (Pfarrhaus) at 20 Maple Avenue in Germantown. The stone section of this bank house (now covered with stucco) is considered the earlier section with the kitchen in the cellar. A side hall entrance on the level above leads to the main room on the left. A framed addition was constructed to

the right of the entrance in 1767. The Germantown History Department is based out of the latest "kitchen wing" of the house. They have published a pamphlet with an in depth history of the early pastors and the later families that have occupied it over the years, including a detail description of the last major renovation started in the late 1940's which most likely saved the house from complete destruction.

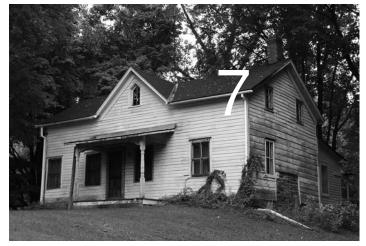
This house is next door to the Progue house on Old Primrose Hill Road. Does anyone know whose house this was and how old?

Also sitting on part of the Wurtemburg tract at 12 Old Primrose Hill Road is the Captain Matthias Progue house with a 1763 datestone and is on the NRHP. Its likely Matthias came over in this second wave and became a captain of a sloop for Henry Beekman. The roadside elevation creates the appearance of a two-story house, but in fact, is built into the hillside with only its upper story exposed at the rear. Further west on the road on just the other side of the hill is a very vernacular wood frame house

encompassing a later style center gable. While I suspect a Progue descendant erected it, this is just a guess and I would like to hear from one who knows more about the place.

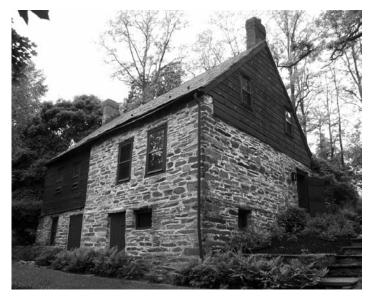
Traver House at 55 Wynkoop Lane in Rhinebeck.

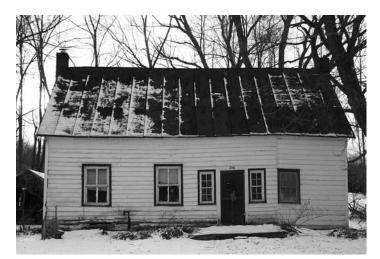
Above: Unidentified house at 246 Spring Lake Road in Red Hook. Could this be an old Palatine homestead?

While following the Dutchess County Tourism driving tour for the northern part of the county, I happened onto a house that just screams "EARLY PALATINE" to me. At 246 Spring Lake Road in the northeast corner of the town of Red Hook, sits on the south side of the road a one and a half story, three bays with a rightsided entrance and four over four sidelights. Two obvious late replacement four-over-four windows are to the left of the door. A later bay was added to the right of the door with an additional six-over-six window. The metal roof is steeply pitched with no dormers. I would like to hear from anyone who has any background on this place.

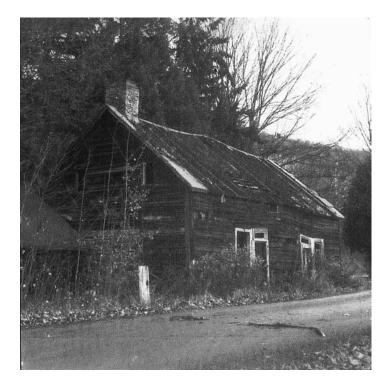
n the *HVVA Newsletter* of January, 2007 (Vol. 9, No.1) there is an article of mine on an unusual half-timbered house located on Rt. 209 in the Village of Westbrookville, Sullivan County. Another half-timber house found on the same expedition in November, 1967 was located in the Village of Gottefroy in Orange County. This ruined and abandoned building was located close to the road. It faced east. Not far behind it were the remains of a lock on the Delaware and Hudson Canal. I have subsequently learned that this was lock 55, one of a flight of locks south of the Neversink Aqueduct. The house had served as a lockkeeper's house when the canal was in operation.

It interested me that the house had the paired door and window arrangement that I had become familiar with in my work on the Minne Schenck house at Old Bethpage Village Restoration, and represented a Dutch-American house type (twin-door house) found in the lower Hudson Valley and Long Island in New York, and in northern New Jersey. The general aspect of the house was of the early 19th century. The walls seen from the road were weatherboarded and it had a moderately pitched roof.

But the Gottefroy house was something different – it originally did not have wooden cladding, as noted above, there was no evidence that the west wall ever did have it. Both the exterior and interior surfaces of the infill had been worked smooth and whitewashed. For many years I had a chunk of this exterior wall material, with its whitewashed

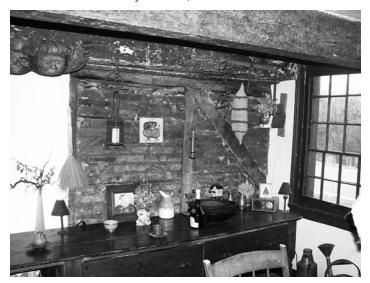
Kittle House - 1346 County Route 22, Ghent

Above: Detail of the Kittle house framing and exposed nogging. Below: Graffiti of Andrew Kittle.

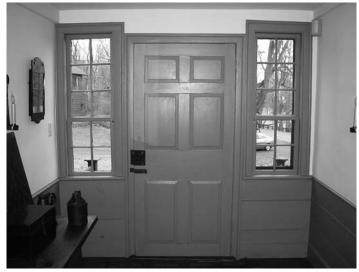
Above: First floor hall at 342 Leggett Road, Gent Below: Attic rafter pair looking east at 342 Leggett Road, Gent

The roof rafters have Roman numeral marriage marks on their west faces, possibly made with a saw, and extending most of the width of the face of the rafters. The rafters are pegged at their apex. Eight pairs were observed, and they are numbered from east to west. Two additional bents at the west end cover the mid-19th century addition. They are sawn and butt joined and nailed at their apex.

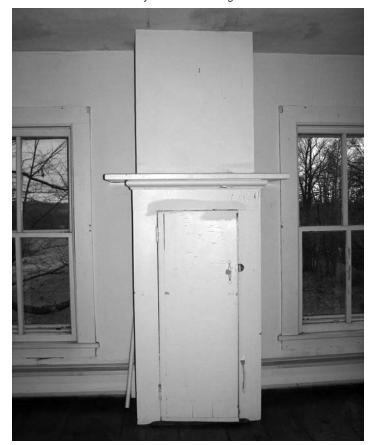
Above: View of the back of 276 Leggett Road, Ghent **Below:** The bracket chimney on 2nd floor wing

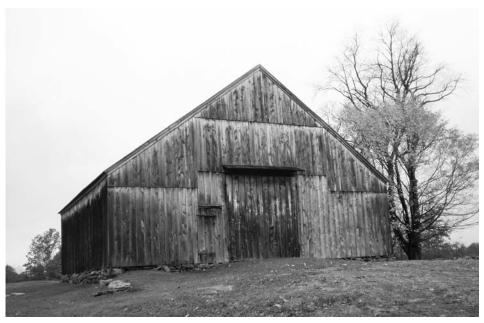
Possible original wagon door section at the Bull barn resting against far end wall. Modern wagon doors were patterned after the frame of this door. No front vertical wood boards remain on very old door.

William Bull and Sarah Wells three-bay three-aisle barn near Goshen in Orange County, New York is purportedly the earliest classic barn that remains in the Dutch-American barn realm. It was dendro-dated 1726. Its roof structure and side aisles are not original.

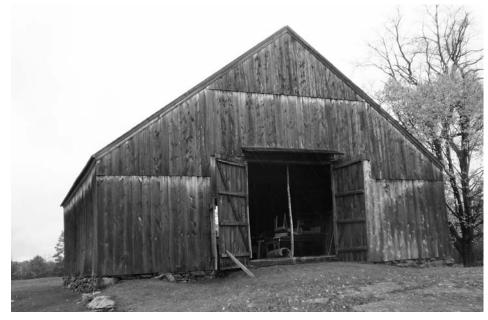
Both sides of Bull barn's near end wall door opening is seen with frame constructed wagon doors.

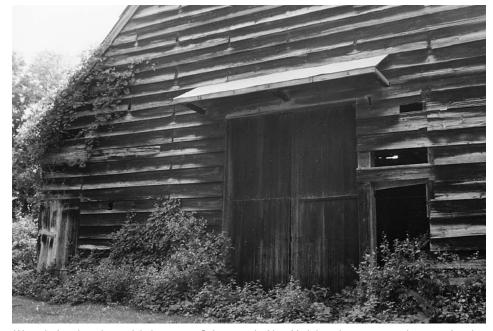
Wemple four-bay three-aisle barn near Schenectady, New York has the most complete set of end wall wagons doors (with wooden hinges) anywhere in Dutch settled areas.

The Wemple barn that stands in Rotterdam near Schenectady in Schenectady County, New York is a circa 1760 structure. This awe-inspiring barn was discussed in Fitchen's book and up-dated in the second edition (2001). It is a classic three-aisle barn of four-bay construction in excellent condition. It measures 56 feet long by 47 feet wide. It retains in nearly 100% original condition both its end wall wagon doors. At each end wall is a single full height door at one side and two half door sections upper and lower halves at the other half of the wagon door opening. Each single height door is just shy of 12 feet high and 4 feet 8 inches wide. Each half door varies in its height - the upper doors are each 5 feet 9 inches high and the lower doors are 6 feet in height (at far end wall) and 6 feet 11/2 inches in height (at the near end wall). All wooden hinges all of oak as originally included in the doors remain intact.

Most of the elements of the one wagon door complex at one end wall in the Wemple barn are nearly identical to all the other elements of the door complex at the other end wall. Thus the statements that follow about the "near" end wall doors (closer to the circa 1760 brick homestead house) apply to the "far" or northeast end wall doors. Certain exceptions will be noted. The only major difference but not related to any original conditions is that the full height door at the far end wall was cut horizontally in half at one point so that two door halves - an upper and a lower - were created. Later the two door halves were re-united. All three wood hinges remain.

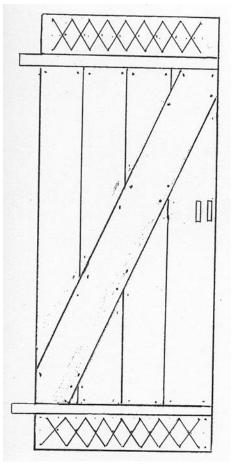
Above: Sketch of half door section at near end or southwest wall of Wemple barn. Note scribed Xs on batten on rear face of door. Below: Sketch of full single height door section at southwest wall of Wemple barn. Note scribed Xs on two rear surfaces of battens of door.

All the placements of the nails that varied somewhat from door section to door section in the Wemple barn were done in an utterly precise manner. That is to say for every batten in a given door the distances between nails in each row of nails or nails relative to other nails in different rows are absolutely consistent. For example, on the bottom batten of the single height door at the northeast wall there are three horizontal rows of nails. The upper and lower rows each consist of seven nails and the middle row consists of six nails. Horizontally each adjacent nail is placed a tad less than nine inches from each other. Each nail in the middle row is placed precisely half way (vertically) between the nails in the upper row and the lower row that are closest to it. In the process six Xs were formed.

All door sections have at least one rear side batten. All the sections have a single diagonal batten. All the sections but one has a horizontal batten. Certain other barns with original wooden hinged doors have no horizontal battens at all such as the doors found at the Oliver barn site on the south side of Route 209 in Marbletown, Ulster County.

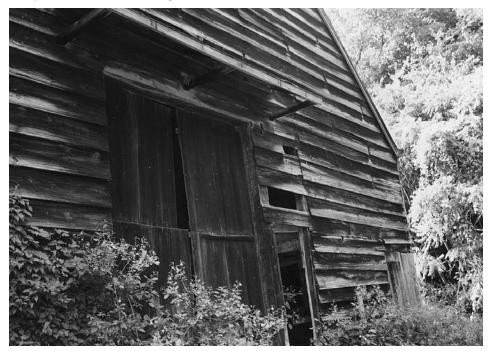
At far end wall of Wemple barn is wagon door with overhead pentice. Note pentice arms that are not original to barn.

Basic elements of pentices consist of two construction features. The first element was the presence of several (3 to 7) horizontal beams or arms that extended depending on the barn from the end wall anchor-beam and out beyond the end walls by about 31/2 feet to 5 feet. These arms basically form the base of the pentices. The arms stretch across the full lengths of the pentices (side to side) and sometimes beyond. For example, in the case of the Larger Wemp barn (Fitchen Barn No. 31) there were four pentice arms on at least one end wall; the one at the one end was apparently to protect the human door immediately adjacent to the wagon door. The second element was the presence of rafters that were each in line with the arms. The Wemple barn at each end wall originally had three pentice arms.

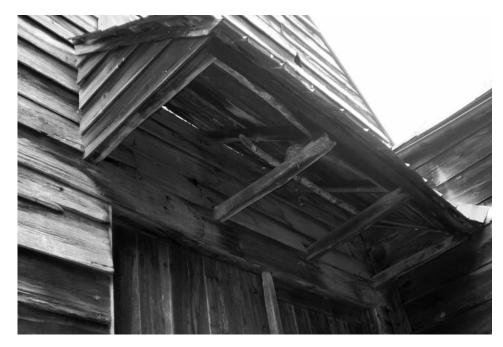
Above: Pentice at end wall of Bogart barn in Marbletown, Ulster County with original arms and non-original rafters. Pentice stretches across full width of wagon doors. Below: Close-up of possible original mittelmanse at end wall wagon doors at Bogart barn. Note how top end of post enters into soffit of end wall anchor-beam. The post in this barn is seen to the exterior of the door while in other barns they are seen inside the wagon doors.

the barn. The Bogart barn has four original hewn arms but the rafters are replacements of the originals. In the case of the Mahoney barn perhaps uniquely the pentice extends across the full width of the nave. Seven original pentice arms are seen except the one arm that is not original in the interior of the barn. The rafters appear to be, quite remarkably, original. As such it is very likely the Mahoney barn that retains the most original pentice anywhere in the entire Dutch settlement area.

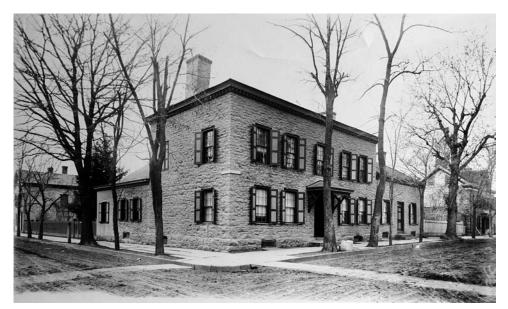
The **Dr. Matthew Jansen House** – located at 43 Crown Street, Kingston, NY – recently visited by HVVA members during our much enjoyed Holiday Tour this past December. Look for more research to come as we piece together the clues to this house's development. Photograph circa 1880, used by the courtesy of the Friends of Historic Kingston.
