The Society for the Preservation of Hudson Valley Vernacular Architecture

April – June 2013

Newsletter

The Ariaantje Coeymans Mansion and its North House*By John Stevens*

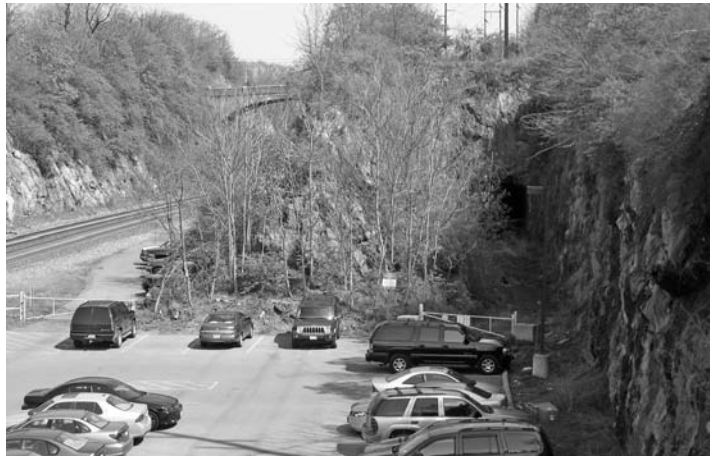
BELOW:
 Original H.R.R.R. tunnel (1850), New Hamburg.

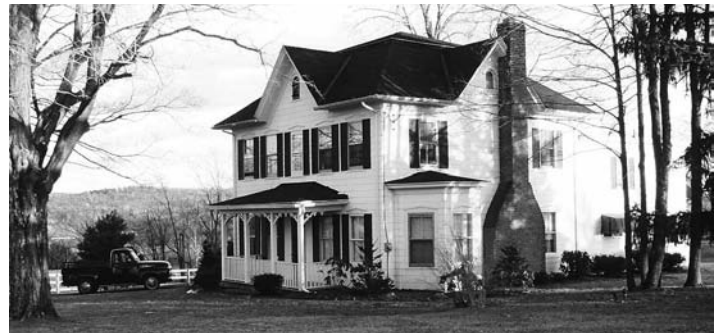
Fig. 1 – Wurtemberg Farmhouse, ca. 1870, Rhinebeck, NY. All photos by Neil Larson unless otherwise indicated.

If we focus on this farmhouse and consider its square massing and hipped roof, we will recall that although these features generally correspond with the pattern book example, the form and plan is not unique to the American Picturesque. They also evince Classical ideals: orderly forms and ornamentation that Picturesque tastemakers disavowed in favor of more “natural” asymmetrical shapes and patterns. Likewise, the cross-gables were as likely borrowed from Renaissance precedents, although in the Romanesque example they were made more pointed in the design plate to contribute to the Gothic feeling of the design.

On closer examination, then, the Classical sources in the farmhouse design become apparent, and its relationship to the pattern-book model becomes increasingly coincidental. What is overlooked by beginning our reading of style with this comparison is that the farmhouse is actually a compact, rectilinear, balanced, two-story house with pedimented facades and an interplay of pedimented and arched elements over windows and doors much more in the Palladian tradition than in a Picturesque one. Of course, there are indisputably Picturesque flourishes, such as the bay window and the veranda, but these popular modern features alone in no way should determine the source of the style.

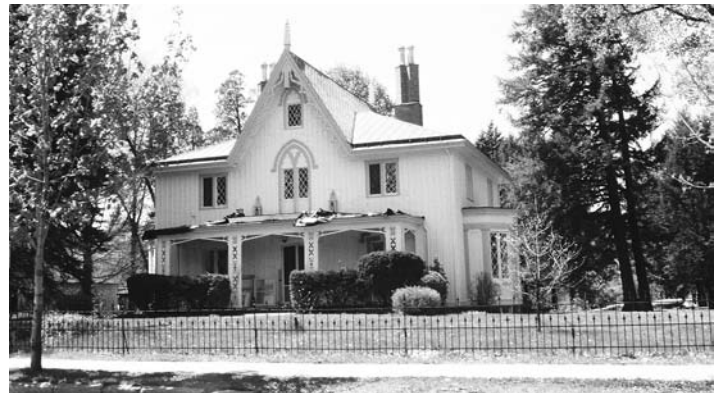
Fig. 2 – Henry Delamater House, 1844, Rhinebeck, NY, Alexander Jackson Davis, architect.

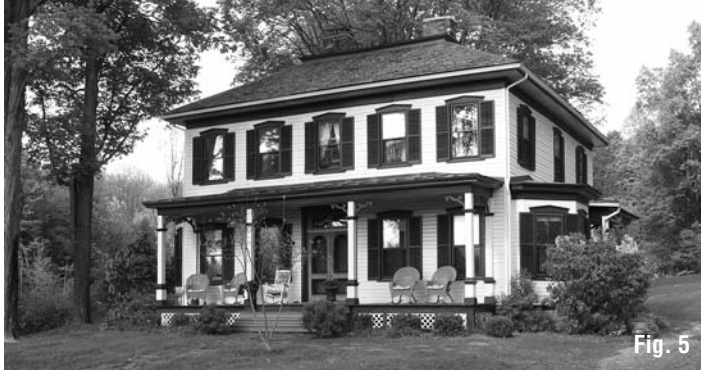
Fig. 5 – Pultz House, c. 1870, Rhinebeck, NY.

Enough examples of this 19th-century house form are extant in Rhinebeck (as well in neighboring “German” towns) to distinguish it as a distinctive local type (Fig. 5). However, it is not my intent here to expound on the particularities of this German-American house type, but rather to speak to the matter of our use of style as a diagnostic tool. Style need not be construed simply as the expression of a fashion or taste or the measure of status, cultural change or assimilation. There is a more complex anatomy to a style, even in vernacular houses, where it is used selectively and conditionally, and we are at a disadvantage in “reading” the building if we are not informed to its stylistic vocabulary.

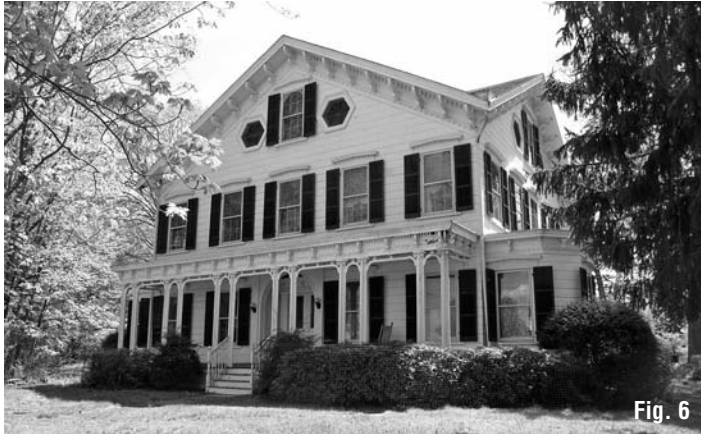
Fig. 6 – Shultz House, c. 1854, Shultzville, NY.

Thus, when we encounter a house like the Shultz House, built c. 1854 in Shultzville, another German hamlet near Rhinebeck, we can look at it either as a quirky attempt to imitate a popular American Picturesque prototype, or as reflecting a design tradition that extends back to the Renaissance and Classical buildings in Germany such as the Brunswick Council Chamber built in 1764 (Figs. 6 & 7). If we begin with a broader sense of the stylistic context in which builders operated and a more detailed understanding of Classical (and Picturesque) architecture, the

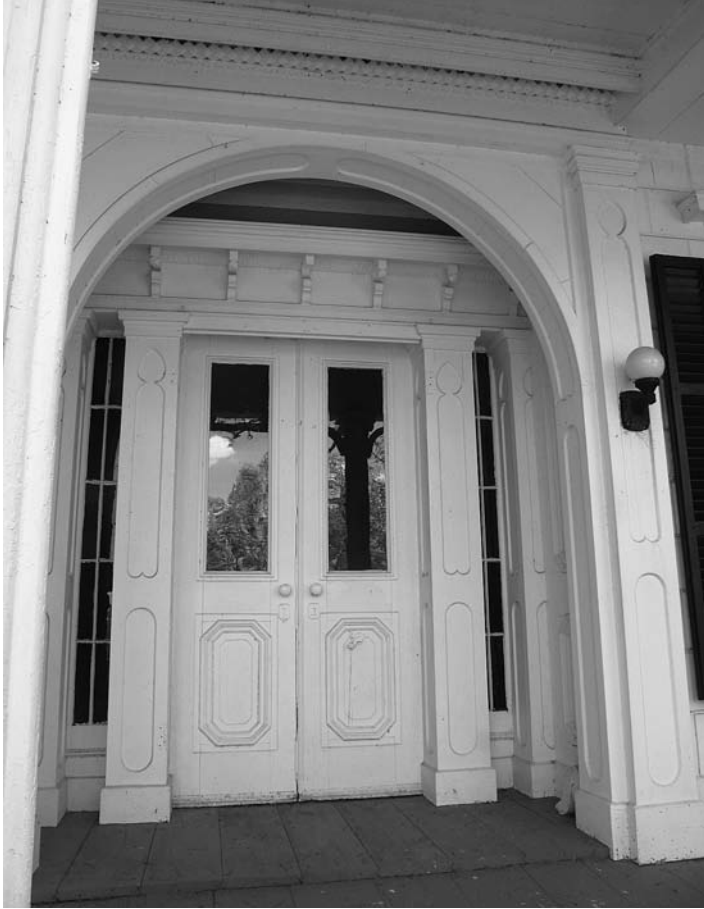
Fig. 8 – Shultz House, entrance detail

For example, the entrance to the Shultz House is composed of multiple layers of ornamented openings, which create the illusion of a processional into the house, a theatrical manipulation of forms and arrangements in a true Baroque spirit (Fig. 8). And the cacophony of freely interpreted ornamentation? Such a lavish display of contradictory elements is a blatant Baroque device. This effect (and its stylistic intent) is vastly different from the strict, controlled entrance and literal ornamentation of a Picturesque pattern-book house.

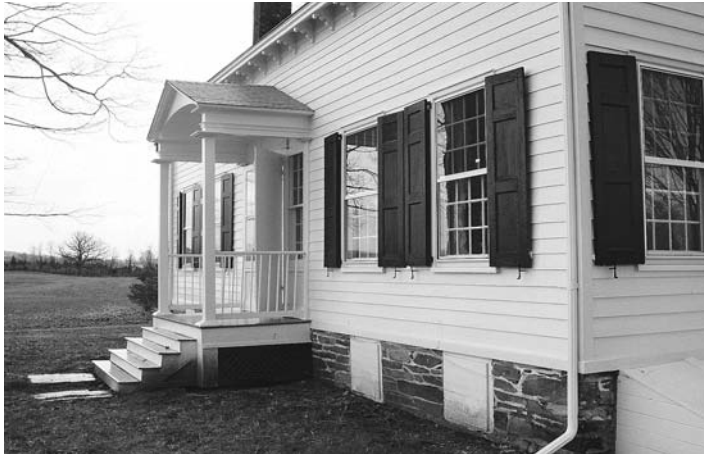
Fig. 12 – Van Dyck House, c. 1820, Hyde Park, NY.

Two Dutchess County houses illustrate different perspectives of farmhouses built by Dutch farmers in the early 19th century. The view of the principal façade of the Van Dyck house, built in c. 1820 in Hyde Park, pictured here, emphasizes what is persistent and conspicuous in the design on Dutch houses in this period, as well as any other: a long, low rectangular form with restrained ornamentation (Fig. 12). In contrast to the diversity of house forms and styles proliferating in the region during this period, the image of this house is decidedly unchanging and

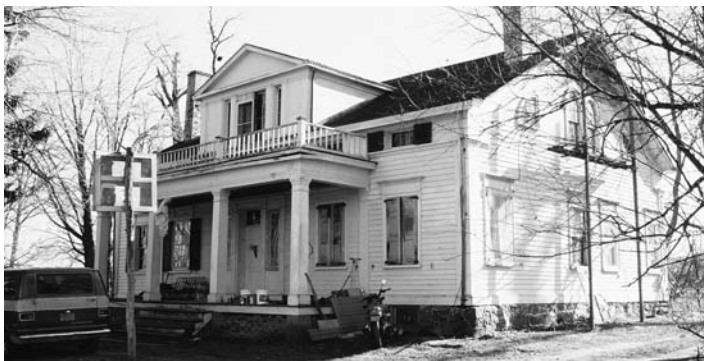
Fig. 13 – Van Wyck House, c. 1830, East Fishkill, NY.

ardently traditional. But it is not sufficient to say that the style of the house is outmoded or conservative. Rather, both the Van Dyck house and the a Van Wyck house, built c. 1830 in East Fishkill, albeit displaying Greek Revival-style features, were designed in aggressive, contemporary manner (Fig. 13).

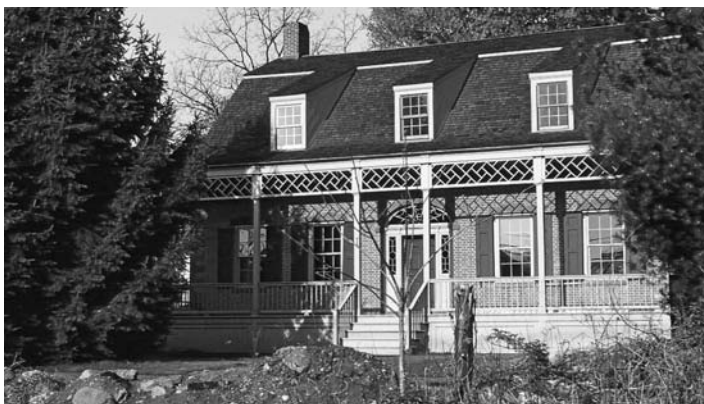
Fig. 14 – Blauvelt-Amos House, c. 1819, east façade, Blauvelt, NY.

The Blauvelt-Amos House in Blauvelt, Rockland County epitomizes the iconic status of the late Dutch house (Fig. 14). Story has it that Jacob Blauvelt had the house built for his daughter and her new husband, John Amos. The house is one of the last masonry gambrel roof houses built in the lower Hudson Valley, and it attracts our attention for its persistence and its faithful preservation of the traditional house form in a time and place (and generation) in which its relevancy was in question. It is almost a “Dutch Revival” house of a very early date. (This is no exaggeration. Within only a few years, people like Washington Irving were lamenting the demise of “old” New York, both physically and culturally. And by 1840 Irving was building his Romantic replica of an old Dutch house at Sunnyside opening the world that had been lost.) Clearly, Jacob Blauvelt wanted to preserve the ideals of his Dutch heritage and traditional rural society in his daughter’s future.

All the primary design features of the Rockland County Dutch house were conscientiously executed and subtly accented in this building. The long, low massing of the house was maintained, the prominent gambrel roof was preserved with its signature bell-cast profile and deep overhangs front and rear. In the front, the roof spans over a broad piazza, noted by Peter Kalm, Mrs. Grant and other travelers far-and-wide as something curiously Dutch-American. By 1820 other more spacious and efficient two-story house designs were available to builders, and many older Dutch houses long ago had pushed up through their roofs to make their dormant attic spaces habitable. However, the Blauvelt-Amos house was built without rooms in the attic (the dormers pictured here are more recent).

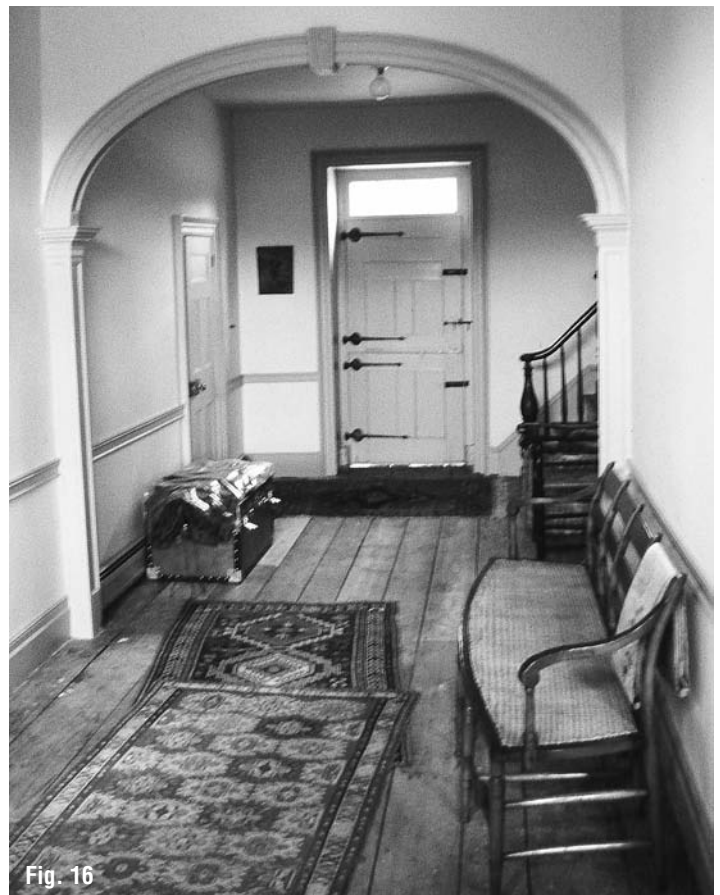
Fig. 16 – Blauvelt-Amos House, c. 1819, center passage looking west, Blauvelt, NY.

The interior also was designed in a manner that artfully expressed continuity over change. The simplicity of decoration, the familiar archway dividing front from back and the old-fashioned twin-leaf Dutch door with strap hinges and bolt latches are traditional features preserved in the center passage (Fig. 16). One novel feature, a pocketed stairway, is the exception that proves the rule: this builder has revealed he could have chosen a far more contemporary treatment for this public space.

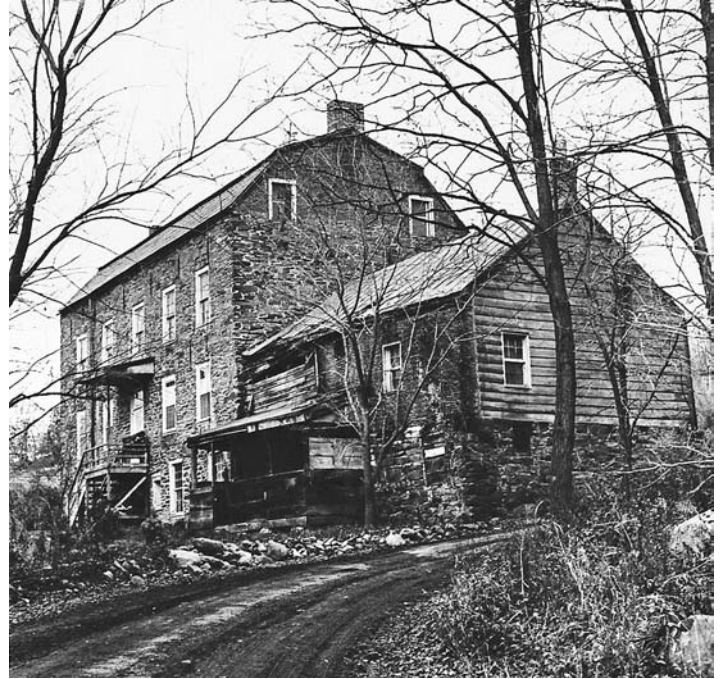
Fig. A – View of Coeymans mansion and North House from the north east. November 1967. Photos by J.R. Stevens.

In 1967 the writer commenced work as architectural historian consultant at Old Bethpage Village Restoration – a project of the County of Nassau on Long Island. His first major assignment was to research details of buildings of the 17th and early 18th centuries as an aid to understanding the c. 1730 Minne Scheck house that had recently been moved to the museum village site from Manhasset – where an upscale shopping mall was being built. Armed with Helen Wilkinson Reynolds' *Dutch Houses in the Hudson Valley Before 1776* (1929) and Eberlein and Hubbard's *Historic Houses of the Hudson Valley* (1942), he made a list of sites of potential value to this research. One of these was the Ariaantje Coeymans mansion located at Coeymans, New York, in the south-eastern corner of Albany County (Fig. A).

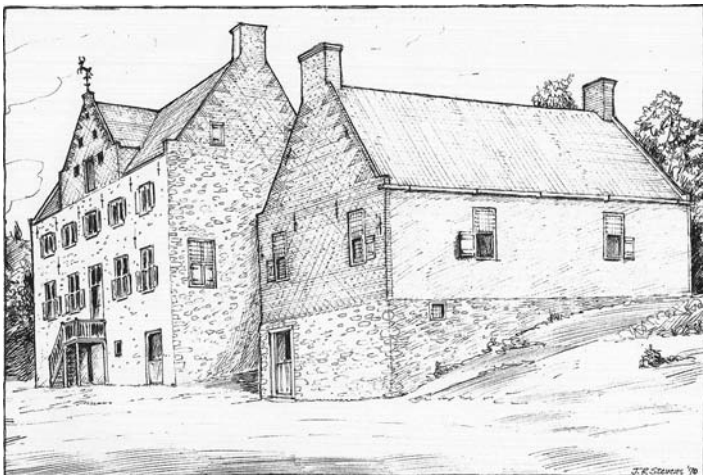
Fig. C – Reconstruction of the early 18th century appearance of the 'North House' and the Coeymans mansion, view from northeast. Pen-and-ink drawing by J. R. Stevens, 1970.

Thirteen feet north of the stone house in a timber-framed structure- or rather a portion of one- that has been believed to be of greater antiquity than the stone house (Fig. C). The dendrochronology program that revised the dating of the main building came up with a date in the early 1720's for the 'North House'. This pretty much corresponds with the date of the marriage of Ariaantje Coeymans (1672-1743) to David Verplanck in 1723.

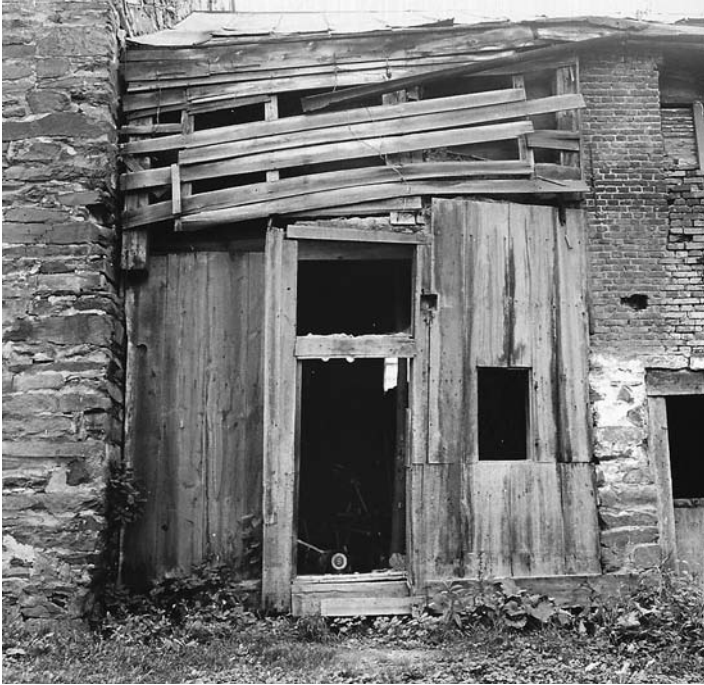
Fig. 1 – East elevation of the 'connector' between the Coeymans mansion and the North House. September 1969. All photos by J.R. Stevens.

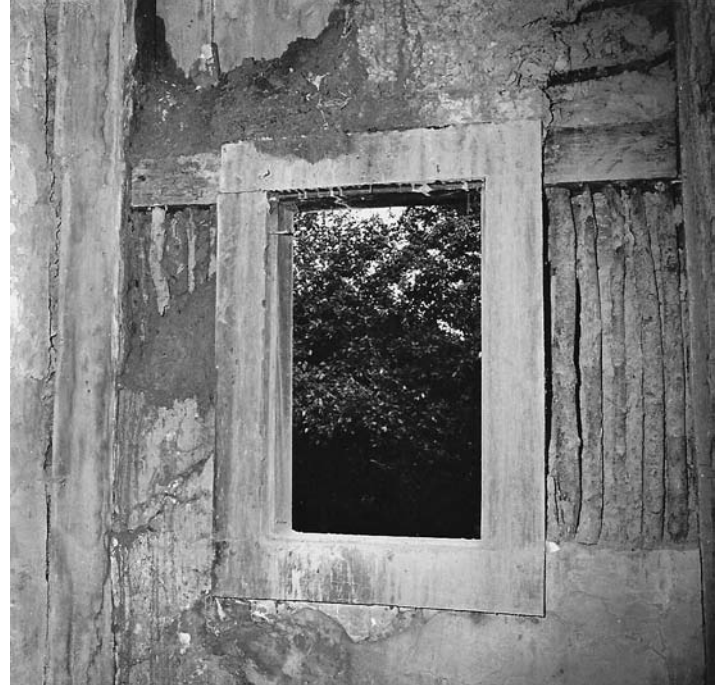
Fig. 3 – Interior of east wall of the 'connector' showing a window frame. Note infill with vertical sticks. September 1969.

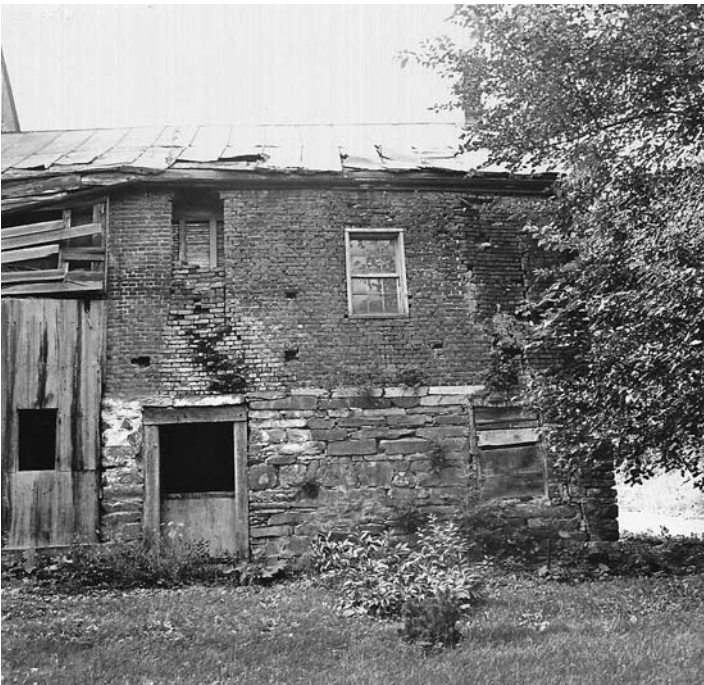
Fig. 2 – East elevation of the North House. September 1969.

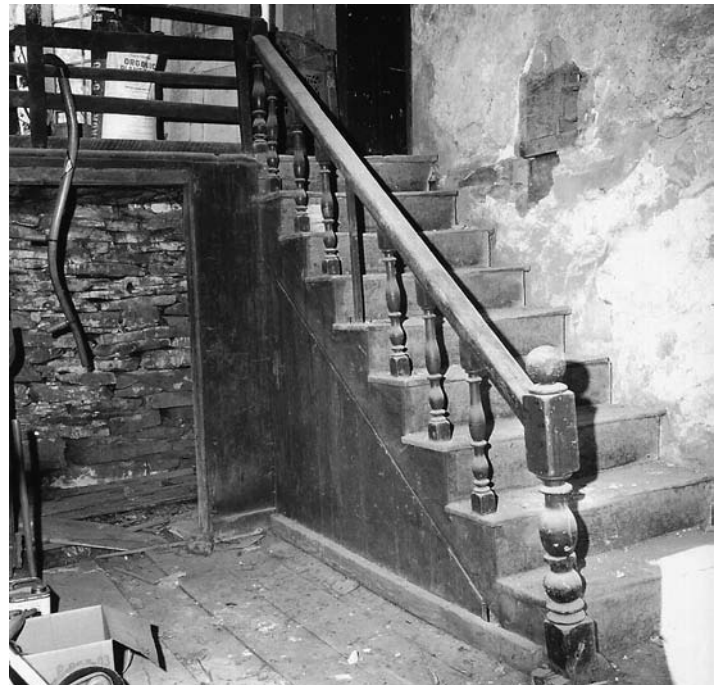
Fig. 4 – Interior of 'connector' with a re-used stair from an unknown source set up against the south wall of the North House. Note the exploratory opening made in the wall to reveal constructional details. October 1969.

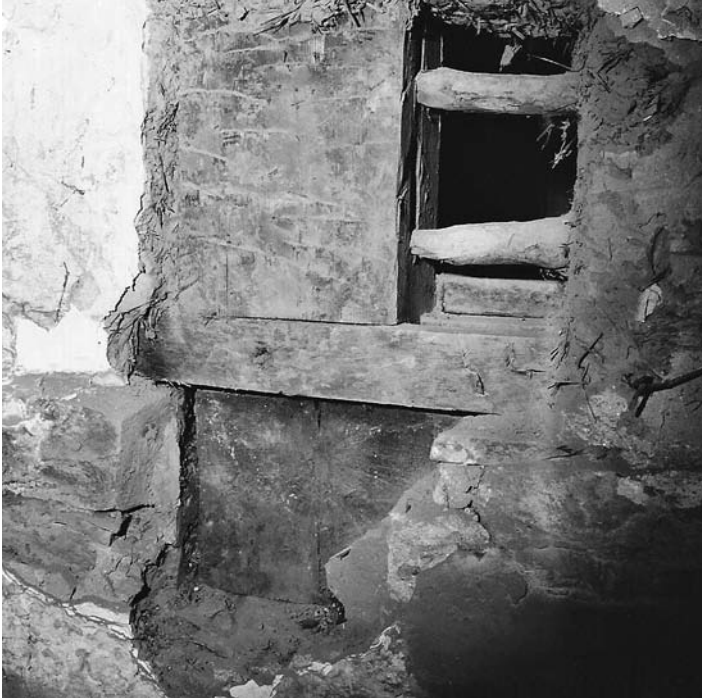
Fig. 5 – Detail of exploratory opening showing the end of a first floor beam; 3 by 6 inch sill let into the end of the beam; lower portion of a wall post showing hacking of its outside surface to hold plaster. Horizontal sticks set on about 6 inch centers to hold infill of clay bound with straw. October 1969.

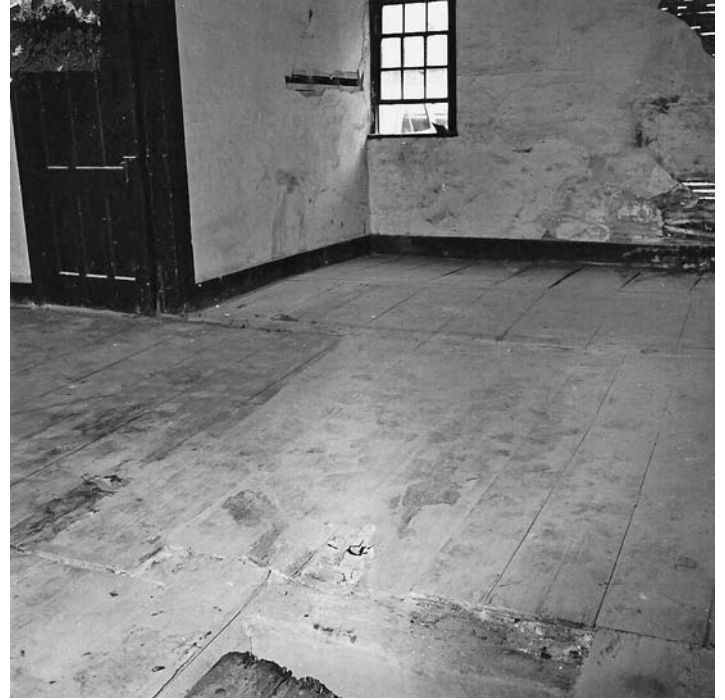
Fig. 7 – Interior of the first floor of the North House looking towards its south-west corner. Original flooring is shown. The closet door and lath-and-plaster walls are work done in 1878. October 1969.

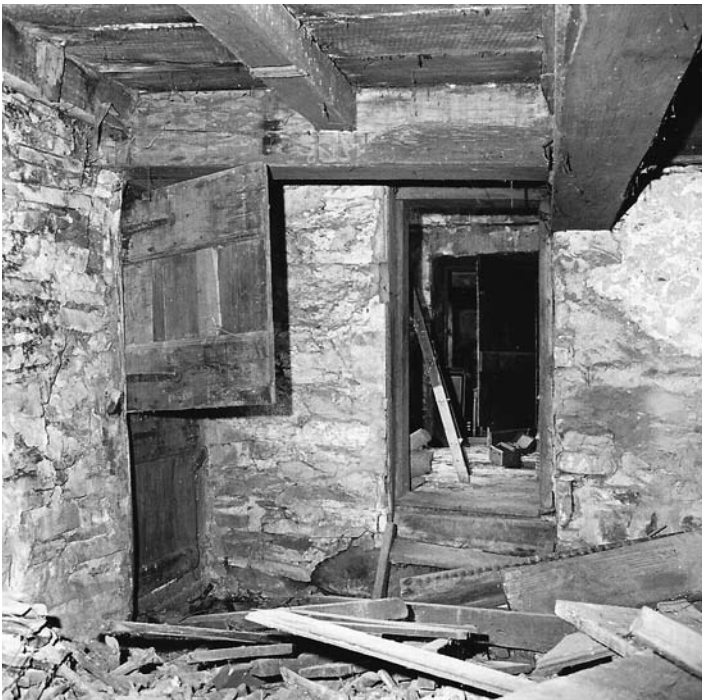
Fig. 6 – Basement of the North House, looking towards its south-east corner. Note the stain on the north face of the hearth trimmer from the iron hanger for the lintel of a basement fireplace. Note also the indication of the curvature of the trimmer arch that had supported the hearth of the first floor fireplace. The doorway at the right leads into the 'hyphen' and beyond there is a doorway into the basement kitchen of the Coeymans mansion. Both of these doorways are part of the late 18th century reconstruction of Coeymans. October 1969.

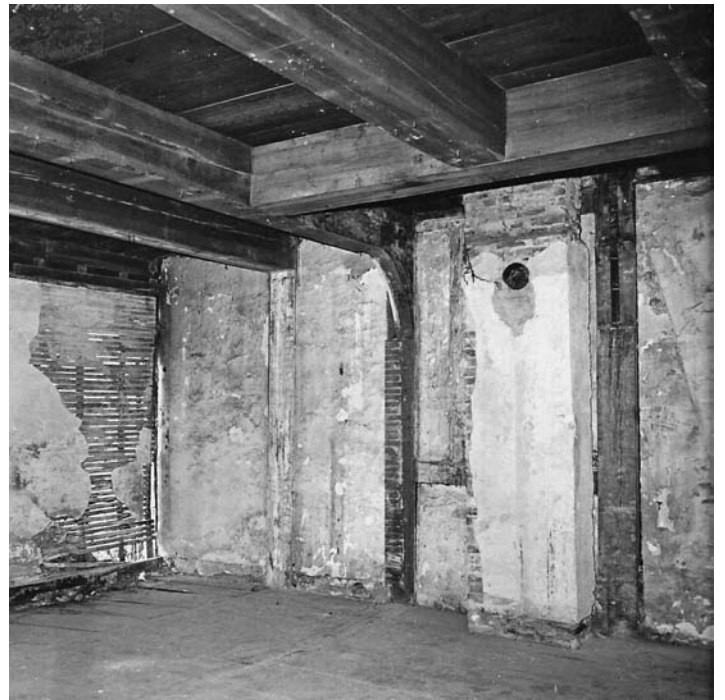
Fig. 8 – Interior of the first floor of the North House looking towards its north-west corner. Note the whitewashed wall post that has a channel cut down the middle of it to hold the bricks of an original partition. Note also the stove chimney in front of an original window frame and the header installed in the second floor framing to make an opening for the smoke hood of a basement fireplace on the north wall. At the right side of the photo can be seen the slanted line of the east side of the former smoke hood which was replaced in 1878 by the stove chimney. October 1969.

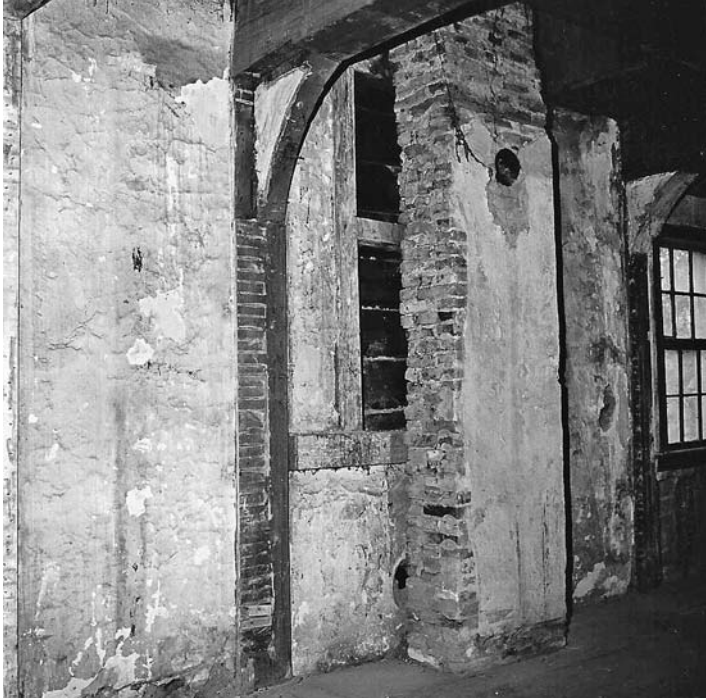
Fig. 9 – Like the last photograph, this shows the stove chimney in front of the 'kloosterkozijn' frame. Within the window openings can be seen the inside of the weather boarding installed at the end of the 18th century. October 1969.

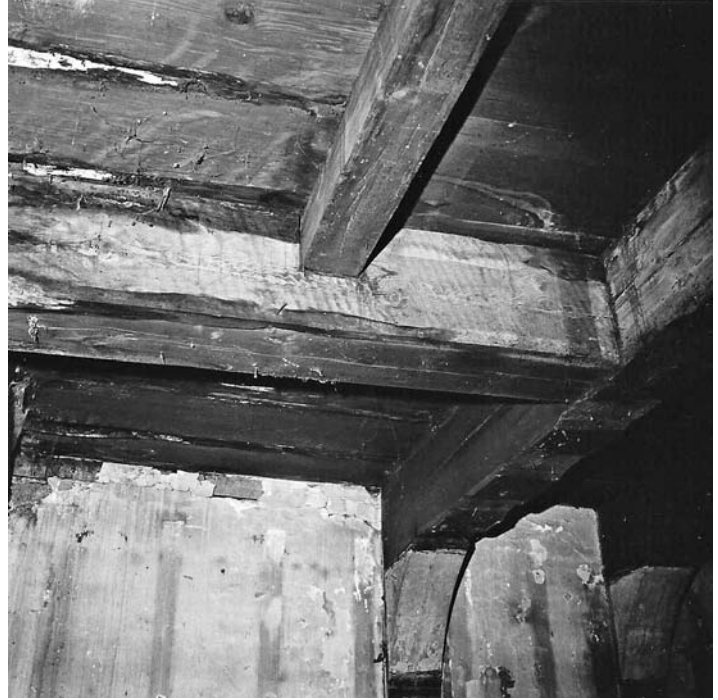
Fig. 11 – Inside (north side) of the south trimmer of the first floor fireplace at the east end of the North House. Note the kerf marks of a water-powered saw on the timber, and near its west end, the ghost of a wooden hanger that had carried the drop hood. October 1969.

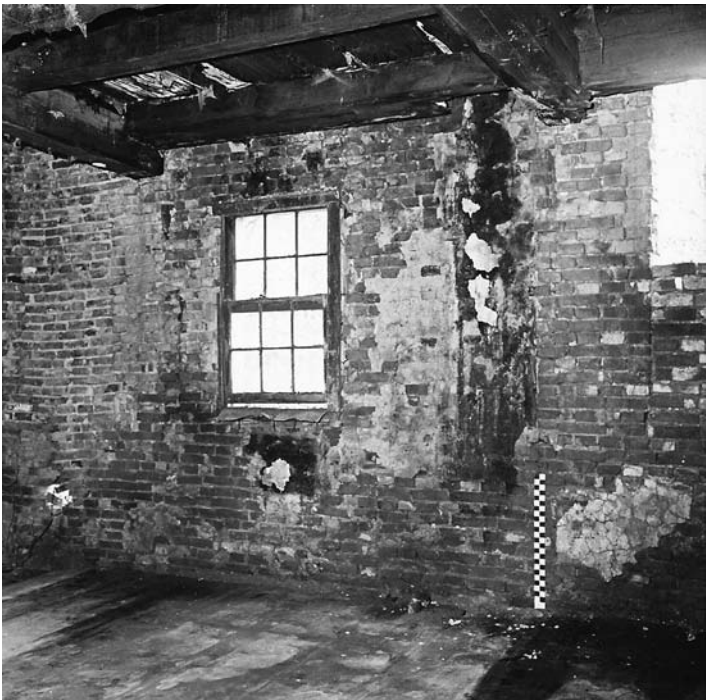
Fig. 10 – Interior of east wall of the North House, first floor, showing the central part of the wall. Note the sooty area that had been whitewashed over when the basement and first floor fireplaces were removed some time in the 18th century. There was clear indication of where the drop hood side members were housed in the brick. October 1969.

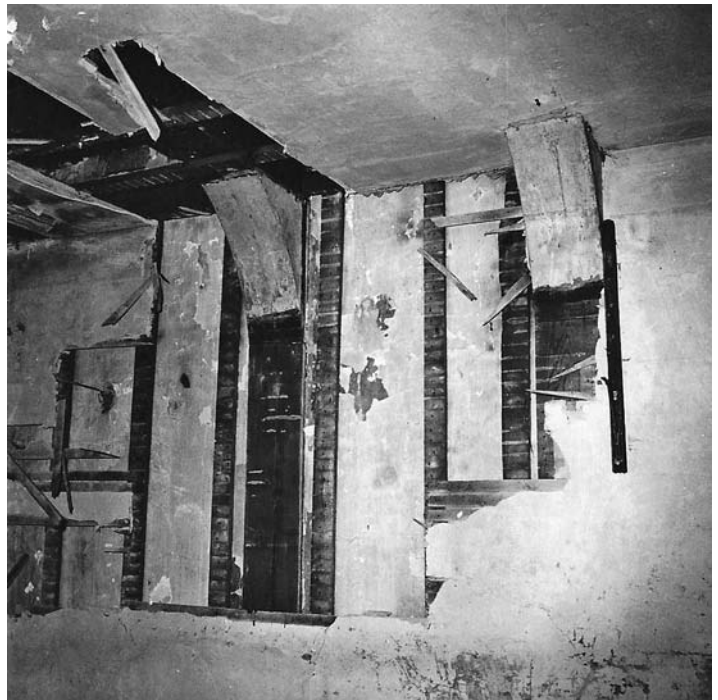
Fig. 12 – Interior of the south wall, first floor, of the North House at an early stage in the removal of the 1878 lath-and-plaster work. At this stage, most of the ceiling plaster was still in place. Note how the 'korbeels' were left protruding into the room space, and their exposed portions were whitewashed along with the plaster. September, 1969.
