The Society for the Preservation of Hudson Valley Vernacular Architecture

October – December 2013 **Newsletter**

Hudson Valley Vernacular Architecture Archetypes: The Tompkins-Scribner House, Yorktown, Westchester County, New York

Demolition Archeology: Building History Revealed

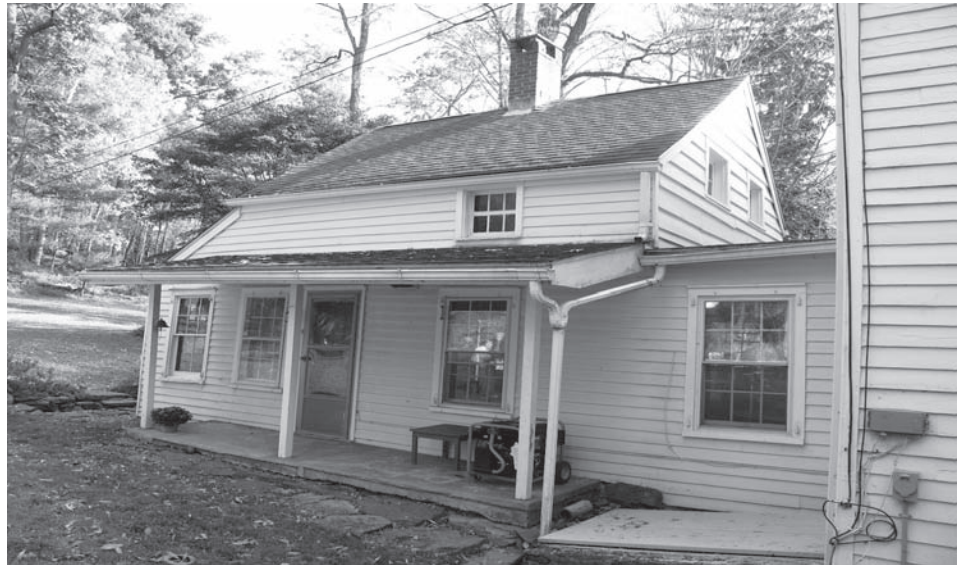
Kitchen ell, Tompkins-Scribner House, Yorktown, Westchester County.
View from southwest. Photo by N. Larson.

Sometimes new discoveries help bring vague ideas into better focus. Take for example the little building pictured above. Those of us who went on a tour of houses in Yorktown, Westchester County in October were introduced to this little 18th-century gem awkwardly attached to the rear of a fancy 19th-century farmhouse. The owners and some local historians understood it to be an older house but had no architectural context in which to interpret it. Our group was prepared to ponder its meaning but knew nothing of its history. This fortuitous interface has imbued this building with new significance, for it appears to be a very rare, if not unique, example of a tenant dwelling on the Cortlandt Manor, with a history possibly as early as 1724.

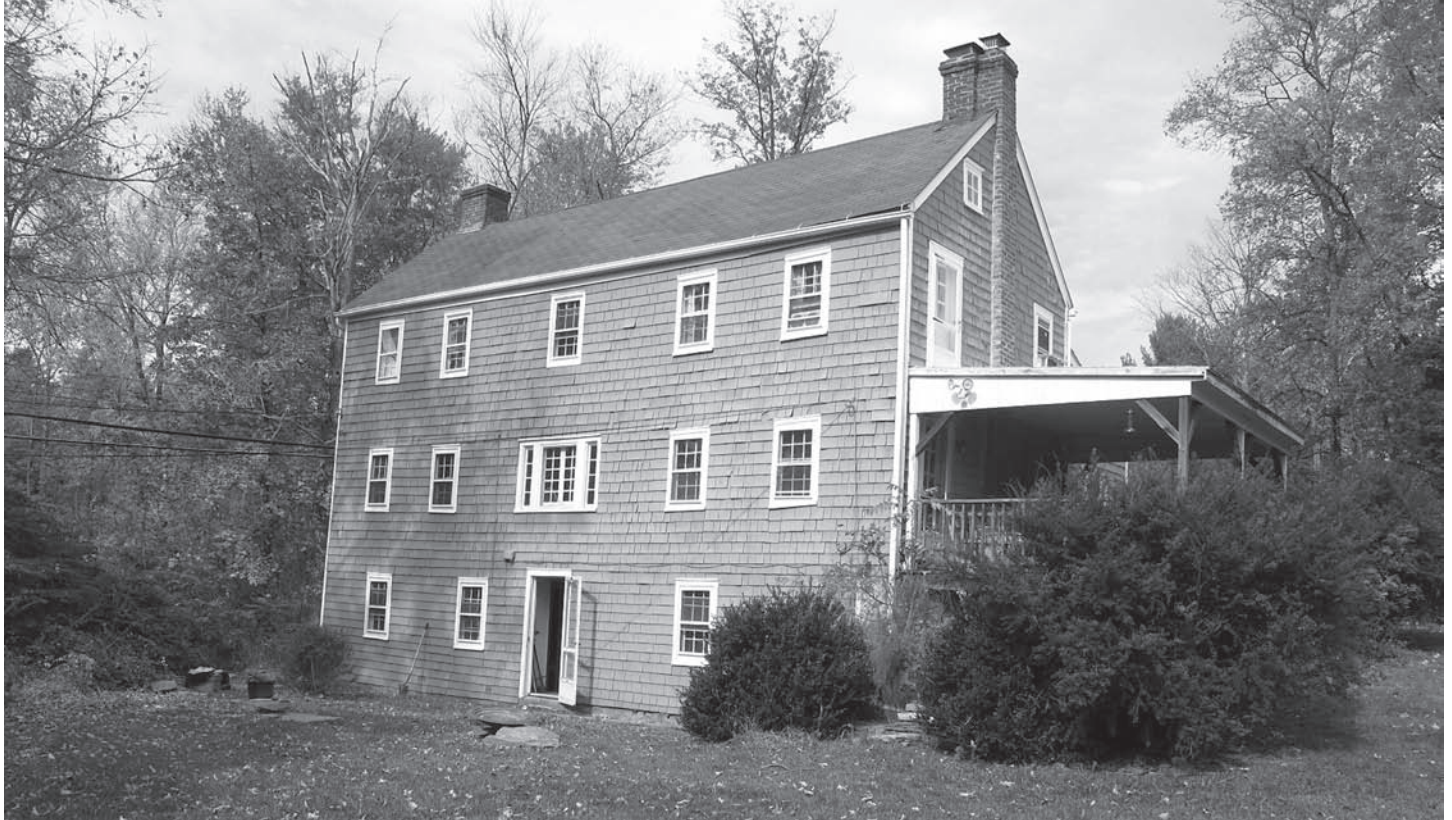
Fig. 1 – House on Croton Heights Road, view of south façade. Photo by N. Larson.

The second stop was my own house on Croton Heights Road about which discouraging little original documentation has yet been found. This house may have started as a bank house with a large hearth with a beehive oven on the left side on the lower level with a loft above that was subsequently enlarged into a two-story center hall structure with two rooms on each floor and chimneys at either end (*Figs. 1 & 2*). Although the original entryway sidelights still remain on the middle story of the southern exposure, the doorway itself has been filled in with a modern casement window. The two-story porch that provided access to this entrance has long-since been removed with the entire exterior resided with shingles. The hewn, scribe marked and sequentially numbered roof rafters suggest that this

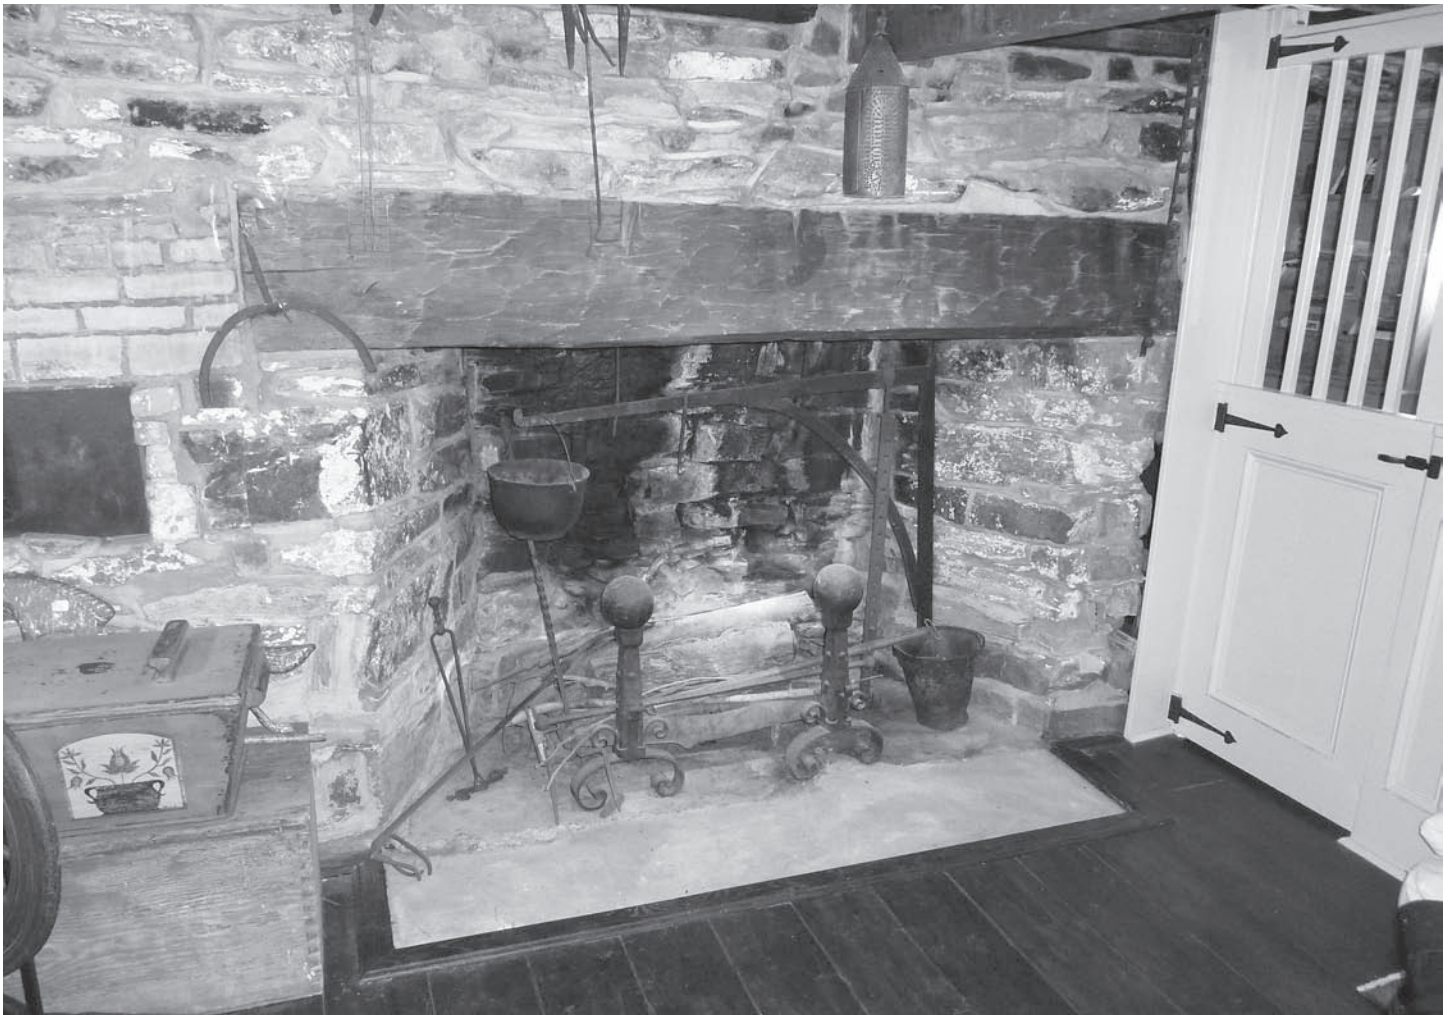
Fig. 2 – House on Croton Heights Road, basement fireplace. Photo by J-F DeLaperouse.

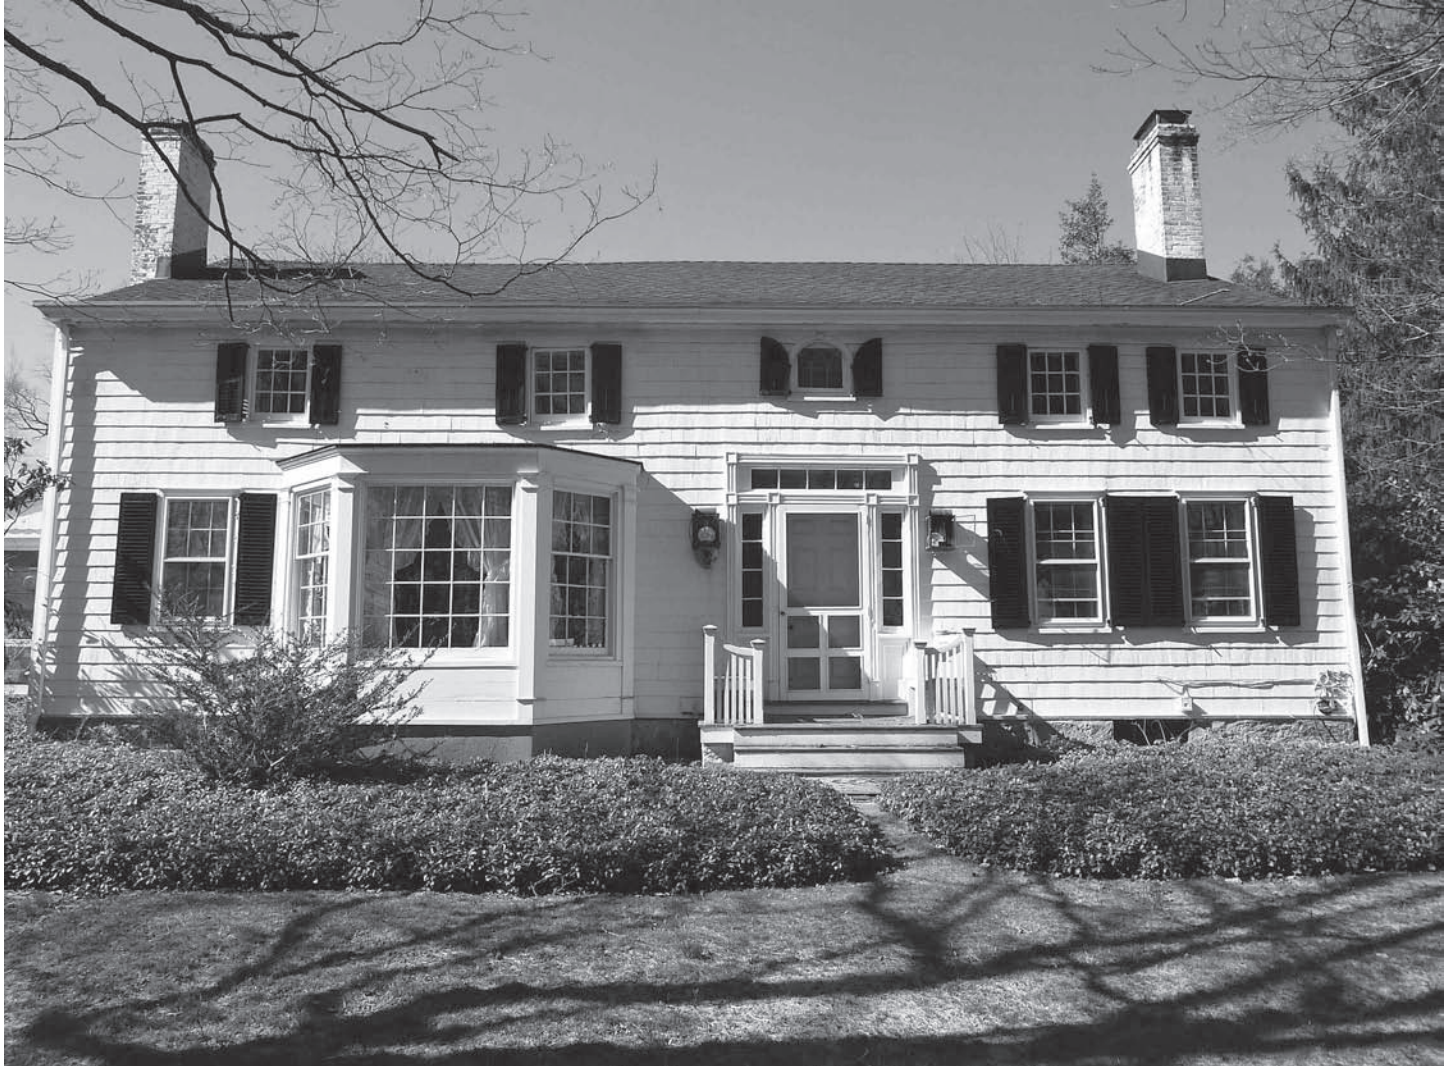
Fig. 3 – House at Hallock's Mill, view of south façade. The three-bays and entrance on right side represent the dimensions of the original house. Photo by J-F Delaperouse.

house was fully erected by late 18th or early 19th century. After lunch the group visited the site of Hallock's Mill on the Saw Mill River, the first industrial settlement in the Yorktown Heights area, where the present house is located above the fieldstone dammed millpond (*Fig. 3*). At the core of the present house is a story-and-a-half dwelling having a three-bay front façade with an offset entrance and a side-passage plan – clearly the most common house local type built during the late 18th and early 19th centuries. The miller Hallock was the master of a post office in this house.

The house was enlarged to a full center hall plan sometime later, which also was common practice. Since then, it has gained appendages and additions as it evolved as a country house in the 20th century, and renovations continue to take place today. A large L-shaped barn complex behind the house consists of a 19th century structure that appears to be original to the site and a large addition constructed in the early 20th century as a seasonal inn using reused early timbers with a massive central fireplace. Our final stop was the Henry Strang House on Old

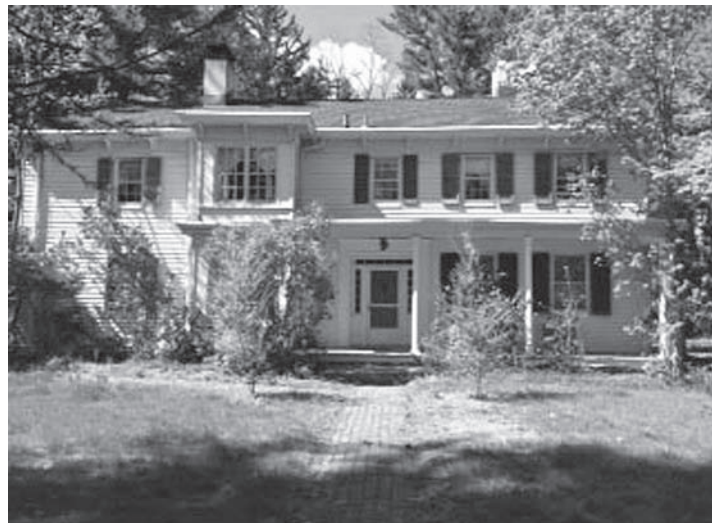
Fig. 4 – Henry Strang House, view of south façade. The three-bays and entrance on right side represent the dimensions of the original house. Photo by J-F Delaperouse.

Crompond Road where three building phases paralleling those in the previous house also could be discerned (Fig. 4). The original two-story house dates to the late 18th century with a three-bay front façade and side-passage plan with back-to-back fireplaces in the two rooms on each floor. Rooms were added on the south side of the passage during the Federal period, which balanced-out the plan and the symmetry of the front façade, as well as doubling living space. Fortunately, a good deal of the original woodwork and hardware in these early sections has been preserved. The last building phase consists of mid 20th century additions on the southern end of the house that fulfills the domestic expectations of a modern family with minimal disruption to the original fabric. Finally, as the sun was setting, an examination of the post and beam barn at the end of the yard revealed that it can be dated to the 1840s. Thanks are due the owners who allowed us to explore their properties and the HVVA members whose expertise helped elucidate many details and resolve some long-standing questions. The hunt is now on for even better candidates for the next Yorktown tour!

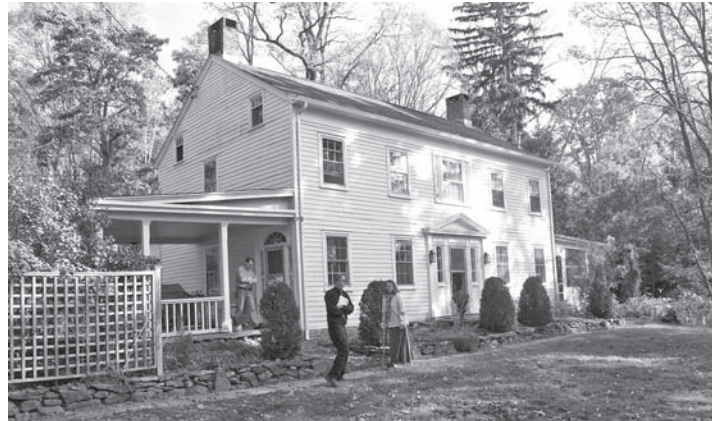
Fig. 1 – View of Tompkins-Scribner House from southwest.
Photo by N. Larson.

A recent HVVA house tour in Yorktown, Westchester County introduced members to a variety of houses that reflect the English role in the early architectural history of the Hudson Valley. Our tour organizer, J-F DeLaperouse provides an overview of these buildings elsewhere in this issue, but a distinctive Federal Period house on Baptist Church Road, which the owners were kind enough to fully open to visitors from basement to attic, receives a little more attention here (*Fig. 1*). Outwardly, the two-story house displayed the characteristics of a large farmhouse with a five-bay front façade centered with a prominent pedimented entrance surmounted by a tripartite second-story window with tracery in the side lights. This stylish treatment was repeated in an elegant doorway with sidelights and an arched transom on the west end of the house, which can be seen in the accompanying photograph.

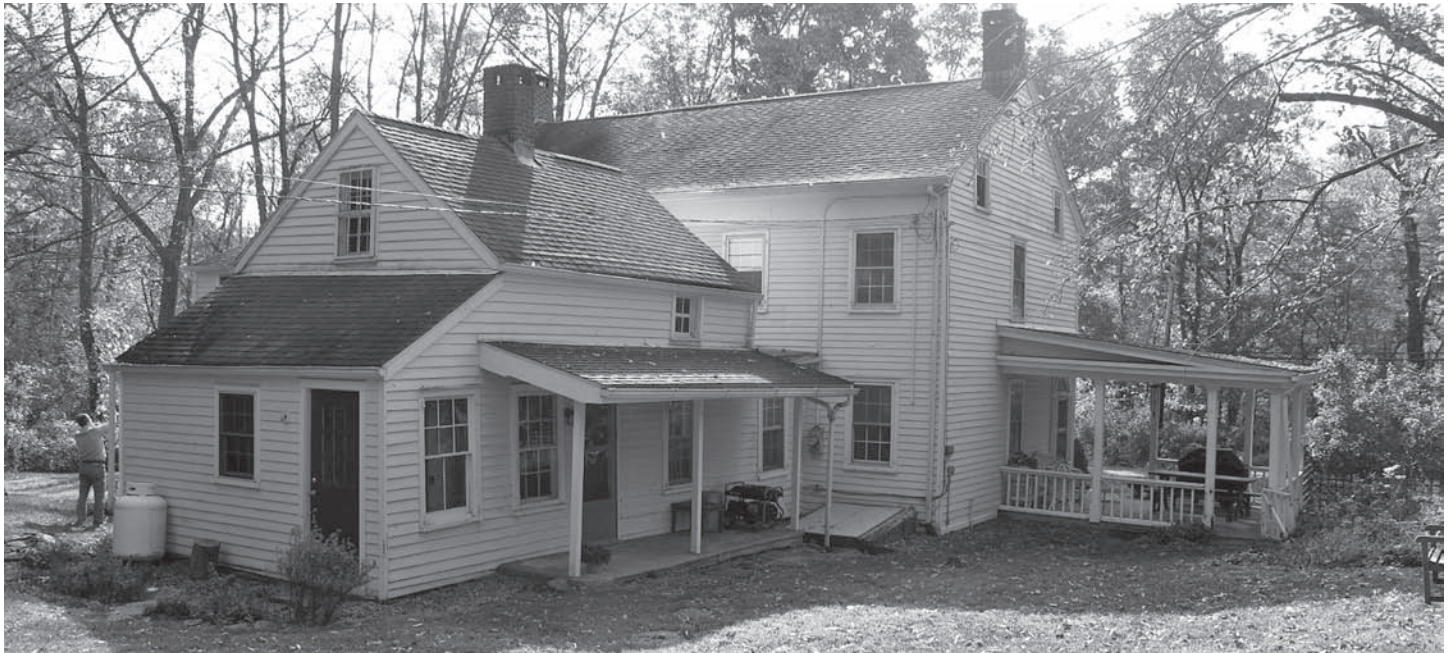
Fig. 2 – View of Tompkins-Scribner House from northwest showing kitchen ell. Photo by N. Larson.

When Amos Tompkins built the house in c.1830, the kitchen was located in a story-and-a-half rear ell (*Fig. 2*). The owners drew attention to the fact that the framing looked older than the house and to the deed history, which stretched back to the 1720s. The small gable-roof adjunct is connected to the house by a flat-roof hyphen as if it once was separated from the house. These conditions suggest three possible scenarios. In one the kitchen was built to be separate from the house and later was connected to the house. There are a number of examples of detached kitchens (not summer kitchens, which rely on another kitchen existing in the house) in the Hudson Highlands where British families settled in the 18th century. Yet, if the house and kitchen were built at the same time, only separate, then it would be expected that their framing materials and methods would be the same, which they are not. The hewn frame of the kitchen, plainly visible in the attic, clearly is 18th-century.

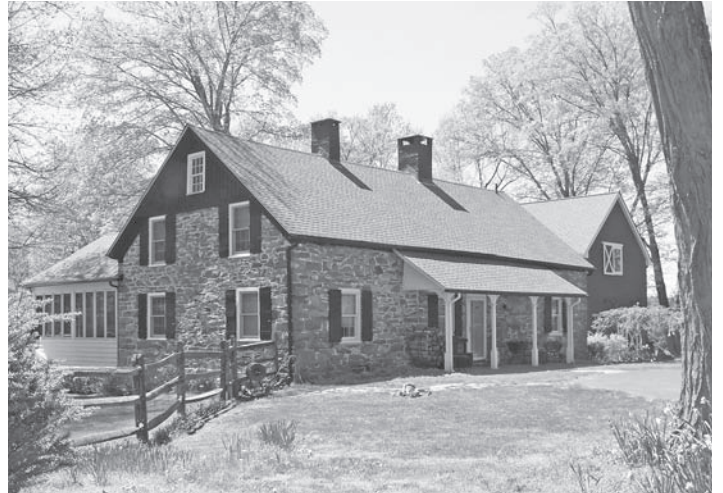
Fig. 1 – Isaac Van Wagenen House. In 1745 Jacob Aertsen's youngest son, Isaac, erected this stone house on the other side of the Rondout Creek from where his siblings resided.

Located on Van Wagner Road, between the hamlets of St. Remy and Rifton, is the house of Isaac Van Wagenen (Fig. 1). This road existed to reach the ford in the creek used by the family to access lands they owned on both sides of the creek. Isaac was the first of his family to create a farm on the lands along the east side of the creek. The current owners still have in their possession the date-stone incised with the year 1745 on it. It is currently standing vigil in the basement as its original position in the south elevation was removed to put on an addition about thirteen years ago. This would suggest that originally the south elevation was considered the front of the house, but all known historic views of the house picture the north side as the front.

Isaac's house started off as a two-room, one-and-a-half-story stone house typical of the area, possibly with an exterior door for each room. However, this house was constructed with a center chimney with either back to back jambless fireplaces or one fireplace with a five-plate stove in the west room. Although both current fireplaces are twentieth century replacements, there is the usual evidence of the original jambless fireplace in the east room in the form of the header beam being larger than the other ceiling beams and trimmer beams still extant. A corbel support for a hearth still exists in the basement wall beneath the eastern hearth. Ceiling beams in both rooms are finished with beaded bottom edges. Now with the modern renovations, it is difficult to determine the original status of the two rooms, that is, which was the kitchen / general purpose room and if the other had higher status as a "Grote Kamer."

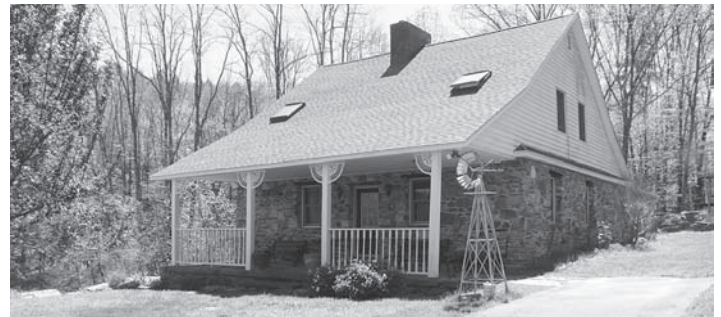
Fig. 3 – Van Wagenen-Krom House. Benjamin Van Wagenen built the house in c.1810 as a timber-frame, three-bay, side-entrance edifice in the Federal style. In the 1970s Ray Krom encased the exterior with stone shifting the entrance to the center. It took three years to complete the work.

This house along with the farm remained in the Van Wagenen family until the Great Depression when it was subject to a foreclosure. The current owner's father, Frank Tesler, acquired the property in 1941. By that time, the house was in a ruinous condition, with the floor rotted right through to the cellar in one room and the fireplaces crumbling, still with no indoor plumbing or electricity. Yet, he renovated it using whatever local resources available to him. The living room fireplace was reconstructed with bluestone from the property. He tried to keep as much of the original character as intact as he could, while introducing modern conveniences. He kept the beams exposed and created a fireplace mantel that mimics the cornice woodwork that would have hung from a jambless hood. In the other room he added paneling that gave the fireplace a more English look. Also on the property is a large Dutch barn with the gables oriented north and south with a side aisle to the west side of the nave; the aisle on the east side was replaced with a smaller lean-to addition (*Fig. 2*). It is certainly worthy of a more intensive inspection at some point in the near future.

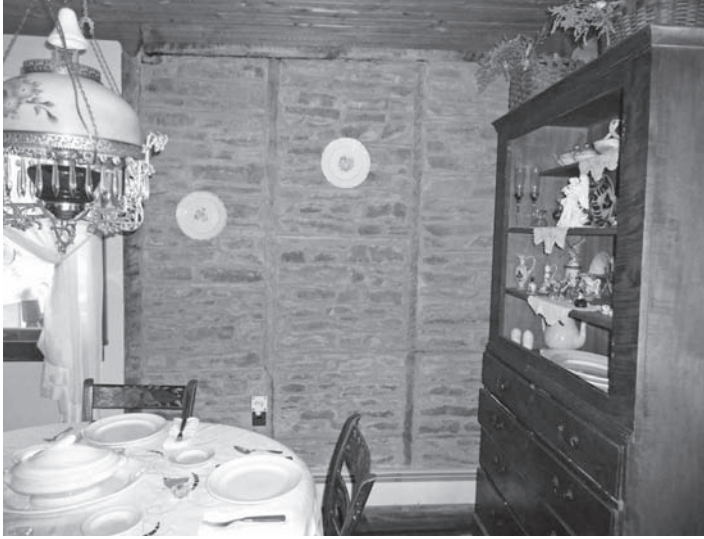
Fig. 4 – Van Wagenen-Krom House. Interior view showing original timber frame and stone nogging.

The one-and-a-half-story house was originally configured with a three-bay front façade having an entrance offset on the right side and back-to-back fireplaces. The current owner changed the entrance to the center and moved a window to the right to make the front symmetrical. He then decided to erect stone exterior walls using beams from old barns as lintels above the windows and doors giving the place the look of old stone masonry. The beams now exposed inside are significantly smaller than those in the neighboring house despite their long span reaching across the rooms; they show signs of having been once covered over with lath and plaster. An unusual surviving feature of this place is the bluestone nogging used instead of brick within the walls; dressed to fit between the posts and braces and laid in courses (*Fig. 4*).

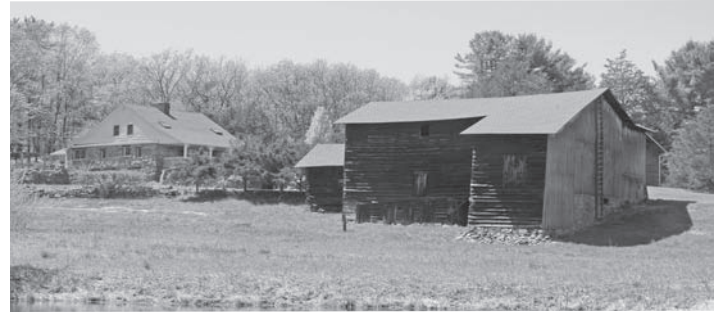
Fig. 5 – Van Wagenen-Krom House and Barn. This view shows the relationship between the house, barn and the topography of the land. The barn takes advantage of the slope of the land to create three levels. The southern portion has an H-bent frame, but with two anchor beams per bent in an odd spacing.

The house is built on a knoll with the barn on the slope between the road and the house and dominates the landscape. The barn is not typical Dutch construction, but takes advantage of the sloping topography to make use of three levels (*Fig. 5*). The south end uses an unusual H-bent variant of two anchor beams of significant size. The first anchor beam is only about six feet above the floor with the second one approximately four feet above the first. This barn warrants closer study. Inside the barn is a 1927 Model T Ford pickup that Leon used to transport his produce to the Rondout waterfront for shipment to New York City.

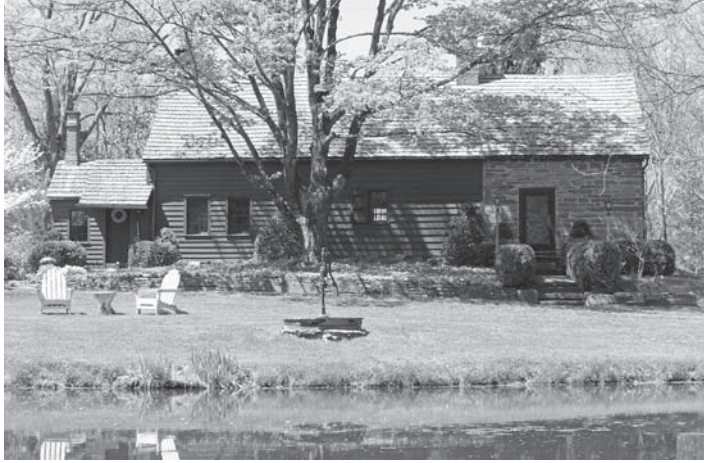
Fig. 6 – Hendrick Smit House. One of the oldest H-bent timber-framed residence in the Hudson Valley. Its construction remains a mystery after an extensive and poorly documented “restoration.”

The house as it exists today represents four construction phases with a front facade facing east (*Fig. 6*). At the southernmost end is a Victorian-era wood-frame summer kitchen 9 x 10 ft. in dimension with a ridgeline lower than the rest of the house. Next is a 15 x 26 ft., timber-frame kitchen with exposed ceiling beams. From its diminutive size and rough surface with evidence of early lath and plastering, it would be my estimate that this kitchen was constructed sometime after 1800. The third (and presumably the oldest) section of the house is built in the Dutch manner with timber "H" framing consisting of three center bents and two end walls with

a plan measuring 20 x 26 feet. The ceiling beams are of significant size reflecting an early construction period. The northernmost addition is constructed of stone masonry with a 16 x 26 ft. footprint. Reynolds claims this portion to be the oldest with the theory of a log cabin having pre-existing it along side. However, the ceiling beams in the stone section are not nearly the size of the center section, but are of a large enough size to suggest a pre-Revolutionary War construction date.

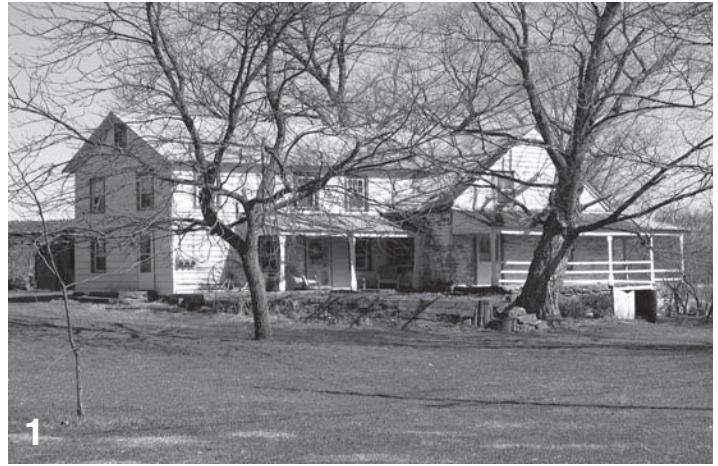
Fig. 1 – View of Osterhoudt house from southwest, 2010.

The Osterhoudt Home Farm on 167 Lower Whitfield Road in Accord was documented as part of a farmstead survey undertaken in the Town of Rochester (Ulster County) in 2010 (Fig. 1). The documentation was more historical than architectural as the buildings were not available for close inspection. In this case, the history suggested that the patriarch of the Kingston family, Teunis Osterhoudt (1668-1746), owned the property by 1703 and that his son, Kryne Osterhoudt, built at least the first section of around the time he married Geertje Decker in 1722. Visible seams in the side walls clearly showed the stone house was built in two one-room stages. (The balloon-frame addition was added much later.) The gable end with its doorway facing the road gave the impression of early Dutch models and was supported by the early history of the house; however, when HVVA toured the house in 2011 and got a closer look, it was determined that the door to have been added later. The original front façade of the house faced west, which was concealed when the wood frame wing was constructed. The interior of the house was significantly altered to the extent that little of the original construction materials and finishes were visible. That was until the house was gutted down to its stone walls and rafters a few weeks ago (Fig. 2).

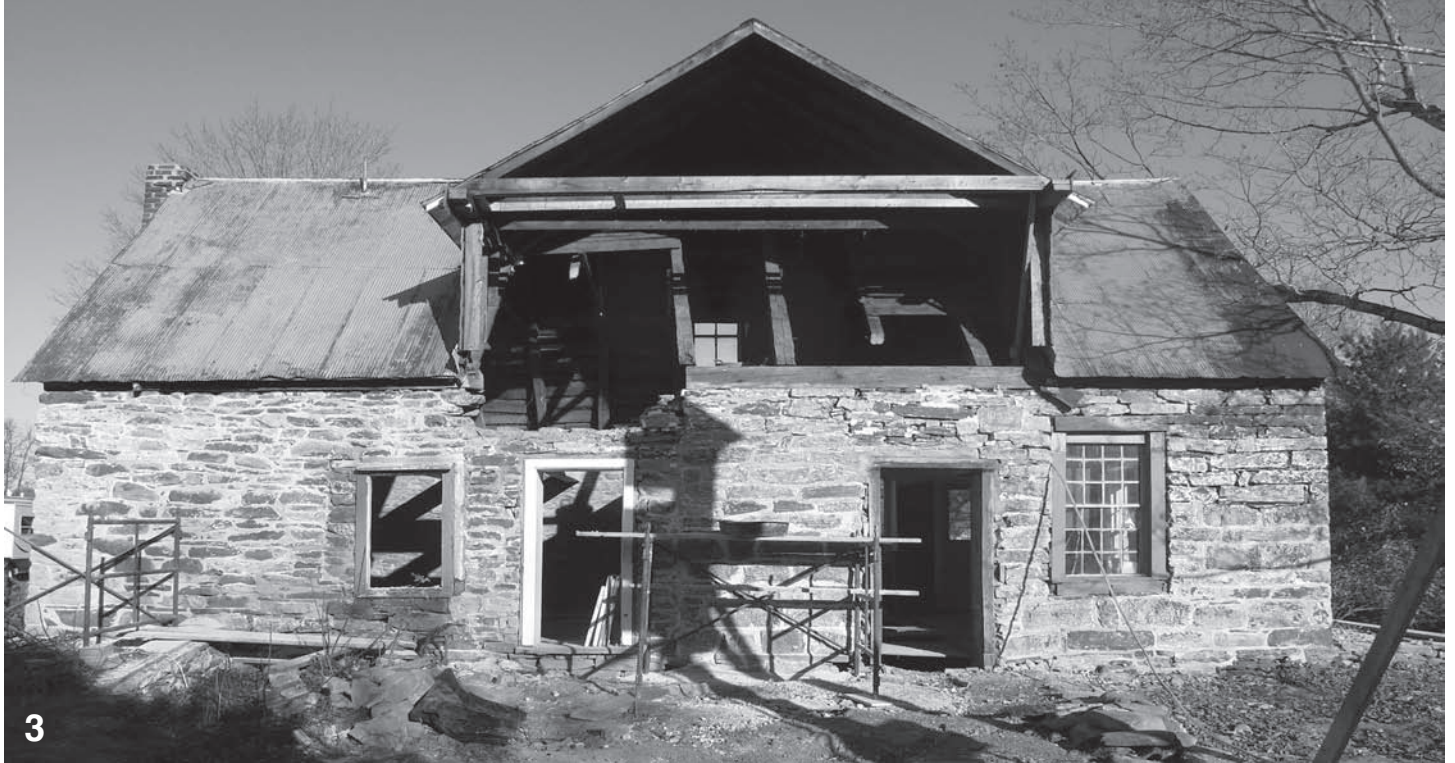
Fig. 3 – View of house from west, 2013. Seam between two sections visible in shadows to right of left door. Note larger stones and more even coursing on right side where door and window openings appear intact unlike openings on left side, which have been altered. View also shows roof framing of demolished addition.

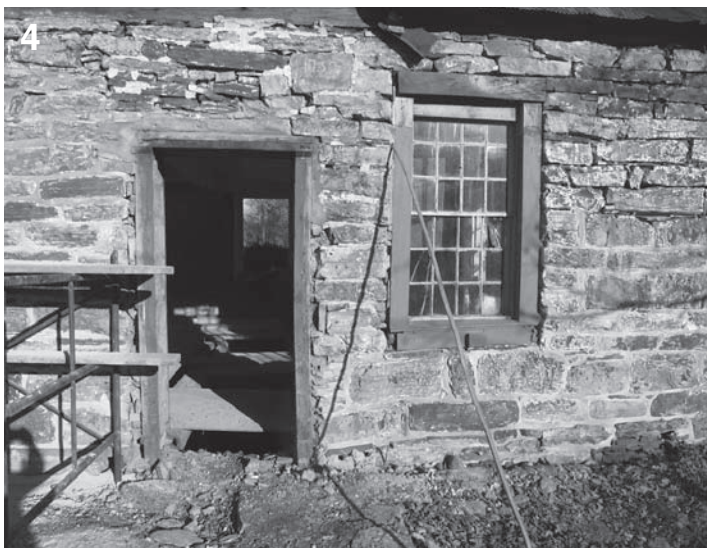
Fig. 4 – Detail of west wall, 2013. Door and window opening on south section of the house with a date stone inscribed with numeral 1752 above door. The neatness of the masonry and the date displayed suggests that the south section was added to the north section in that year and was constructed by Kryne and Geertie Osterhoudt's son Cornelius shortly after his marriage to his cousin Helena Osterhoudt two years earlier. A stone below the date stone is incised with the initials I V W (Van Wagenen?), perhaps the mason as Osterhoudts occupied the house until 1946.

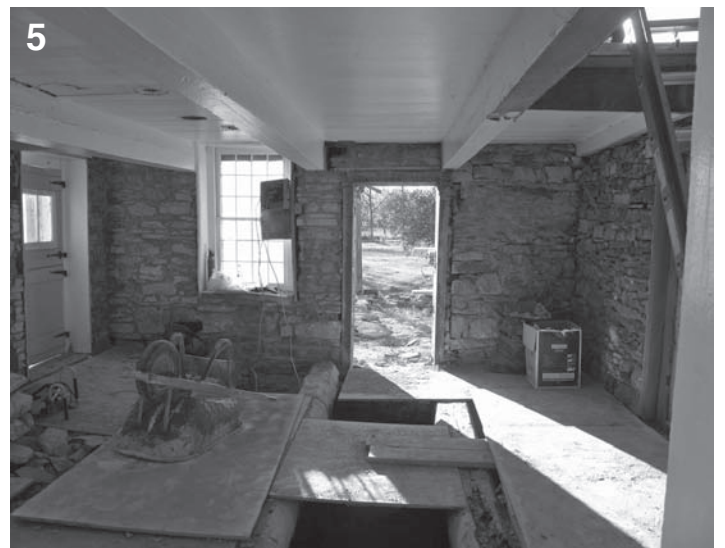
Fig. 5 – View of interior of south section looking west, 2013. Exposed stone walls and door and window framing appear to be intact. A heavy lintel spans the door opening and the window is neatly placed between ceiling beams. Note floor beams, which are logs flattened on the top for flooring, and finished beams and boards in the ceiling. The doorway on the left side of the image is in the gable end facing the street. The hole for the stairs is partially visible in the upper right corner of the view; the stairs and their enclosure were removed.

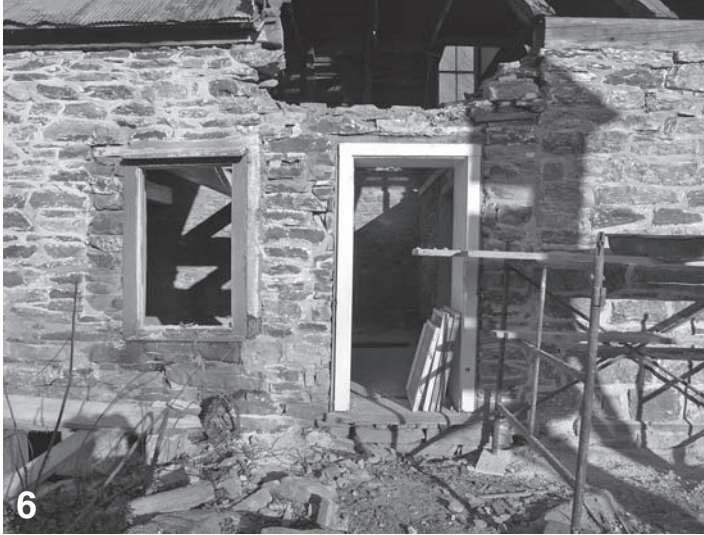
Fig. 6 – Detail of west wall, 2013. Door and window openings in what appears to be the original house built c.1722. The window opening was reduced in size probably when a casement window was replaced with a sash unit. The door appears to have been a still later addition, possibly cut through when the balloon-frame wing was added. The interior stone wall between the two sections is nearly flush with the right side of the doorway, which would align its exterior face with the seam.

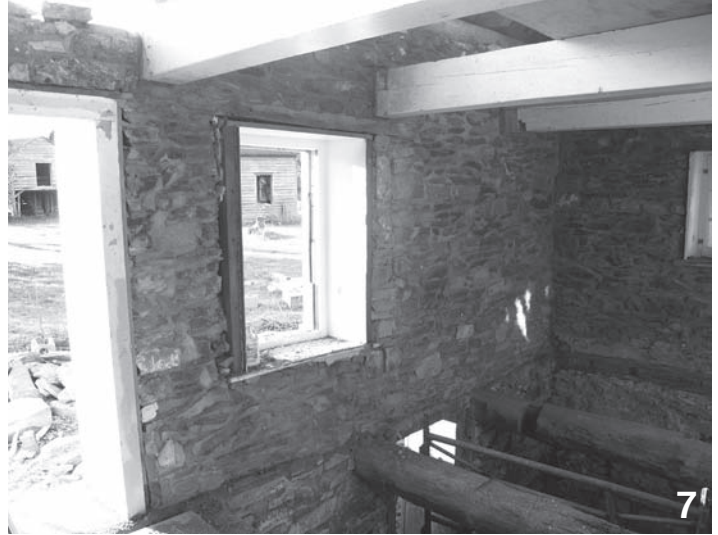
Fig. 7 – Interior view of north room looking northwest, 2013. The window opening is spanned by a wood lintel typical of 18th-century methods, although it does not fully span the original larger opening. The casing for the doorway is much later. Floor and ceiling beams are similar in dimension and tooling as those in the adjoining room.

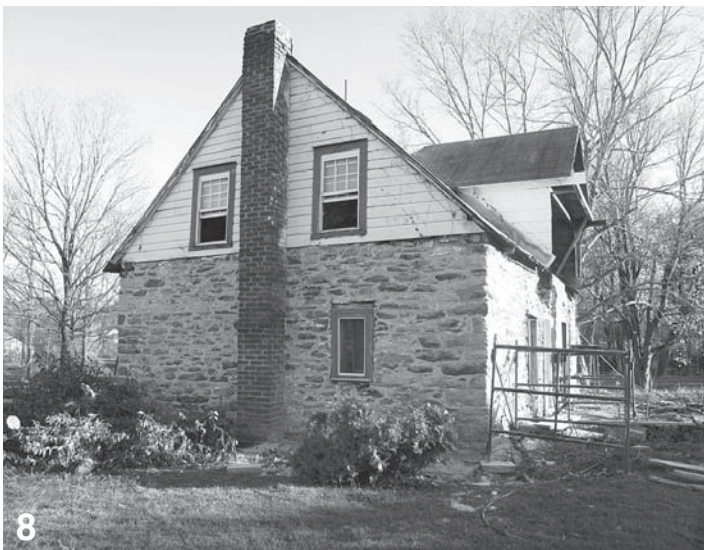
Fig. 8 – View of house from northwest, 2013. The casement window on the north end of the house appears to be original. The wood frame upper story has later windows and siding appropriate to period when the ell was added and bed chambers created in the garret.

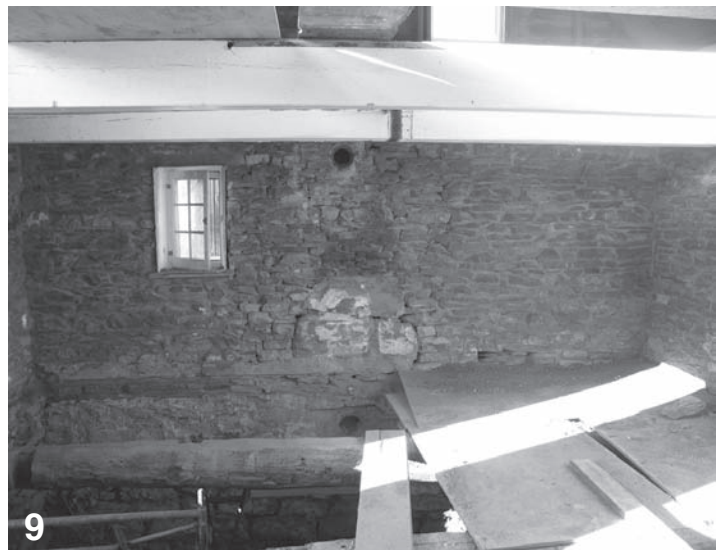
Fig. 9 – Interior view of north room from south, 2013. The casement window opening with its wood lintel appears to be intact. Evidence of a firebox back from a hearth later removed is visible at floor level in center. Trimmers surviving in ceiling and pockets in floor beams, as well as a shelf in the basement wall that once supported cribbing, all point to the prior existence of a jambless fireplace.

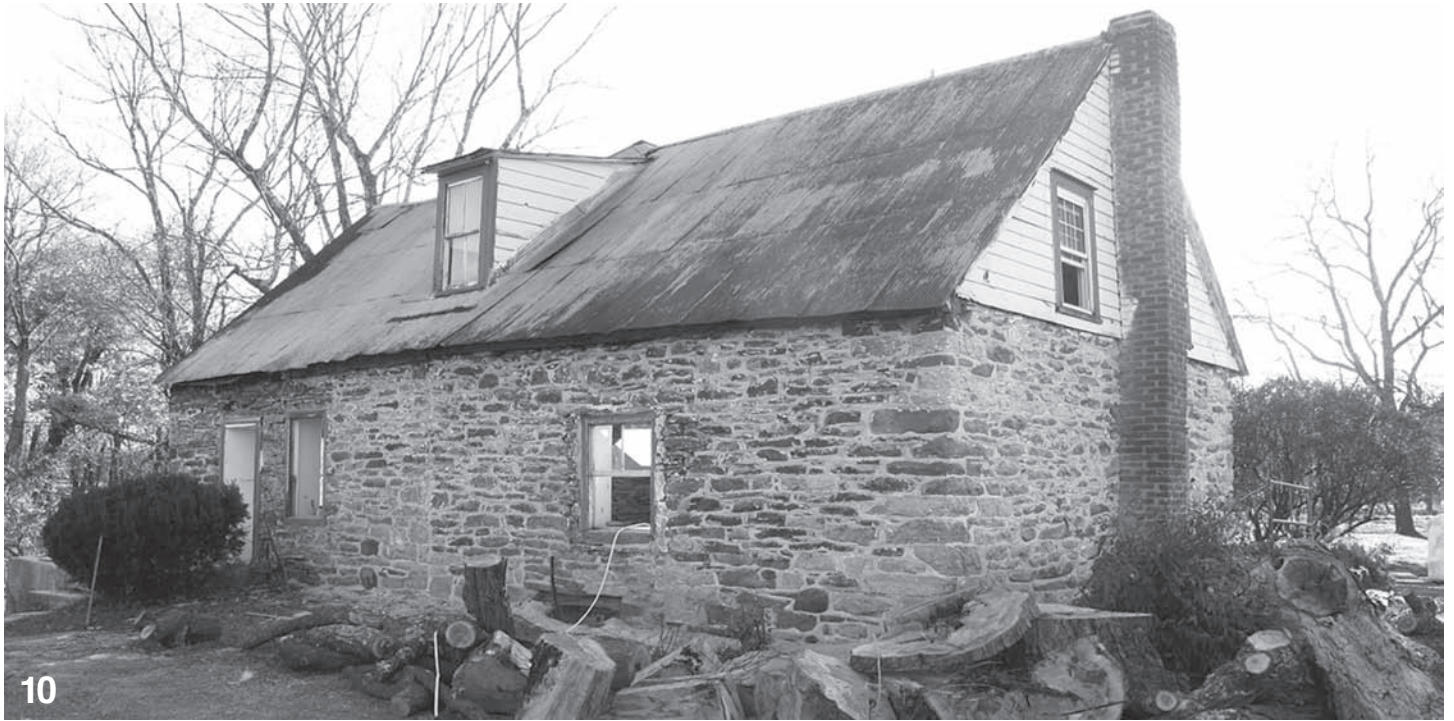
Fig. 10– View of house from northeast, 2013. The east wall of the house contains an added window in the north section and an added doorway in the south section. From the stonework, it does not appear that the c.1722 house had any openings on the east side. The window opening near the doorway appears to be in its original dimensions. Like the window on the opposing side of the room, it is positioned between beams on the interior. Unlike the windows in the original house, the windows in the 1752 addition were sash units. The seam between the two sections is visible in the center and the lintel for the original basement entry is just discernible under the window on the right and behind the tree parts. It was filled in with stone when a new door was created on the west side of the house.

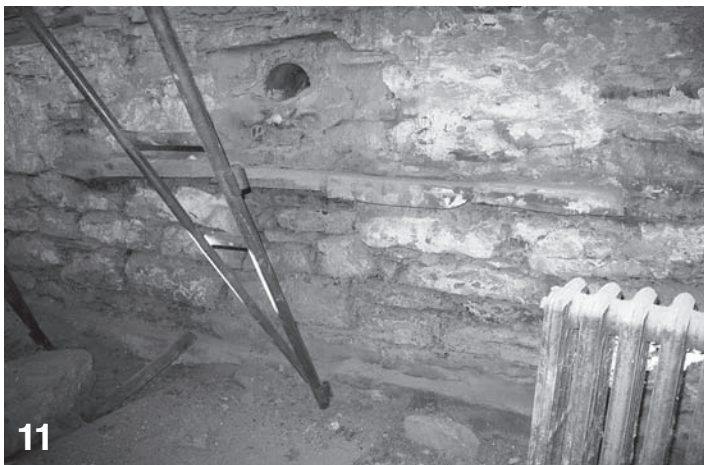
Fig. 11 – Detail of north basement wall with shelf for hearth cribbing, 2013

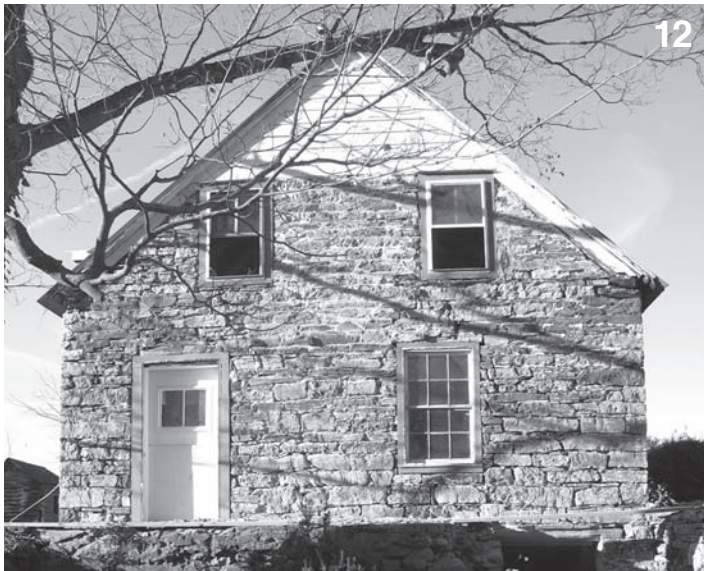
Fig. 12 – View of house from south, 2013. The window and door on the first story and the basement door in this façade were added after the fireplace was removed from this end of the house in the 20th century. The second-story windows predate those below and possibly are original to this section. The stone coursing has been extended half-way up the gable whereas the entire gable is framed-in on the north side.

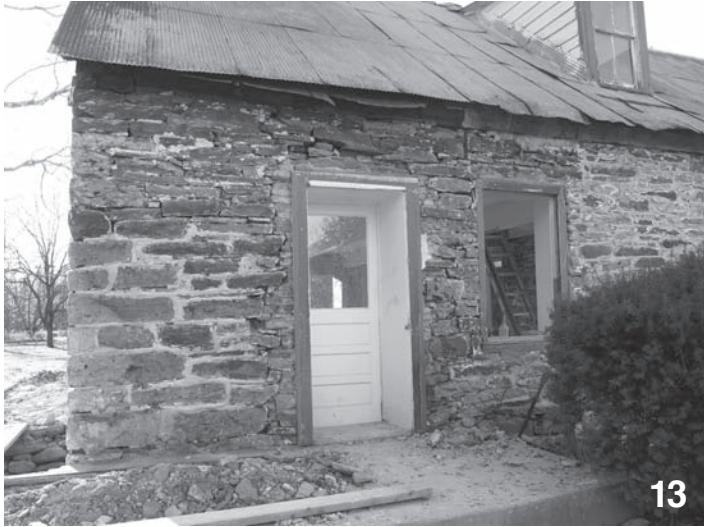
Fig. 13 – View of south end of east side of house, 2013. Evidence that the doorway has added later is visible in this view. The 1752 window opening is intact.

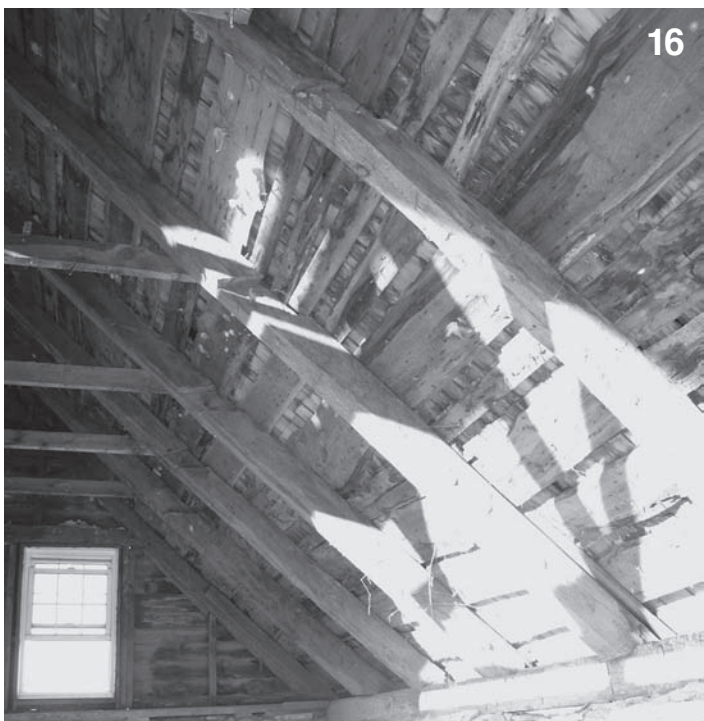
Fig. 16 – View of rafters and plate in north section of house, 2013. Original hewn rafters remain in place. Joined collar ties were removed and replaced with nailed ties evidently to create more head room in attic spaces.

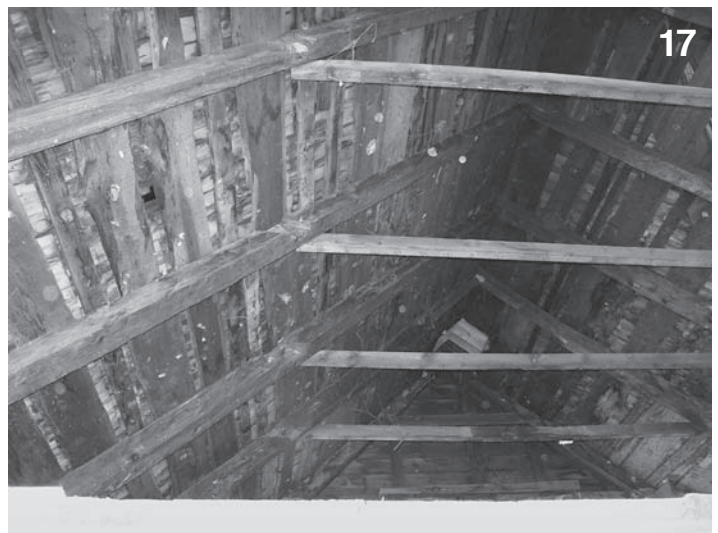
Fig. 17 – View of rafters in south section of house, 2013. No distinction can be made between the roof systems in the two sections suggesting that the entire roof was built in 1752.
