Dutch Barn Tour

Saturday, June 21, 2008, 10 AM

Text & Photos by Ned Pratt, DBPS Albany, NY

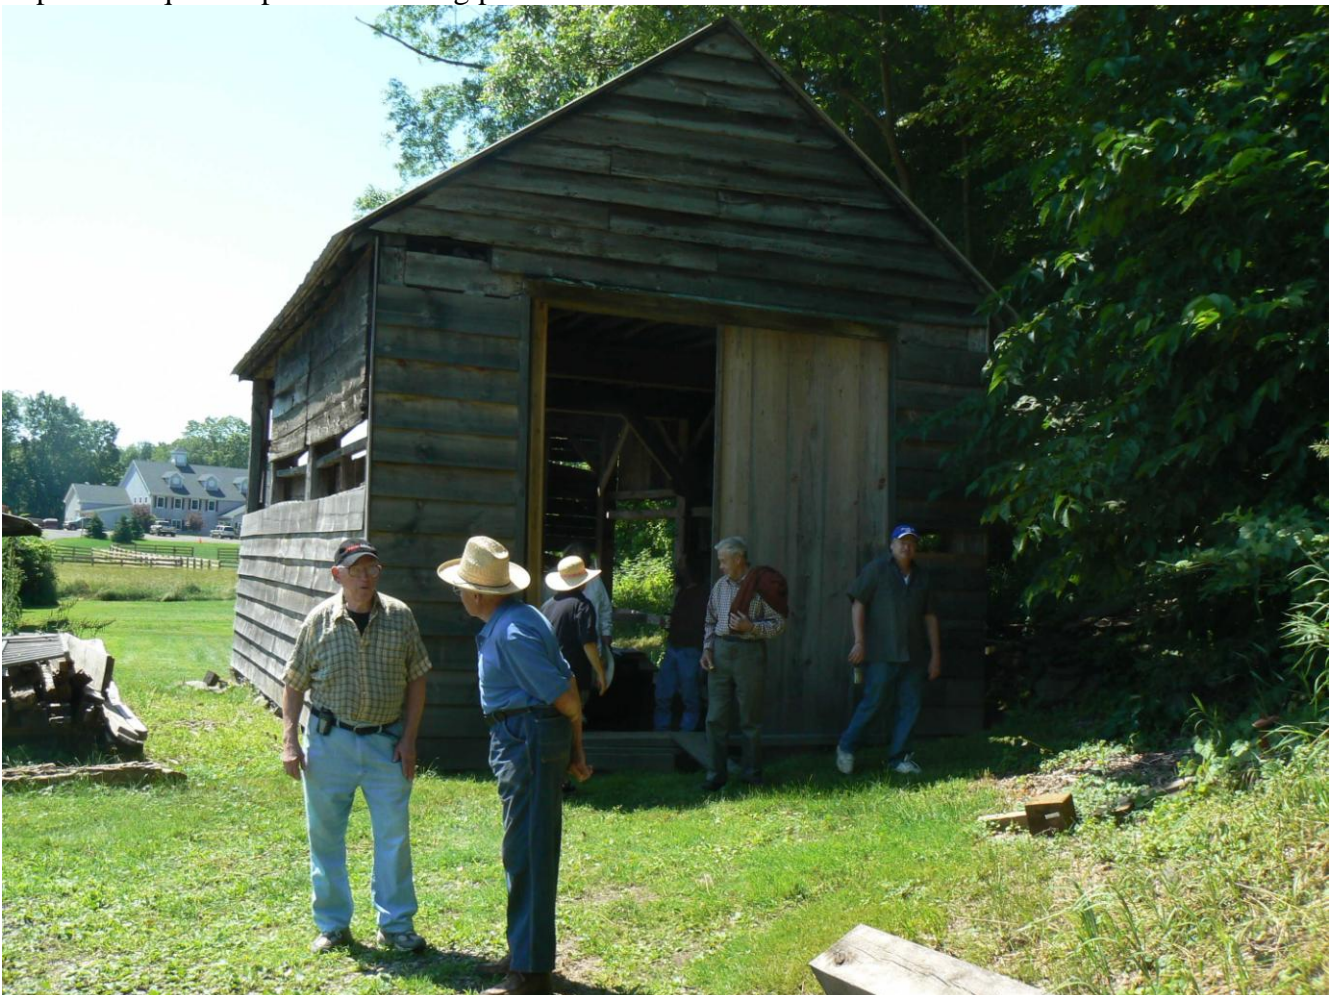
Our first site was the Palatine Farmstead, about ¼ mile towards Rhinebeck on Route 9 and across from the Quitman Center. At the site are an old house, a barn, and the remains of an outhouse. The Farmstead is owned by the Quitman Resource Center. The house is very close to the road, on the east side of Route 9, in what was the first area of settlement of Rhinebeck- here and stretching another ¼ of a mile south, perhaps. There's a website with pictures of restorations at <http://www.quitmanpreservation.org/palatine.htm>

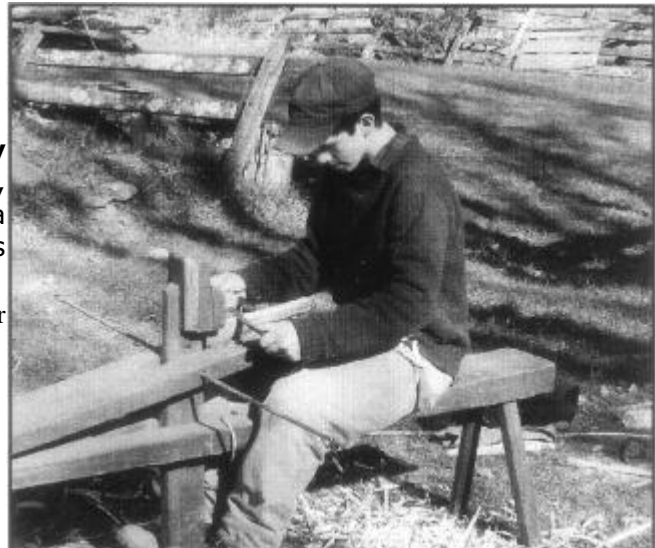
Eric Schatzel of Hurley

Seated at the shave-bench, using a draw knife, Eric shapes a trunnel (wooden peg) riven from a block of locust wood. photo by Bob Hedges

“From the Editor... The week-long barn repair workshop at the Palatine Farmstead in Rhinebeck was a great success blessed by the best weather. The building was leveled and secured to new 7x9-inch white oak sill plates. A dedicated and hard working crew of instructors and participants cut the traditional scarf joint, lap dovetails and mortises in the north sill using hand tools and some modern shortcuts, rebuilt part of the dry-wall stone foundation on the north side, numbered and removed the 2-inch oak floor boards, dug out the accumulation of dirt bellow the floor exposing the internal sills and

This beginning of the restoration process stabilized the timber frame but there are other things that need attention before the building is fully secure. We will be treating parts of the old frame with antifungal chemicals and we have ordered new 12"x3/4" pine siding to enclose some of the barn. It is being cut on a Wood-Miser band; saw mill that will give it a vintage look of vertical saw marks as if the wood were cut: on an early sash mill. We will be planning another work session soon. (see Coming Events)

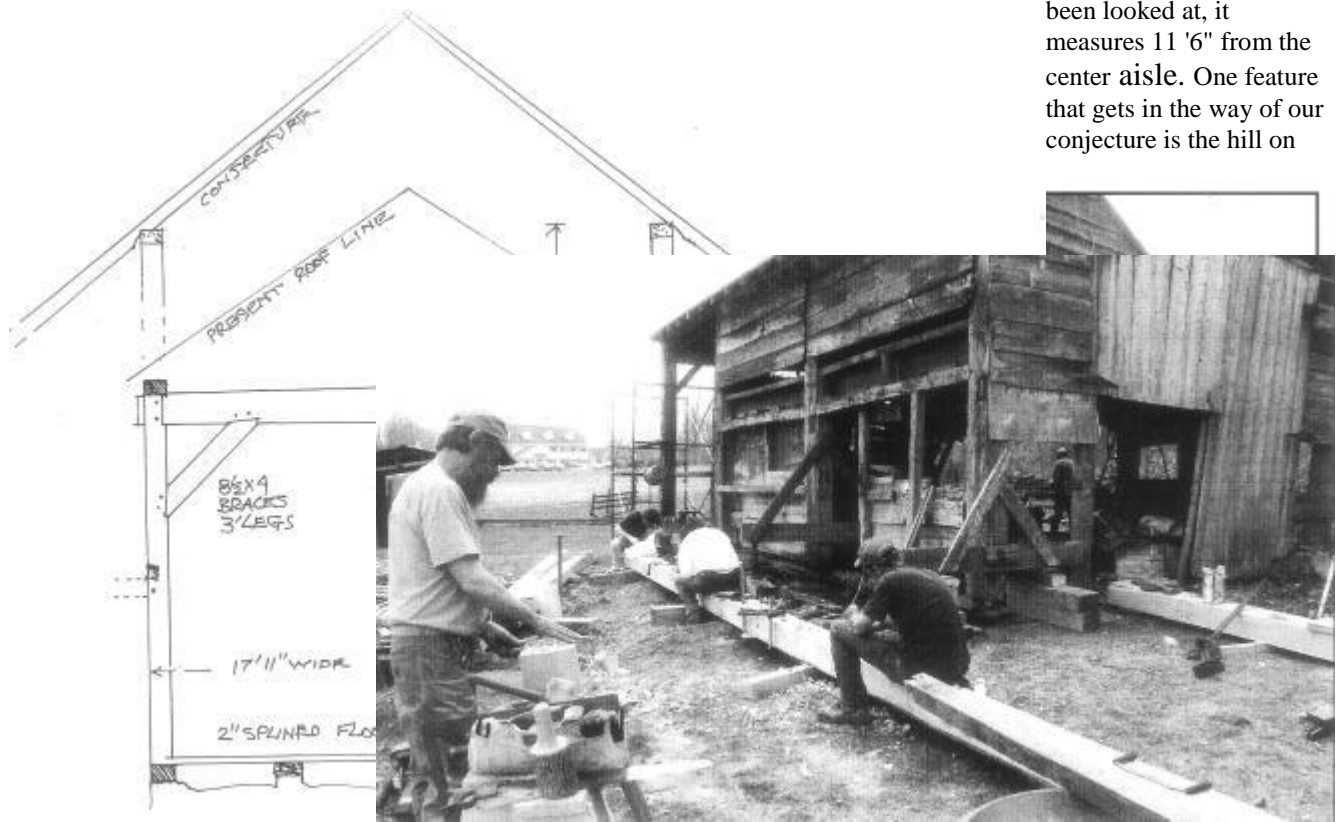
Bent 3. Facing East

The drawing shows a bent of the present cut-down frame of the barn and a conjectured original barn with 5'5" column (post) above the anchorbeam and an 11'6" side aisle. Only one side aisle is indicated in the drawing.

The Palatine Farmstead barn is missing its columns above the anchorbeams. Why these were removed is not clear. The original plates were reused and are in good condition, indicating the upper columns (*verdiepingh*) were also in good condition. Using a nearby barn as a model, The Mosher (Dut-Rhi-18) 3-bay Dutch barn, 11'6" wide side aisles, are conjectured and a 5'5" column above the anchorbeam for the original Palatine Farmstead barn. There is a north side wall foundation that has not

been looked at, it measures 11'6" from the center aisle. One feature that gets in the way of our conjecture is the hill on

the south side that is held back 9 feet from the nave with a 4 foot high stone wall. Does this all represent accumulated dirt eroded from the steep hillside? There should be a dig done to uncover foundation evidence. Devan found one bottle fragment in the soil close to the stone foundation wall that he was rebuilding. It suggests an 18th century date for the foundation wall.

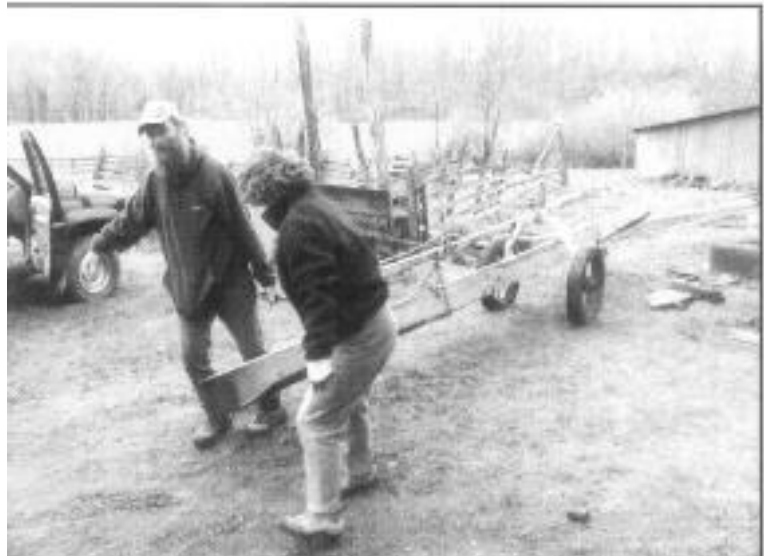
Bob and his wife Marg move a 20 foot 7"X9" white oak timber.

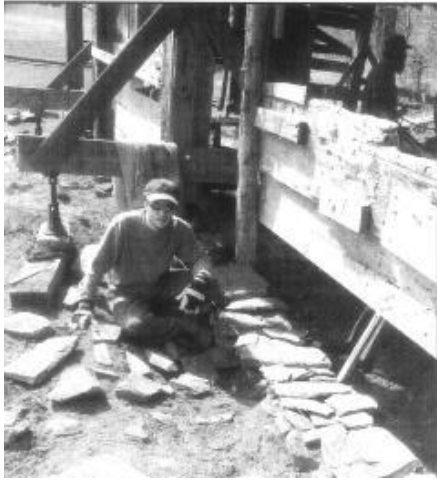
Devin repairs the stone foundation

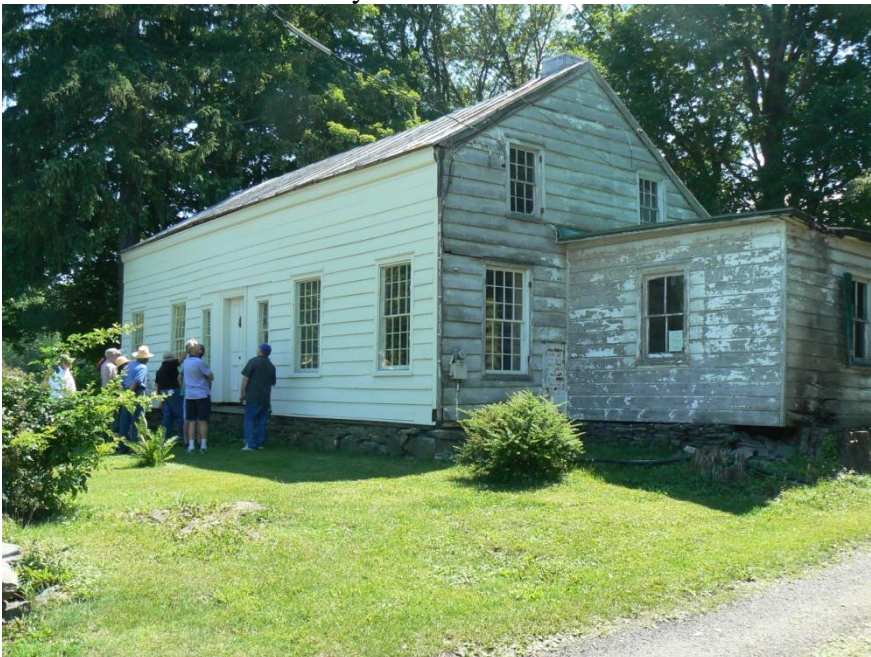
The house is a 5 bay center entry house with a lean to addition at the back, and a couple of later additions at one end, the south. There’s a center door facing west, toward Route 89, which can’t be much more than 10 yards away. The back addition has a nice reconstructed beehive oven; the size and location were determined by the foundation.

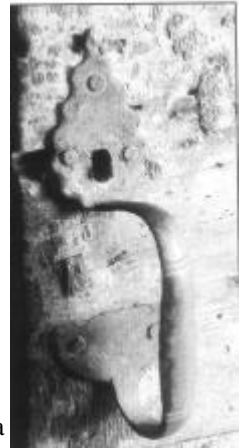
Suffolk Latch from the Possible 1740 Front Door Palatine Farmstead, Rhinebeck.

This latch has been renailed to the reused false panel door. It has a Pennsylvania German look and its method of attachment is unique.

The decorative Suffolk latch that has survived on the 1740 front door of the Palatine House in Rhinebeck is very unique. Of the 198 Suffolk latches illustrated in *Early American Wrought Iron*, 1979 edition, by Albert H. Sonn, none has the bottom plate turned up as this example does. Perhaps this was done later when the latch was renailed to the door. The decorative feature of the top pad has a German look.

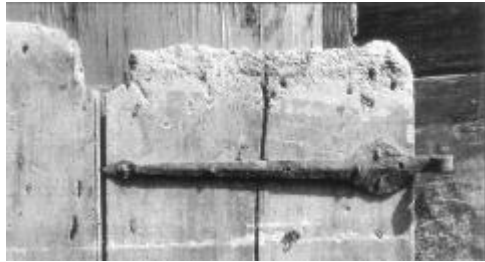
Strap Hinge from the 1770 Dutch Barn Palatine Farmstead, Rhinebeck." This hinge from a door fragment found in the barn has adopted a pointed

<-Finally the remains of a three-batten door were found in the 1770 barn at the Palatine farmstead in Rhinebeck. It might have been an animal door. The surviving hinge has a pointed finial and a round pad.

finial. The door is particularly well made with 1.26-inch splines joining the three vertical boards.

The holes are rectangular and the hinge is nailed with the same hand-forged T-headed nails used to construct the door.

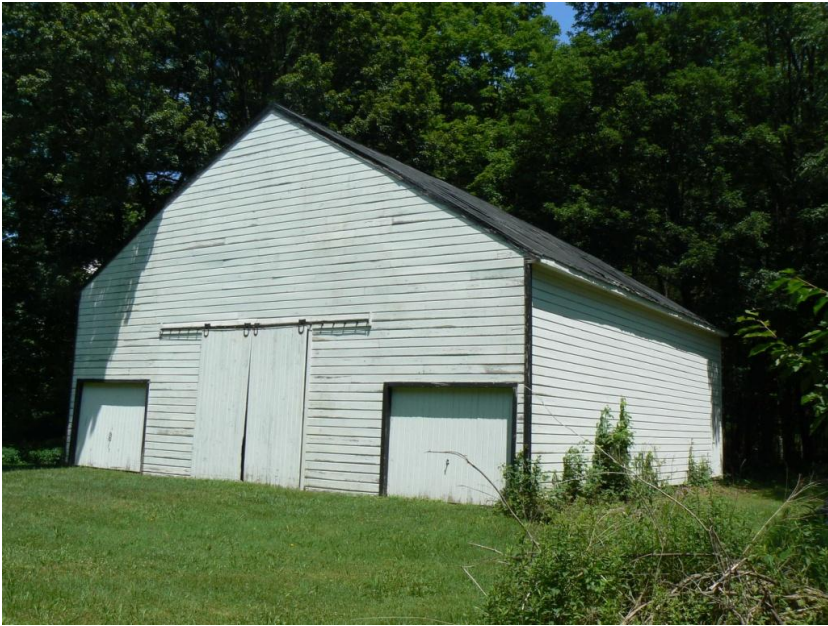
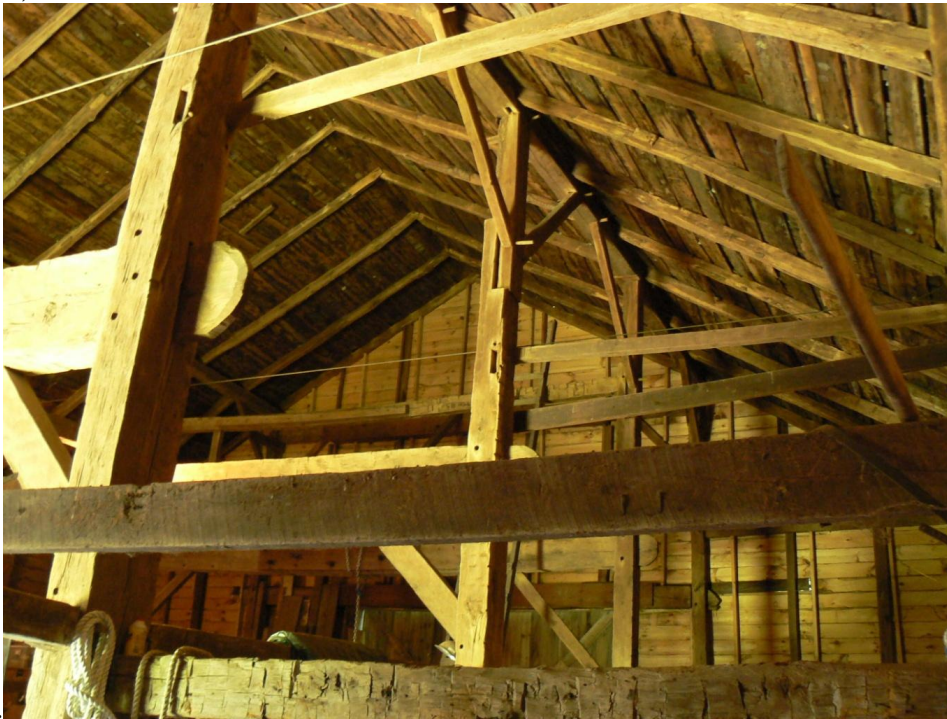
Our next stop was another Dutch Barn. This has all new siding- novelty wood siding, a new roof, and new sliding doors, replaced corner doors, etc. It is near an older house, but we didn't go there. Inside, the barn is quite well preserved.

This was a 4 bay Dutch Barn with two side aisles. Originally a 3 bay barn, a bay was added at the rear, and the anchor beam posts were extended about 4 feet; it also looks like the roof pitch was lowered. Some of the rafters show an extra bird's mouth. There are no wedges in the tenons of the anchor beams, and it is a scribe rule

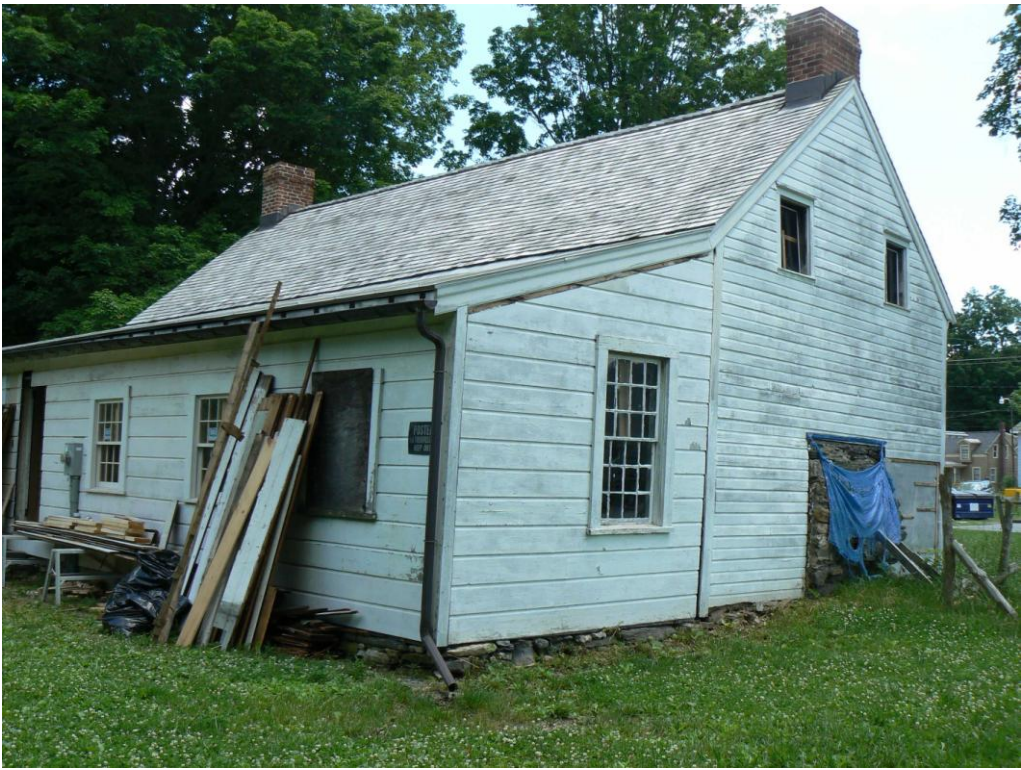
measured drawing by R. Hedges

Our next stop was **the Brush [Sp?] Log Cabin in downtown Pine Plains**, a fabulous building being saved by the historical society. A log cabin, with the first part built perhaps 1747, and an addition 1776?, then a lean-to on back, and covered by siding in the 1880's.

Bob Hedges did these drawings, which were published in their June 1999 Newsletter
