HVVA Tour of New World Dutch Bent-Framed Houses in Berkshire County,
Massachusetts.
15 September 2012.

Today's houses all share a familiar framing strategy, applied to New England house forms.

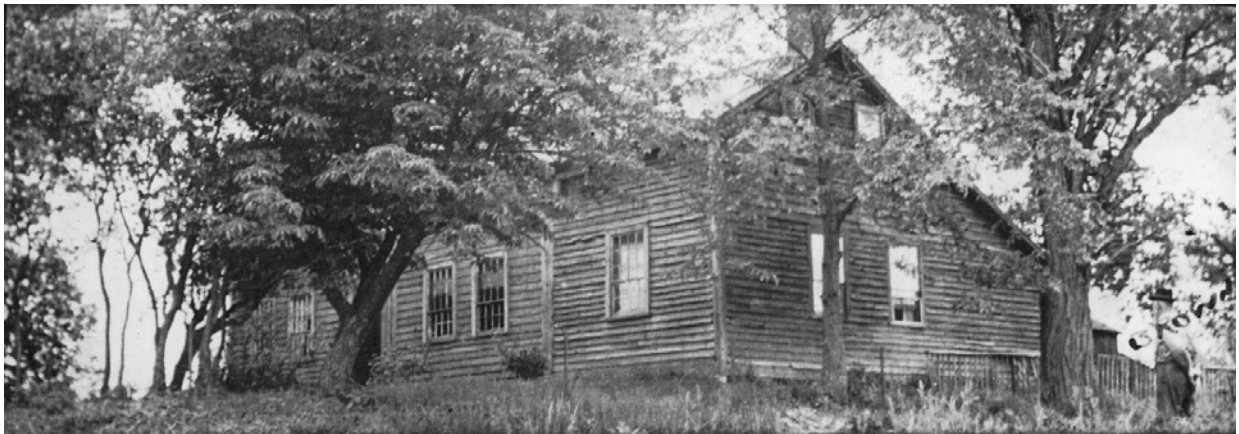
Photo 1. Photo of the house taken in the 1880s, looking southeast. The 1837 single-bay addition is seen at center right, with its leanto.

The earliest known photograph of the house dates to the 1880s, and shows it much as it appears today (Photo 1).

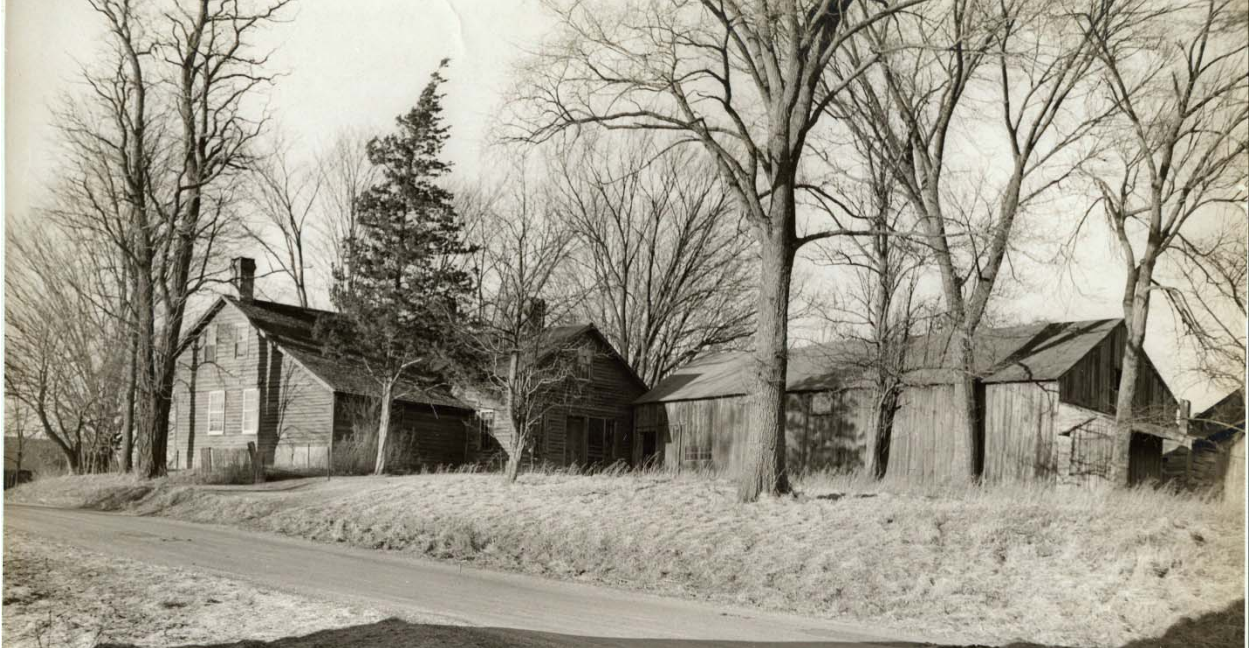
Photo 2. Photo looking north-northeast from Creamery Road, taken in 1946. The wing seen on the back of the house no longer stands.

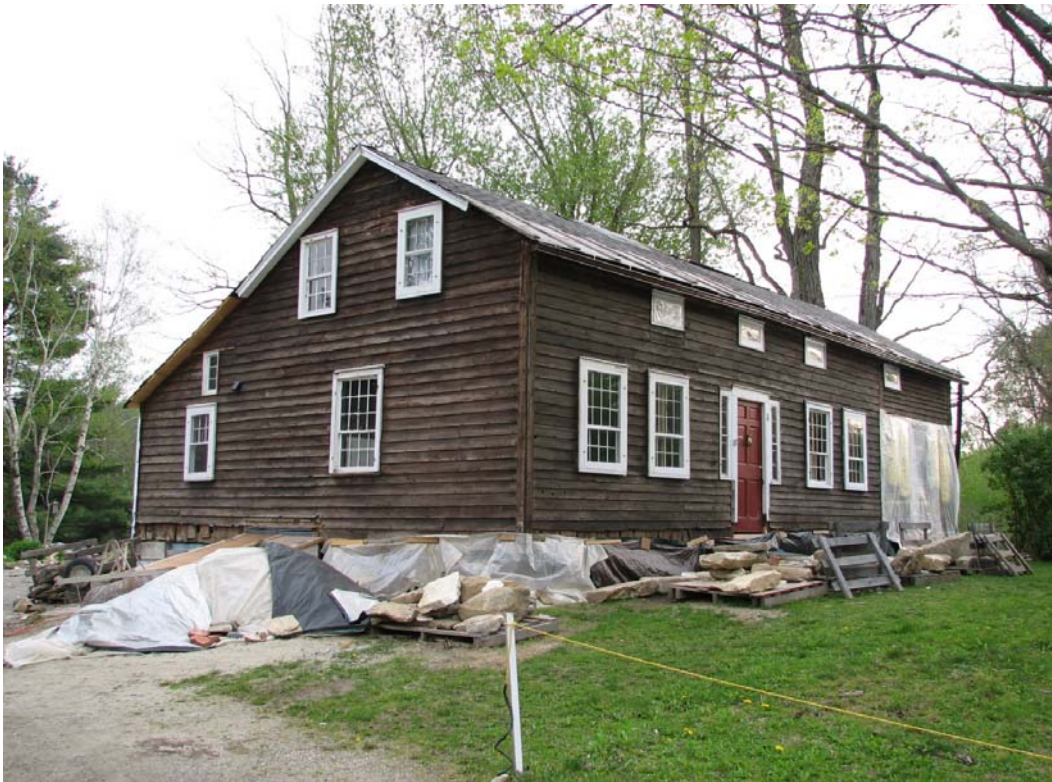
Photo 3. View looking southwest, May 2010 (all photos unless otherwise attributed are by W. Wheeler).

This house was dendrodated by Bill Flynt of Historic Deerfield in 2009. His sampling revealed harvesting dates of 1808 and 1809 for the hemlock used in the frame of the earlier portion of the house, suggesting a construction date of c.1810. The single bay addition to the south was dendrodated to 1837. The house was constructed for the family of Michael Hollenbeck, who had formerly lived on the Livingston Manor lands. Its framing is modified New World Dutch; its plan is derived from lobby entry houses of New England.

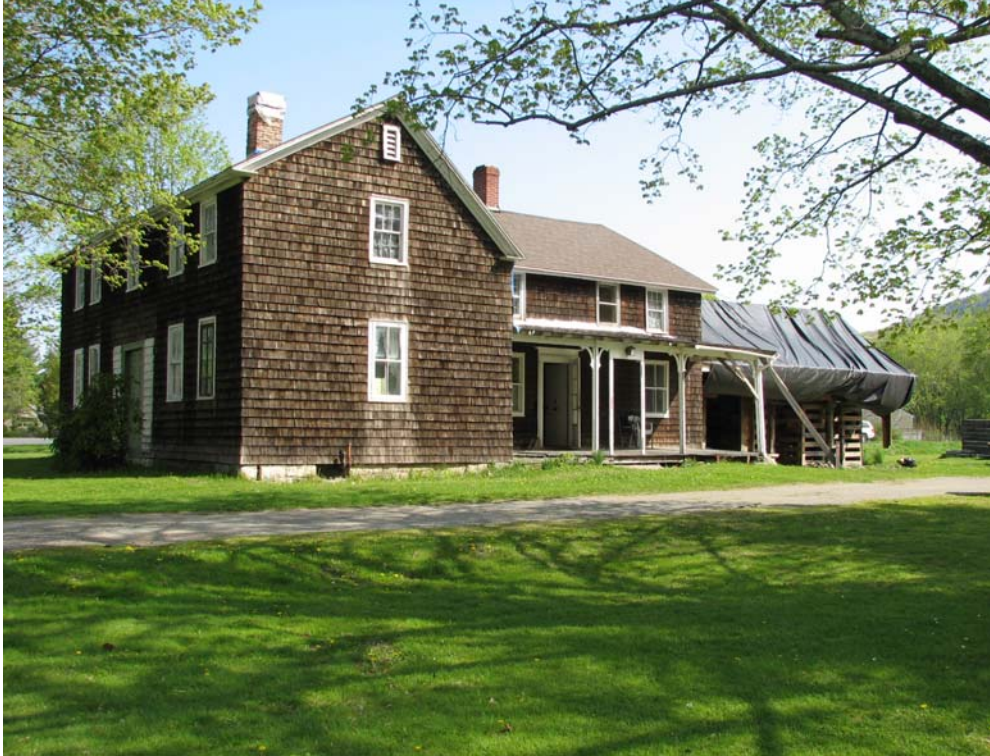
Photo 4. The house as it appeared in May 2010, looking northeast.

The house has a number of unusual and interesting features and components. Among these is the single-room bent-framed dwelling that was later encapsulated in the expanded house. Interestingly, there never seems to have been an attempt to cover the exposed posts of the frame. This contrasts with the highly-finished south parlor, which features a fine paneled wall and wainscot (Photo 6). A large structure—the original use of which remains unclear—was attached to the back of the kitchen wing. It's framing—currently being restored by Jack Sobon—is something you'll want to see.

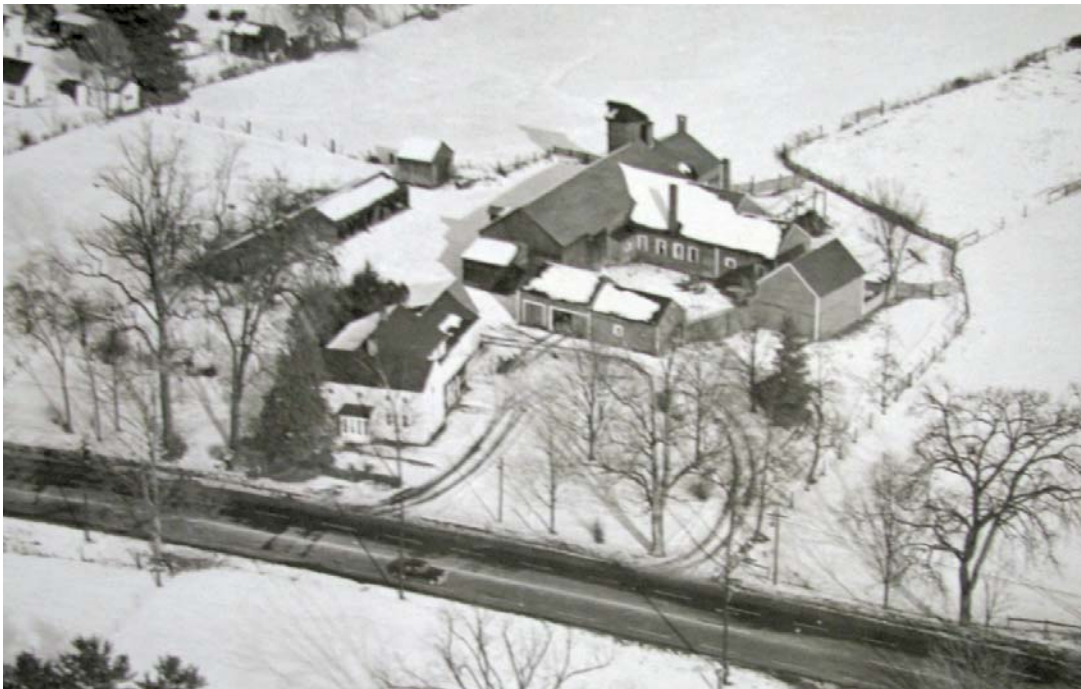
Photo 5. An historic aerial view of the Wheeler farmstead. Many of the associated outbuildings and barns remain on the property. (Collection Great Barrington Historical Society)

The Wheeler Family Farmstead is located on the southern edge of the city of Great Barrington in the Berkshires of western Massachusetts. The once rural area, with East Mountain a prominent eastern backdrop, has developed into a busy commercial strip along U.S. Route 7, which follows the course Housatonic River through Connecticut and Massachusetts. With its headwaters in Berkshire County, the Housatonic is a major interstate watershed located midway between the Hudson and Connecticut rivers, supporting scores of agricultural and industrial centers along its route to Long Island Sound. At its peak, the Wheeler Family Farm contained 130 acres extending west from the nearby Housatonic River and west across the Rt. 7, then known as the Sheffield Road. Now without its farm setting and separated from the river, the nominated property contains 1.5 acres with the historic house and farm buildings that have accumulated there since 1764 or earlier. Five generations of the Wheeler family occupied the farm and each has left its imprint on it. The family's progenitor, Truman Wheeler (1741-1815) began assembling land for the farm in 1768, and in 1771 he purchased the house in which he apparently had already been living and operating a store since his arrival in Great Barrington from Woodbury, Connecticut. The house is distinctive for its combination of both Dutch and English framing methods, a regional feature resulting from the interplay of cultures along the New York-Massachusetts border, which was in dispute during most of the 18th century. Later alterations to the house reflect the changing composition of households and local taste over the ensuing 200 years. Two 18th-century farm buildings survive, a wagon house attached to the house and a workshop that may have originated as a barn. Other buildings illustrate the periodic improvement of farm practice, such as a late 19th-century hay barn, and early 20th-century cow house and silo.

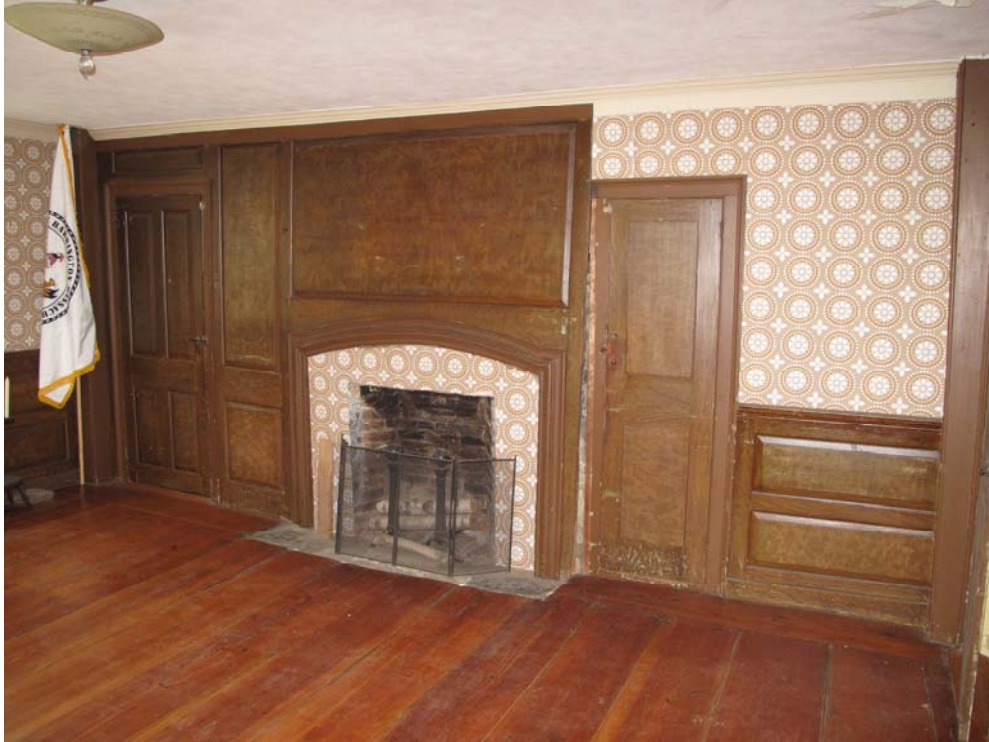
Photo 6. Paneled wall and wainscot in the south parlor, looking north-northeast, 2010.

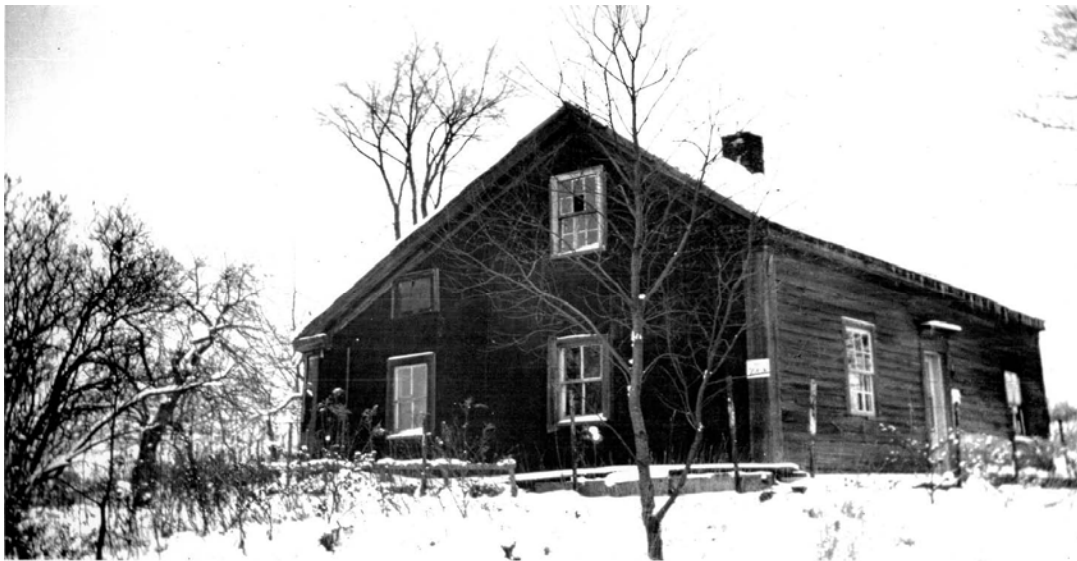
Photo 7. View of the house in 1937, looking northeast, before renovations (from the National Register nomination).

An examination of the roof's structural system revealed that the northern portion of the roof appears to have originally had a greater slope, but since that time it has been raised. An interior brick chimney pierces the roof ridge at its center. The chimney is not original, dating from the 1938-39 renovation of the house.

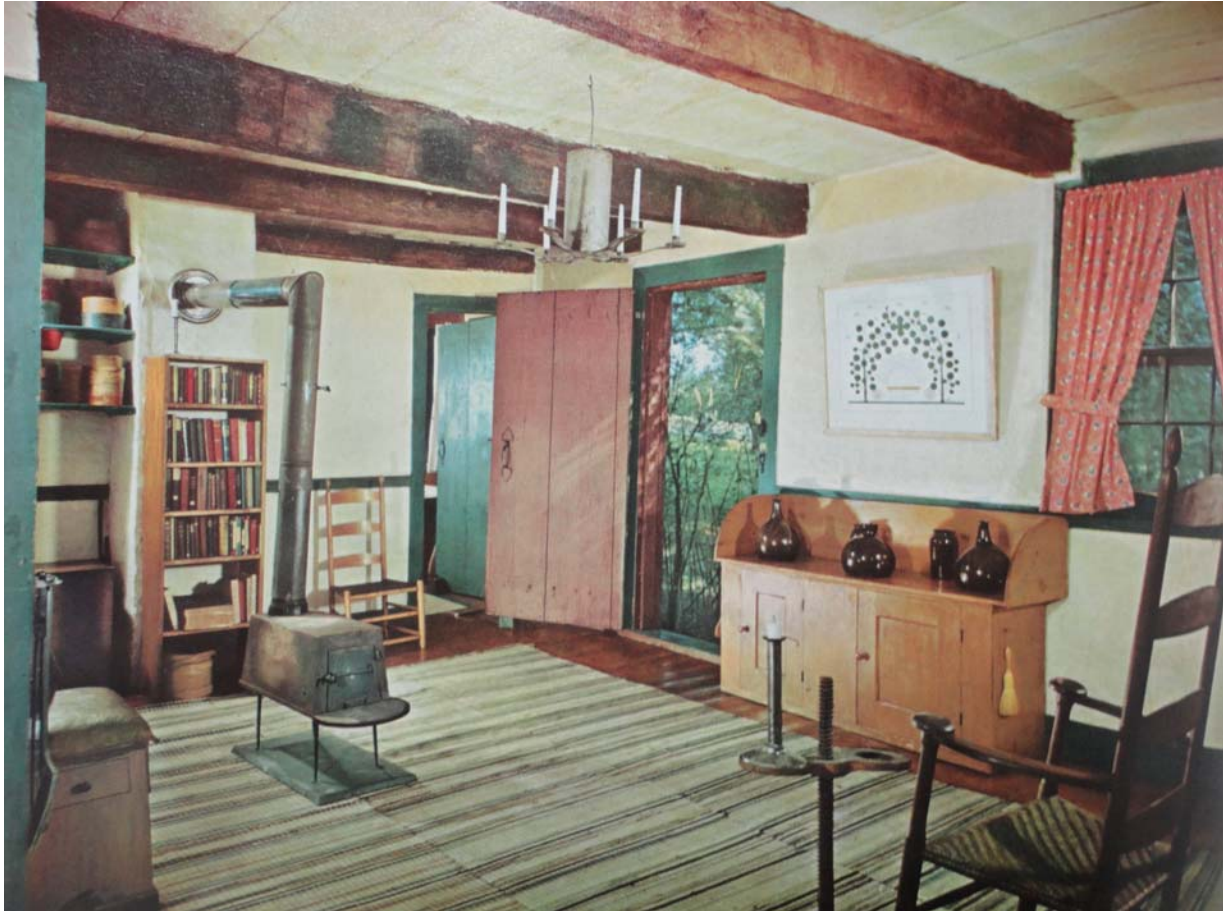
Photo 8. Interior view from *The Golden Treasury of Early American Houses* by Richard Pratt, showing the appearance of the main room of the house as occupied by the Andrews' in the 1960s.

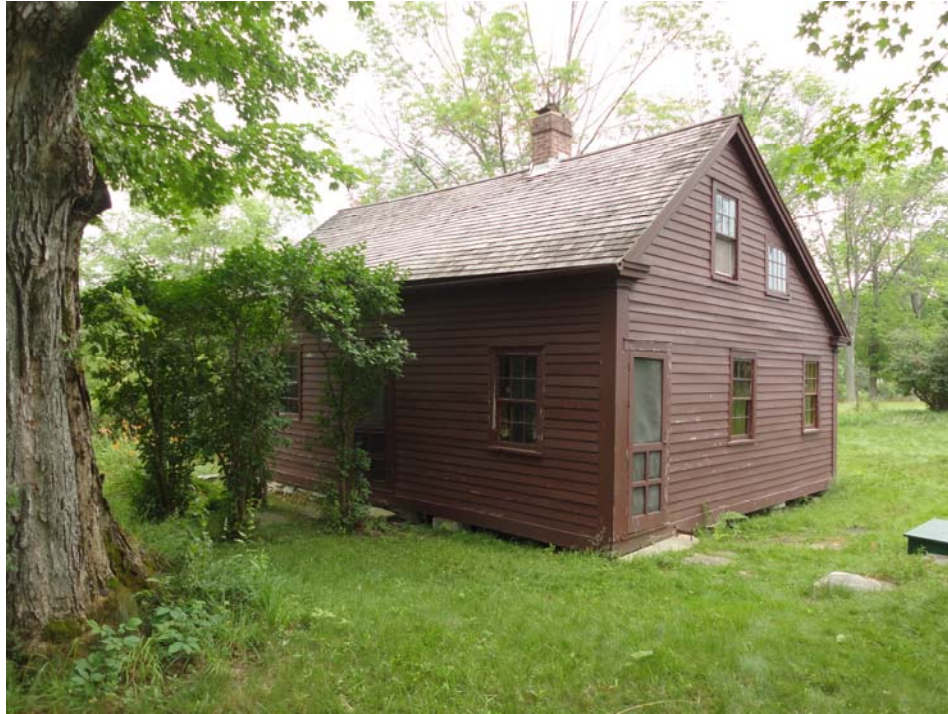
Photo 9. Looking northwest, July 2012.

During a recent visit to the house it became apparent that the original plan likely incorporated a lobby entry and a central chimney. In addition, the house was clearly built in at least two (and likely more) major campaigns, with the older portion of the dwelling taking in the entry and west end of the house. While appearing straightforward at first, the evolution of this house eludes easy interpretation.

Ted Andrews, the current owner and grandson of Faith and Edward Deming Andrews, has been renovating the house, most recently improving its structural integrity with additional framing designed by Jack Sobon. He has removed the Beaverboard interiors installed on the second floor by his grandparents, and has begun refinishing the spaces on that floor with more modern finishes.

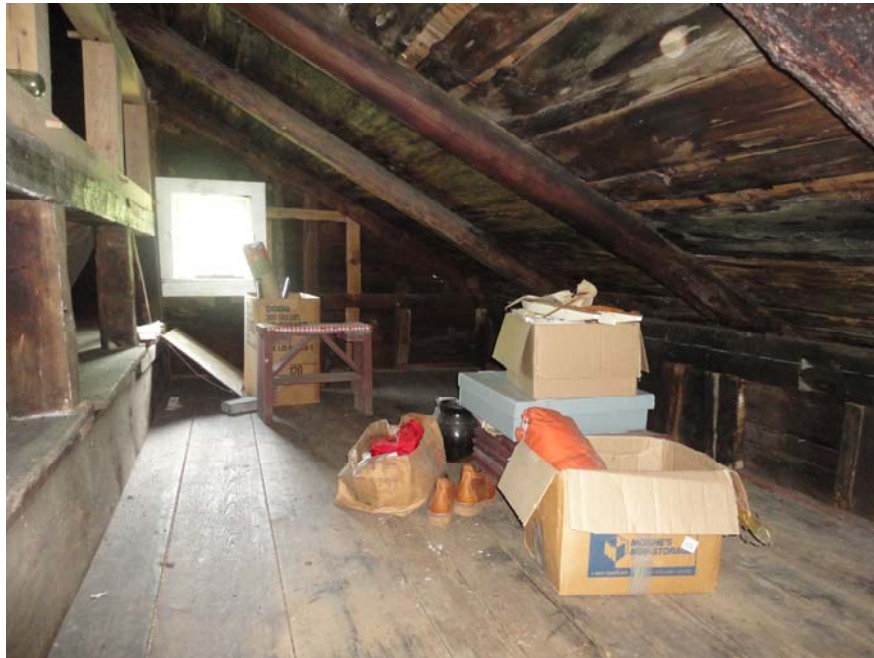
Photo 10. View looking west, in the leanto, second floor, July 2012.
