Pittstown Tour

22 October 2016

A joint tour for the members of the Dutch Barn Preservation Society (DBPS) and the Society for the Preservation of Hudson Valley Vernacular Architecture (HVVA). Tour starts at 11AM, from 59 Sherman Lane: http://nipmoosebarns.org/directions-nipmoose-farm/

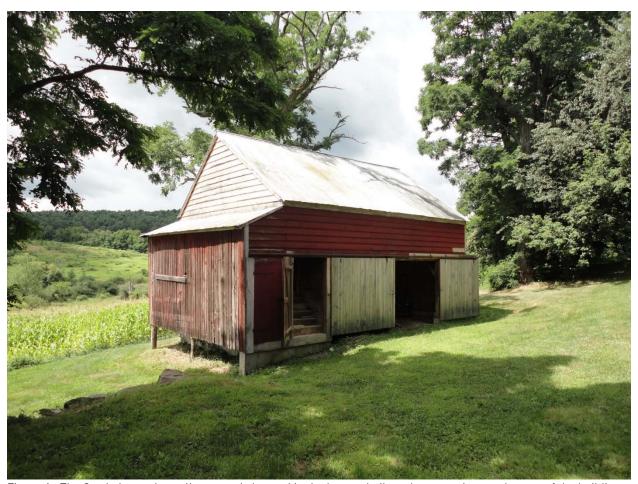
Figure 1. The Cartin barn. A small granary is located in the leanto, built at the same time as the rest of the building (photo by W. Wheeler, 2013).

Some examples, such as the Cornell barn, on today's tour, and the Cartin barn, conflated multiple uses into one building. The Gibbs barn, for example, contains a hay loft, horse barn and granary within a single structure measuring 21 by 28 feet.

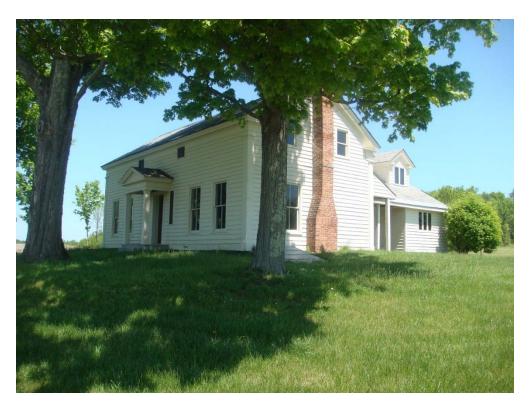
The modest story and a half farmhouse was built circa 1800. Since the farm was established prior to that date, the house must have replaced an earlier dwelling.

Figure 3. The Clapp house at Nip Moose (photo by W. Wheeler, 2012).

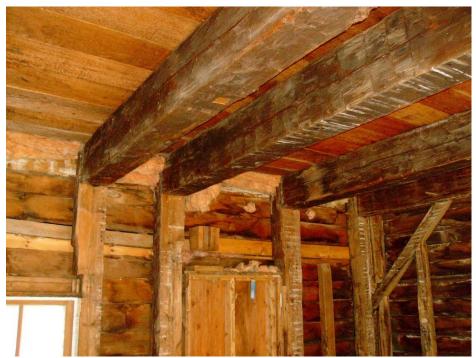
Figure 4. Interior of the Clapp house at NipMoose (photo by Pete Shaver, 2007).

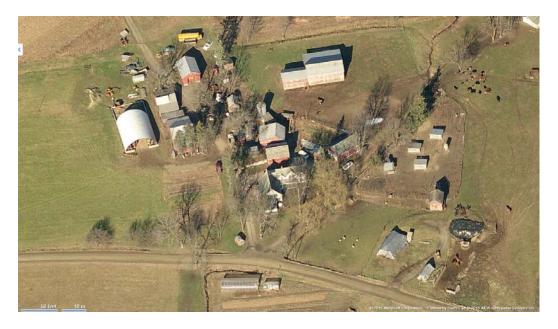
292 Lower Pine Valley Rd, Hoosick. A single-aisle banked combination barn, combining a wagon house having a second floor banked drive, with a corn crib. Many other interesting outbuildings are located on the property, which also has what appears to be an 18th century bent-framed house.

Figure 5. Aerial view of the Cornell farmstead.

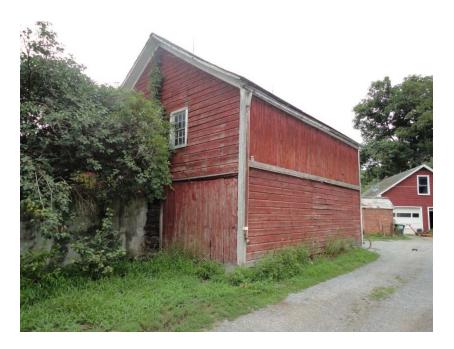
Figure 6. The Cornell barn. A roughly 4'-6" wide corn crib is located on the south side of the second level of this combination barn (photo by W. Wheeler, 2012).

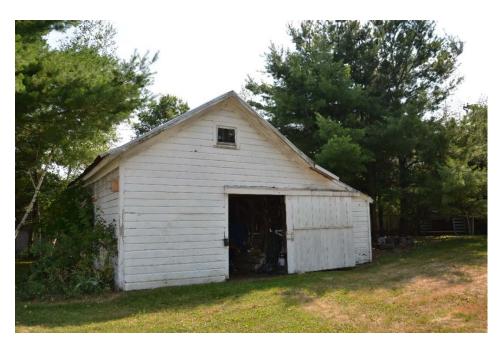
Figure 7. The Peck barn (photo by W. Wheeler, 2010).

This small barn, 18 by 22 feet overall, with an early 10 foot deep addition to the rear, features ten H-bents. The bents in this barn are spaced between 2'-10 and 4'-3" apart, suggesting that the building was intended to carry substantial weight at its second floor level. Some of the anchorbeam posts have marks indicating that lath and plaster was once attached to them.

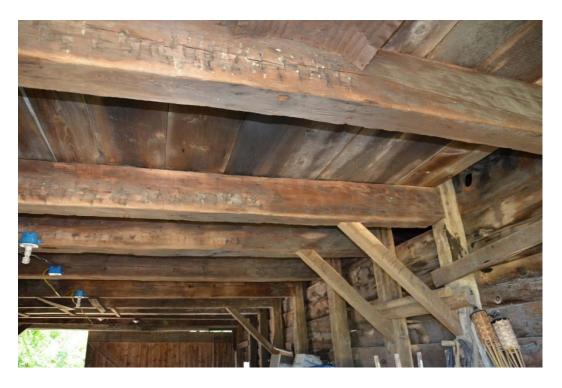
Figure 8. The closely-spaced bents of the Peck barn (photo by W. Wheeler, 2010).

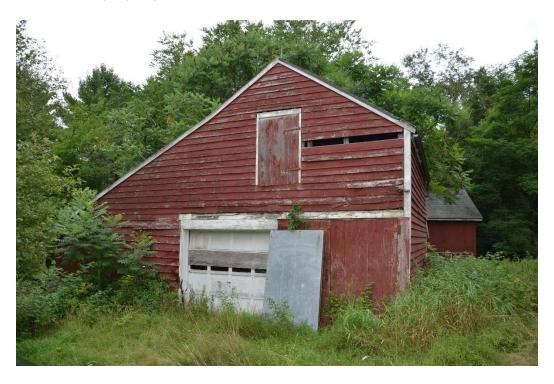
Figure 9. Gibbs barn, before disassembly (photo by Connie Kheel, 2012). The leanto appears to have been original, or a very early addition to the building.

The Gibbs barn is a small structure—18'-1'' wide and just over 21 feet long—with seven closely-spaced anchorbeams. The anchorbeams of the barn are of similarly diminutive size, typically measuring between 7 and 9 inches high and between 6 and 8 inches wide, indicating a probable construction date in the early 19^{th} century. The wood used in the frame includes oak/chestnut and pine or hemlock. The side walls of the barn stand about 12'-3'' high, with the top of the anchorbeams at about 6'-10'' from the ground surface. The paired rafters are $5''x 4 \frac{1}{2}''$ or so in size, and are pegged where they join at the apex of the roof. The spacing of the bents—generally about 3'-4'' on center—and the size and scale of the remaining elements used in the frame, are all typical of dwellings built in the late 18^{th} or early 19^{th} century. It is clear, however, that the Gibbs barn frame was not originally intended to be used for a house; its lack of finish and absence of witness marks for the attachment of lath demonstrate that it was not used for that purpose.

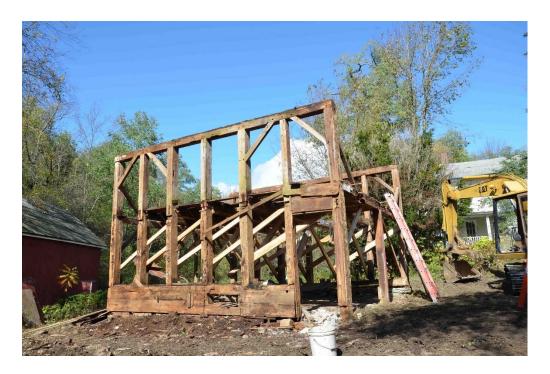
Figure 10. The Gibbs barn in the process of being disassembled (photo by Connie Kheel, 2012).

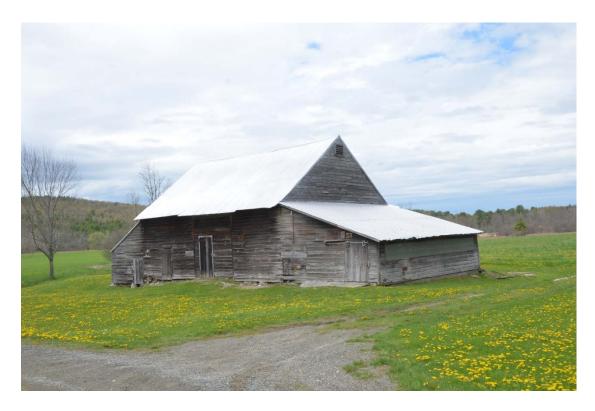
Figure 11. The Moseley barn (photo by Connie Kheel, 2016).

Not much is presently known about the Moseley barn. It appears to have been constructed in the late 18th or early 19th century. The barn measures 28 by 40 and is, at its core, a three-bay threshing barn.

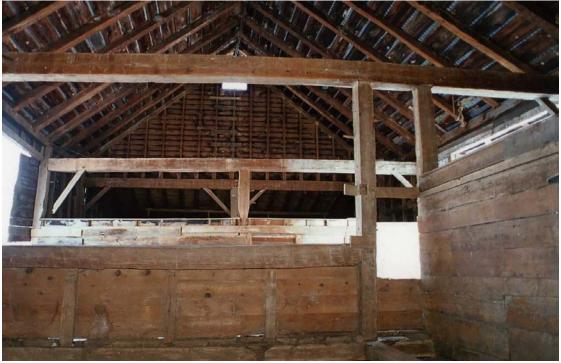
Figure 12. Interior of the Moseley barn, showing bents (photo by Connie Kheel, 2016).
