Newsletter

Vol. 17, No. 4-6

The Jan Martense Schenck House at Brooklyn

By Henk J. Zantkuyl

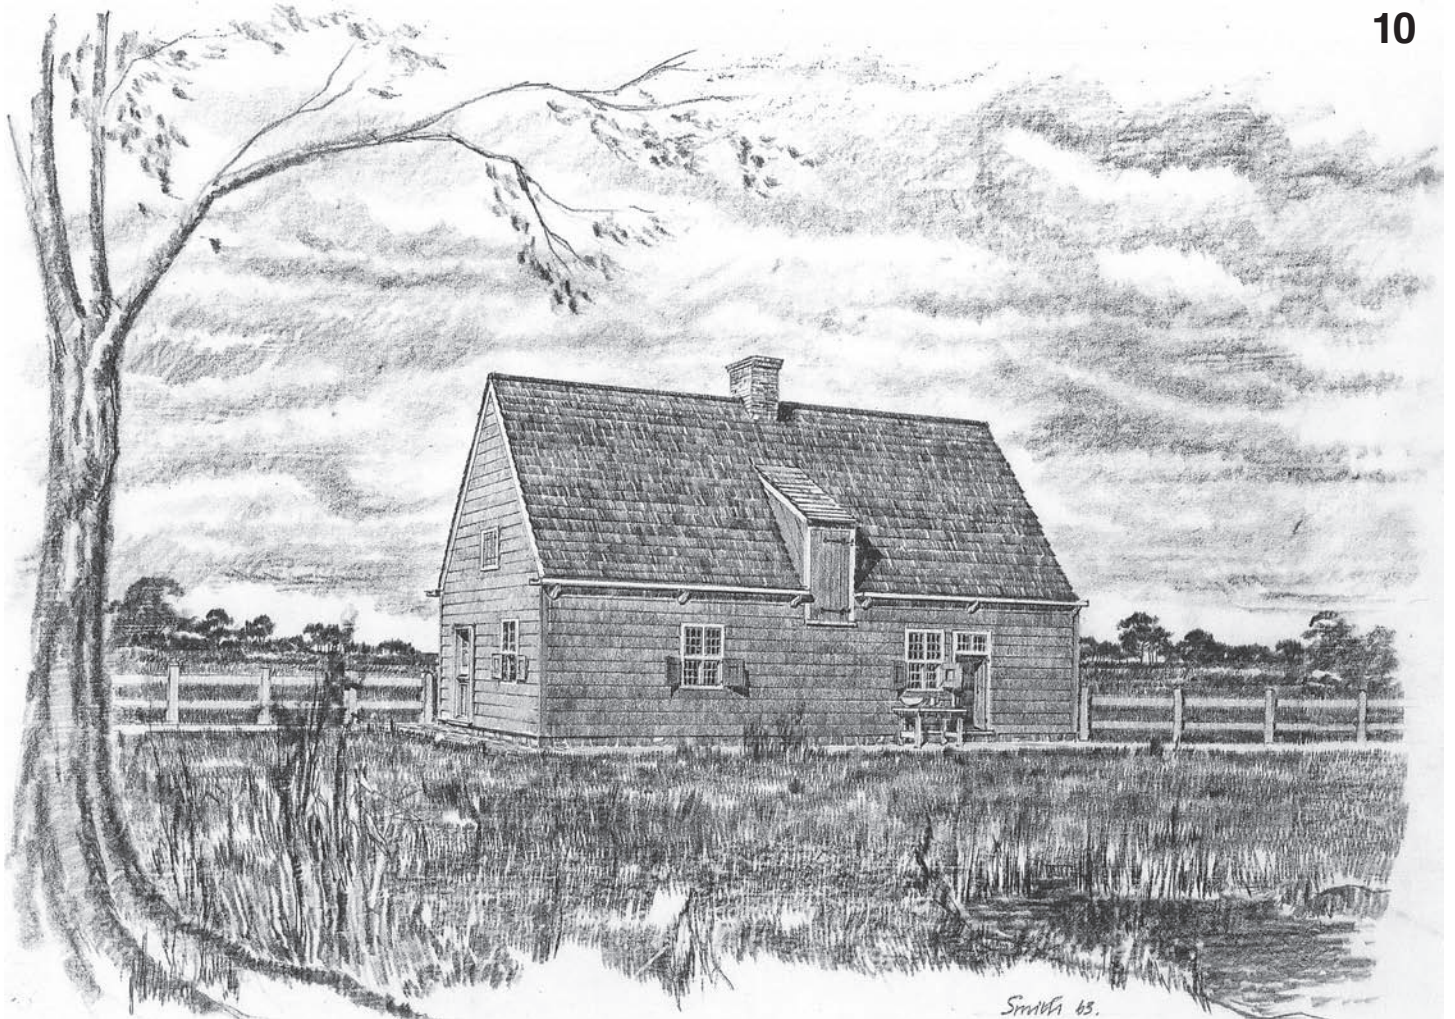
Pl. 10 – Reconstruction of the Jan Martense Schenck house. Drawing by Ian Smith (Courtesy of the Brooklyn Museum).
